Special Forces Camps in Vietnam 1961–70

Gordon L Rottman • Illustrated by Chris Taylor

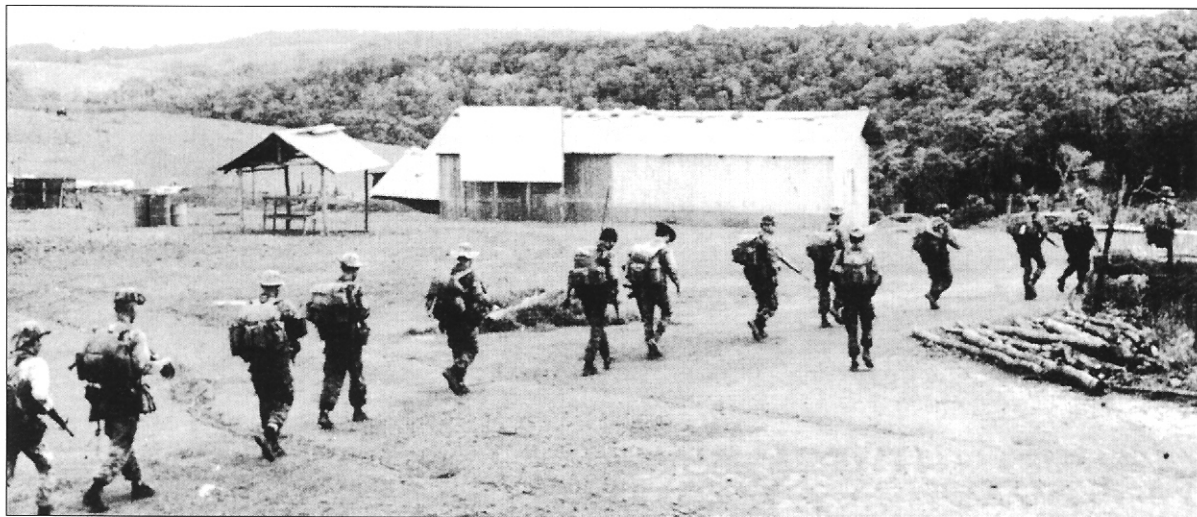
A CIDG Camp Strike Force company departs for a patrol. In the background is a typical camp wood-frame administrative building. Such buildings were not provided with protection. An outdoor movie screen is mounted on the building's side.

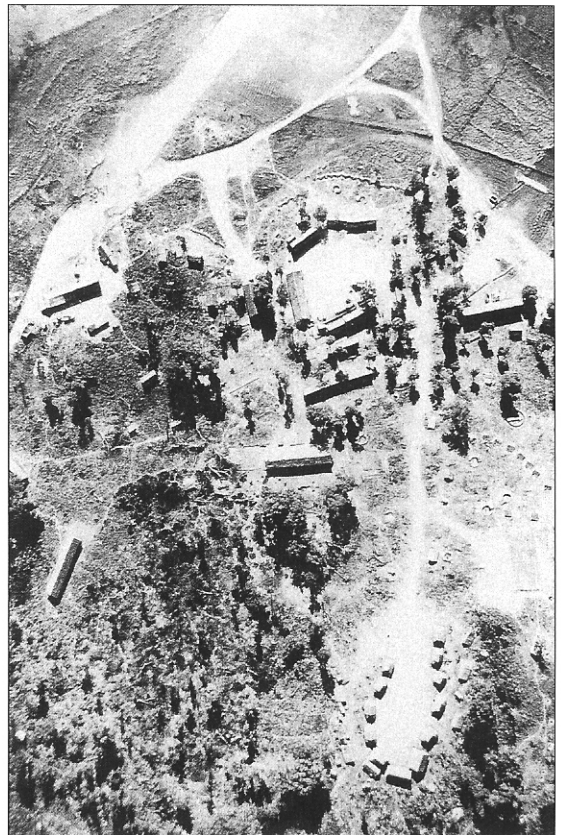
RIGHT Thien Ngon, A-323, III CTZ, opened February 1968. This was in the shape of a five-pointed star with broad arms (part of which are cut off) surrounding a large five-sided inner perimeter. The outer perimeter is a high earth berm lined with covered fighting positions and backed by CIDG and dependents' quarters. A circular road surrounds the inner perimeter, with a wire barrier on both sides. The 105mm howitzer platoon position is in the lower right arm. Camp Prek Klok, A-322, was of similar construction.

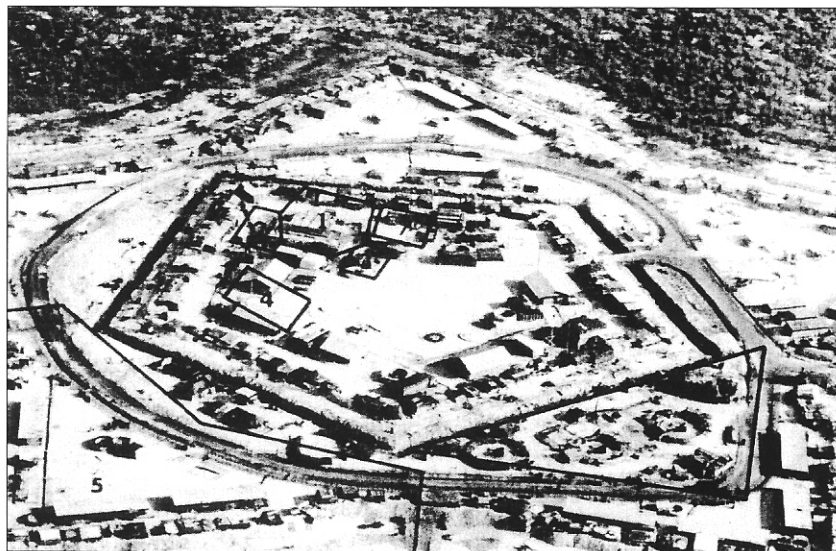
FAR RIGHT Camp Dong Xoai, A-342, III CTZ, opened May 1965. The irregular rectangular area to the right contains the 105mm howitzers and was probably an existing government compound. The extensive trench system on the outer and inner perimeters was added in 1966. The small barracks were replaced by a smaller number of larger barracks situated perpendicular to the perimeter. While under construction by Seabees the outer perimeter was overrun, but the inner perimeter held.

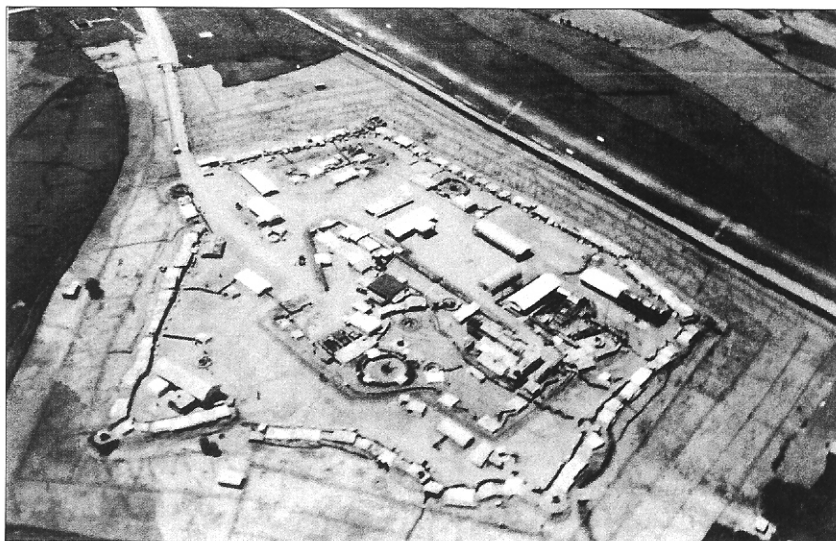
Camp Gia Vuc, A-103, I CTZ, opened February 1962. Its five-sided perimeter is a raggedly aligned trench with covered fighting positions. The inner perimeter is sprawling and irregularly shaped, as was the case in many of the early camps. It appears that one 105mm howitzer position has been completed and the other (above it) is still under construction. The four wire barriers are completely clear of vegetation. An internet virtual tour of Gia Vuc can be found at: <http://www.gia-vuc.com/GIA-VUC-CAMP.htm>.

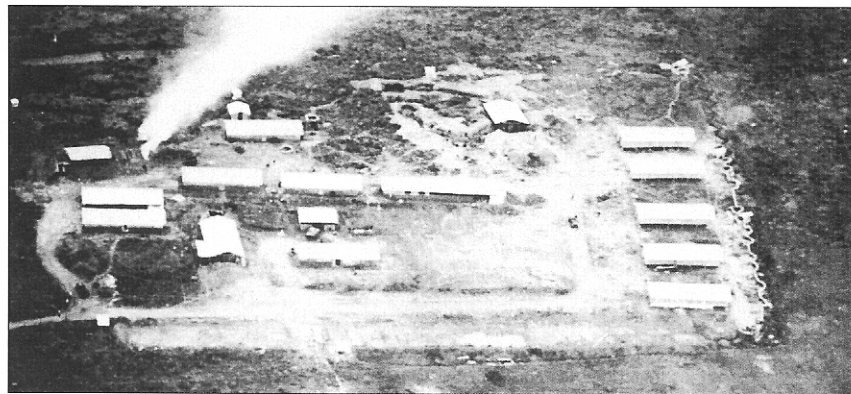
Camp Phu Quoc, A-427, IV CTZ, opened February 1965. This little camp was built at the base of a small knoll on its upper side. It has no inner perimeter as such, but the knoll was developed as a stronghold. The outer perimeter is a low sandbag wall with open fighting positions.

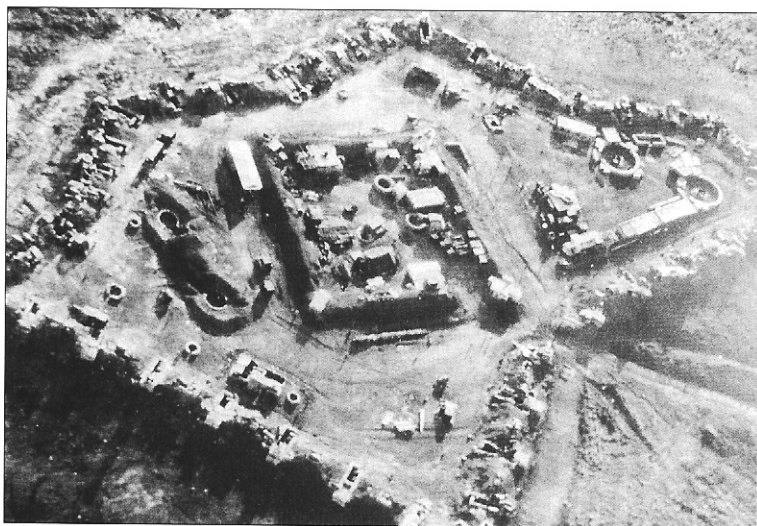
Camp Tong La Chon, A-334, III CTZ, opened March 1967. Most of the later camps were larger, but Tong La Chon was small and cramped. It was later enlarged. When attacked and almost overrun five months after its opening, conditions were so poor only 50 assigned CIDG remained (others had quit). It had to be defended by a company rotated from another camp plus almost 600 MIKE Force. The earth berm outer perimeter is defended by almost 40 fighting and living bunkers, each with its own well-revetted entry trench. Two 105mm howitzers are positioned in the right arm; two 81mm mortars are in the inner perimeter and two in the left arm.

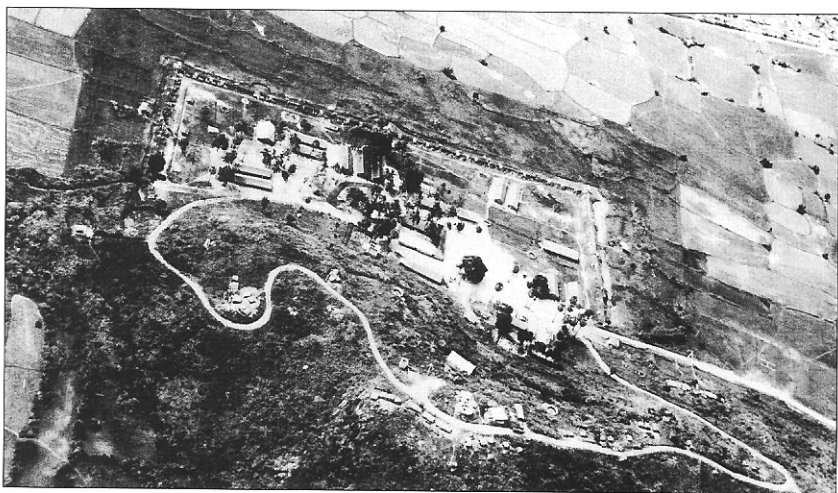
Camp Dan Thanh, A-423, IV CTZ, opened April 1964. This rectangular camp was built at the base of Ap An Nong Hill (115ft above sea level), which was incorporated into the camp. There is both an inner perimeter in the lower camp and a stronghold atop the hill. The outer perimeter is an earth berm with individual fighting positions.

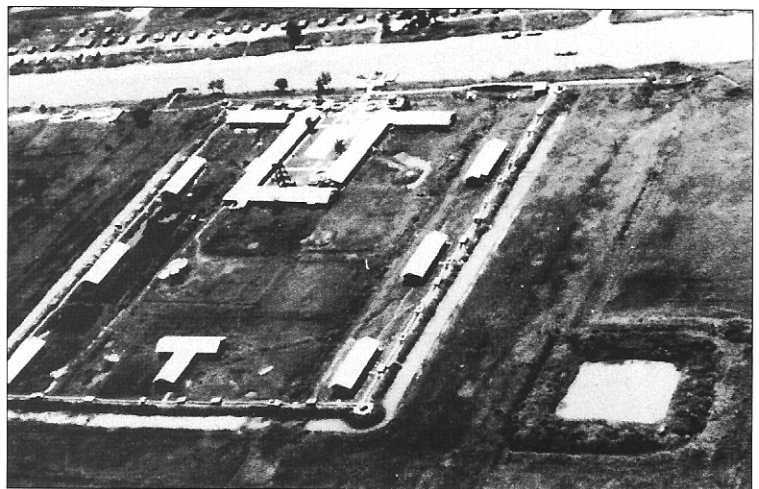
Camp Bu Dop, A-341, III CTZ, opened November 1963. This camp originally had a moat. It was extensively rebuilt after attacks in 1967. The zigzag trench has over 20 fighting positions and two machine gun bunkers on each concave wall plus corner bunkers. Most of the barracks and other buildings are sunk to almost ground level. No less than 18 mortar pits can be seen. Several machine gun and/or recoilless rifle positions are inside the upper wall. Two 105mm howitzers occupy the right side while a composite ARVN battery of four 105mm and two 155mm howitzers occupy the left side. Rows of CONEXs are near the inner perimeter gate for additional bunkers.

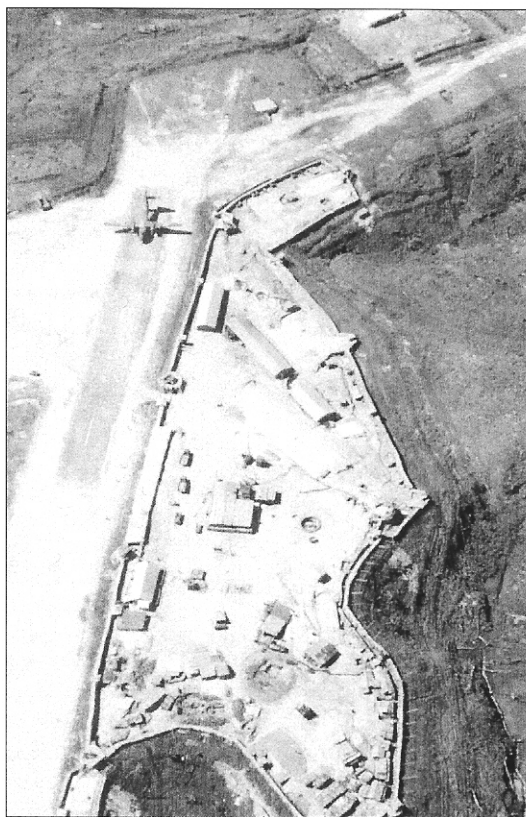
Camp Mang Bak, A-246, IV CTZ, opened July 1964. This small camp, like so many of the early ones, follows the contours of a ridge. There is no inner perimeter as such. In the upper portion a large below-ground combined TOC is under construction. The outer perimeter is a high wall with firing ports and machine gun bunkers at key points backed by living bunkers and barracks. A C-7A Caribou transport sits on the partly planked runway. If the runway's soil was sufficiently compacted, only the landing portion required planking.

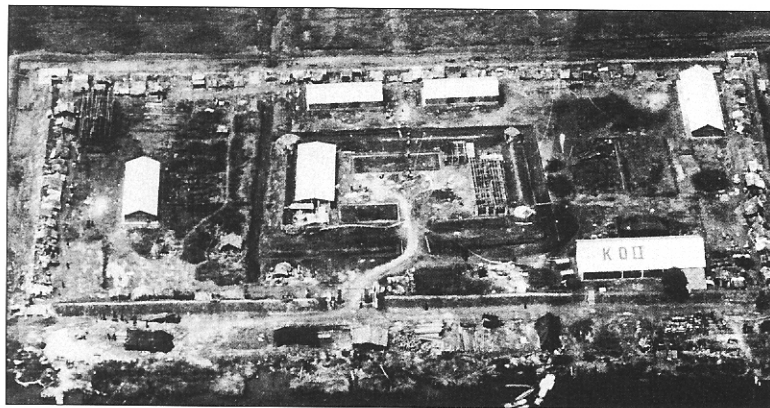
Kinh Quan II, A-412, IV CTZ, opened October 1965. KQ II is still under construction in this photo. The outer berm is lined with temporary fighting and living bunkers, but with few on the river side. Buildings inside the inner perimeter are still under construction. The inner perimeter is unique in that it possesses a moat. It appears the camp was built over an existing fortification.

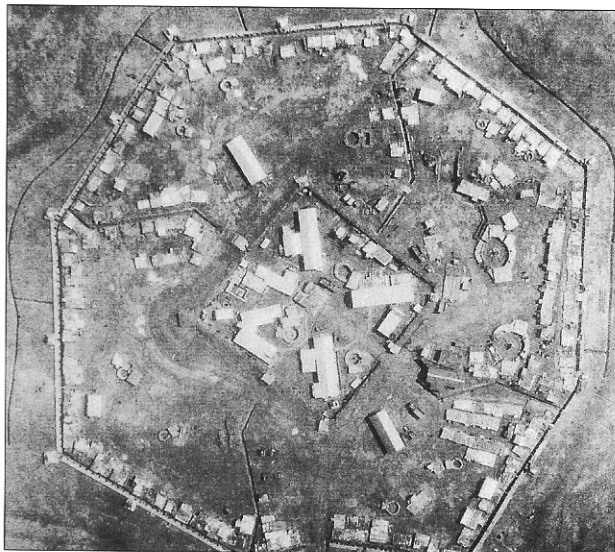
Camp Chi Linh, A-333, opened January 1967, was originally known as Cau Song Ba. Compare this photo to the camp diagram on page 21. The USSF team house (the V-shaped building) had its team quarters (the upper arm) destroyed by fire. The drainage ditches outside the outer perimeter are actually shallower and narrower than they appear and choked with concertina wire. This was the author's camp.

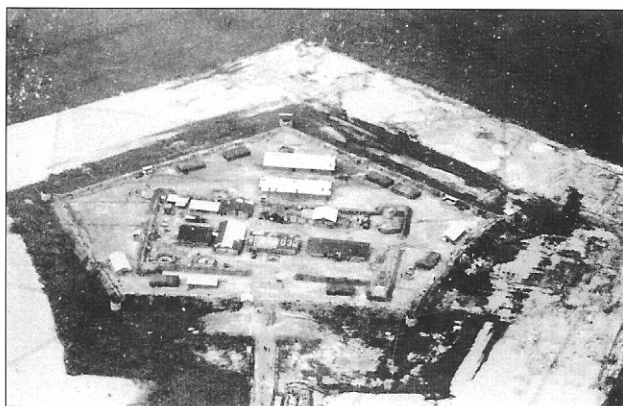
ABOVE LEFT Camp Binh Thanh Thon, A-413, IV CTZ, opened May 1965. This small camp is still under construction in this photo. While two CIDG barracks have been completed most of the troops are still housed in tents. All mortars are contained in the comparatively large inner perimeter. Its design is less than desirable as it has four very wide openings in its berm. This was probably corrected at a later date. The wire barriers are still being installed.

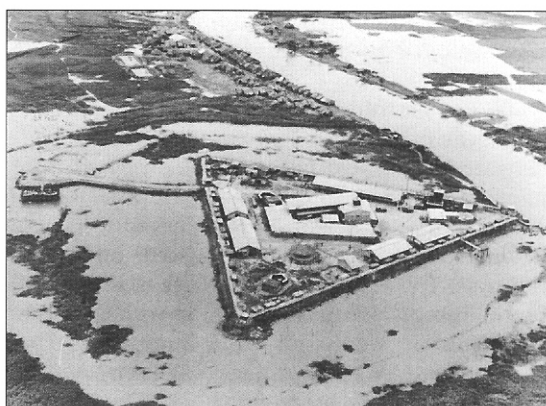
ABOVE RIGHT Camp Cai Cai, A-412, IV CTZ, opened April 1965. The early camp had barracks on each wall and a large administrative building between the combined team house complex. The 1965 flood seriously damaged the original barracks and smaller barracks on 4ft concrete block stilts replaced these. The old administrative building was torn down and replaced by a two-story fortified TOC in the open end of the central complex. One of its wings was provided with a second story for occupation during flooding. During the 1966 flood, with the river 12ft above normal level, temporary hoochs were built atop the barracks. It was soon after this that the camp was modified as a floating camp. The team's designation was changed to A-431 in June 1967.

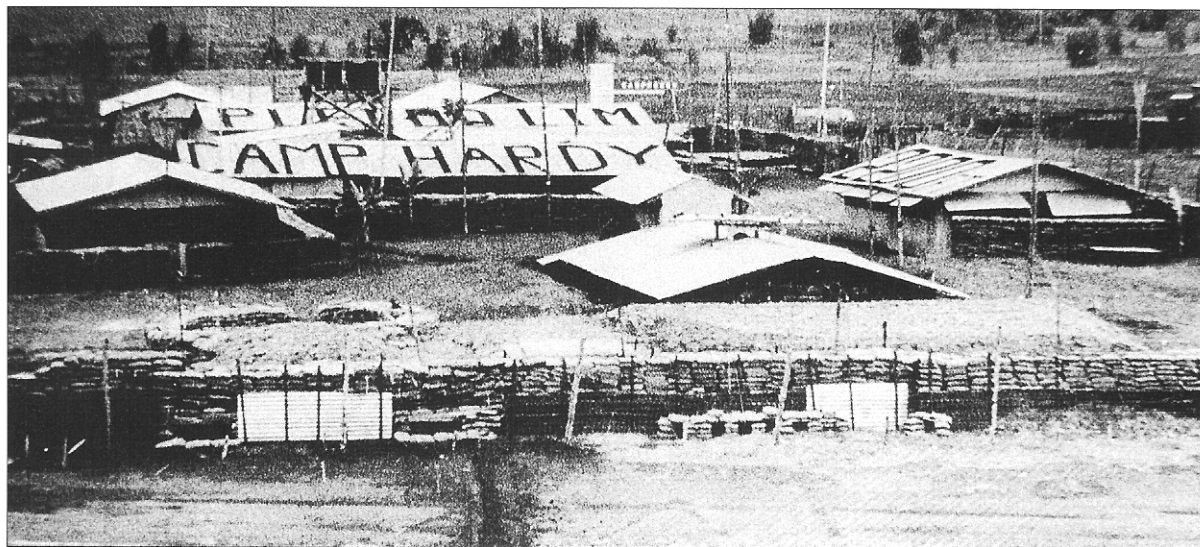
Camp Plei Do Lim, II CTZ, opened April 1962. Because of difficulties with the LLDB, the new commander of A-334 named it Camp Hardy after CPT Herbert F. Hardy, Jr., killed in action during April 1964. Naming strike camps after Americans was extremely rare and this may have been the only instance. C-team camps, though, were sometimes named in honor of an American. This view displays the outer perimeter sandbag wall faced with PSP and various types of firing ports. The wire barrier comprises two rows of double-stacked concertina. A six-strand cattle fence is set 2ft outside the wall.

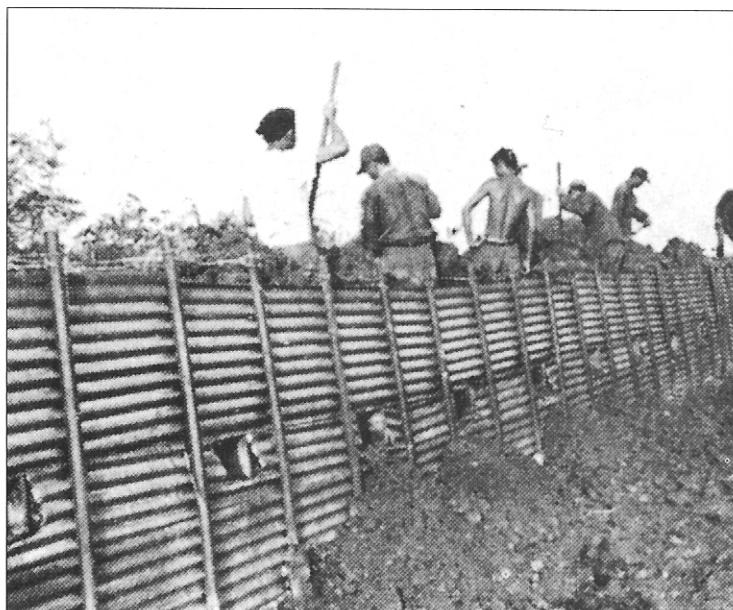
The outer perimeter sandbag parapet is faced with corrugated sheet metal held in place by steel pipes anchored with barbed wire. Small wood-framed firing ports are provided and each firing step has overhead cover.

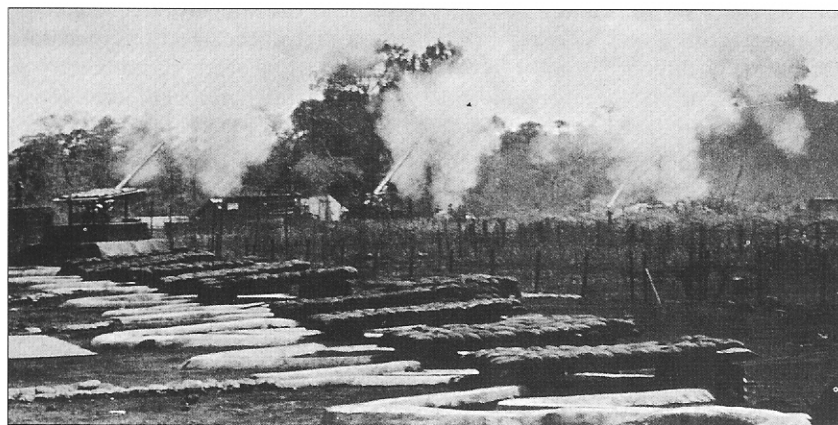
Camp Bu Dop. A US 175mm gun battery established in an adjacent temporary fire support base opens fire. In the foreground is the camp's concrete-capped, sandbag-revetted perimeter trench with sandbag-covered individual fighting positions.

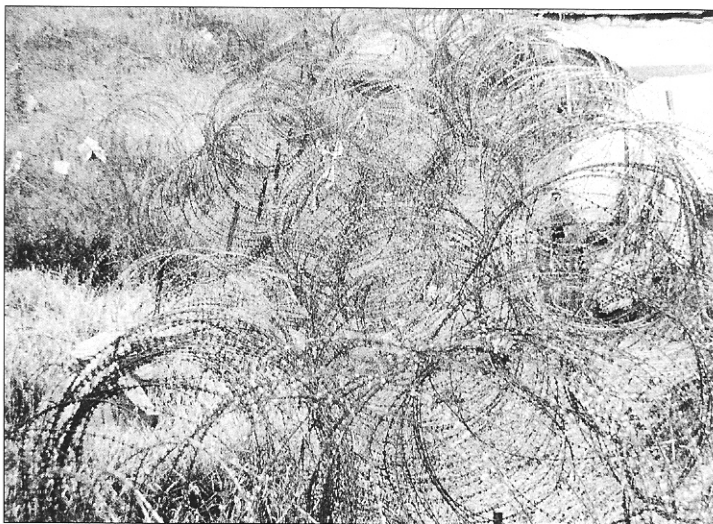
An especially dense razor-wire concertina belt. While providing a formidable obstacle, the difficulties involved in controlling the growth of vegetation can be seen. Some camps sprayed motor oil or asphaltic cutback in an effort to reduce growth, but over time the weeds would still take root. Wire tended to ensnare a lot of blowing waste paper.

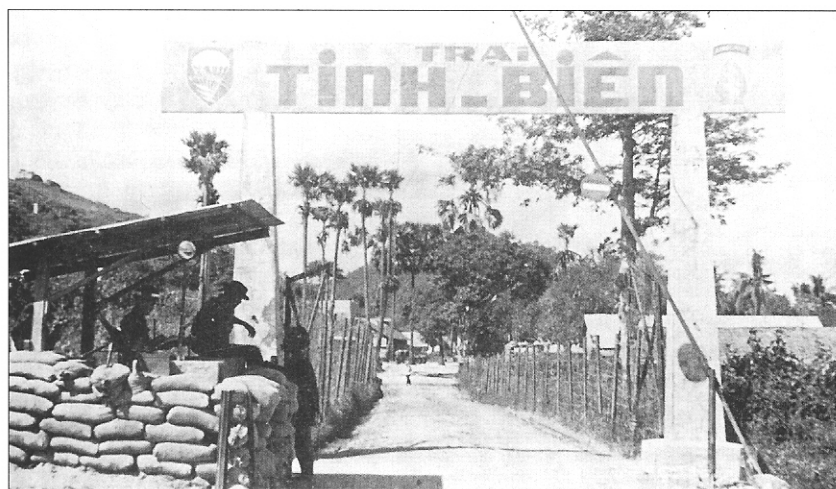
A USSF officer walks the outer perimeter road (few camps had this feature) between the outer perimeter and wire belts. About 3ft in front of the concrete-capped parapet is a five-strand cattle fence backed by a coil of concertina. Covered fighting positions top the parapet.

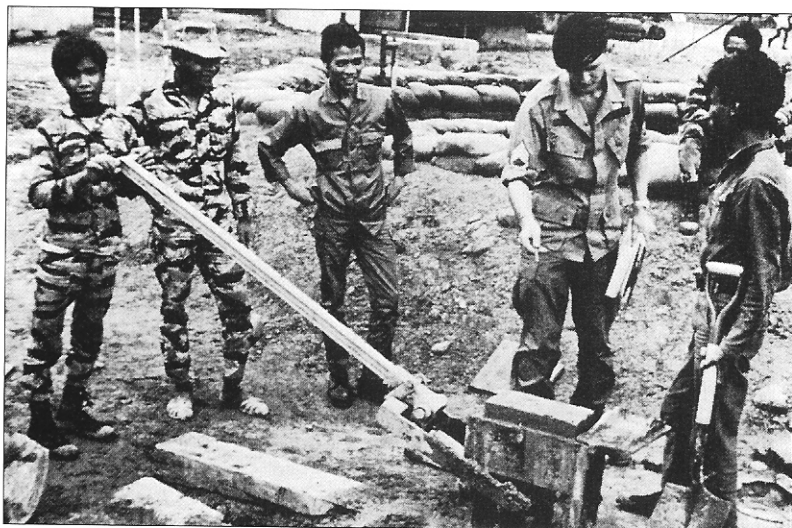
Strikers are taught how to operate a Cinva-Ram concrete-brick-making machine. The simple machine was invented in Colombia in the 1950s and introduced into Vietnam by the Seabees. The ram compressed the cement with 1,800 lbs per square inch, precluding the need for gravel aggregate.

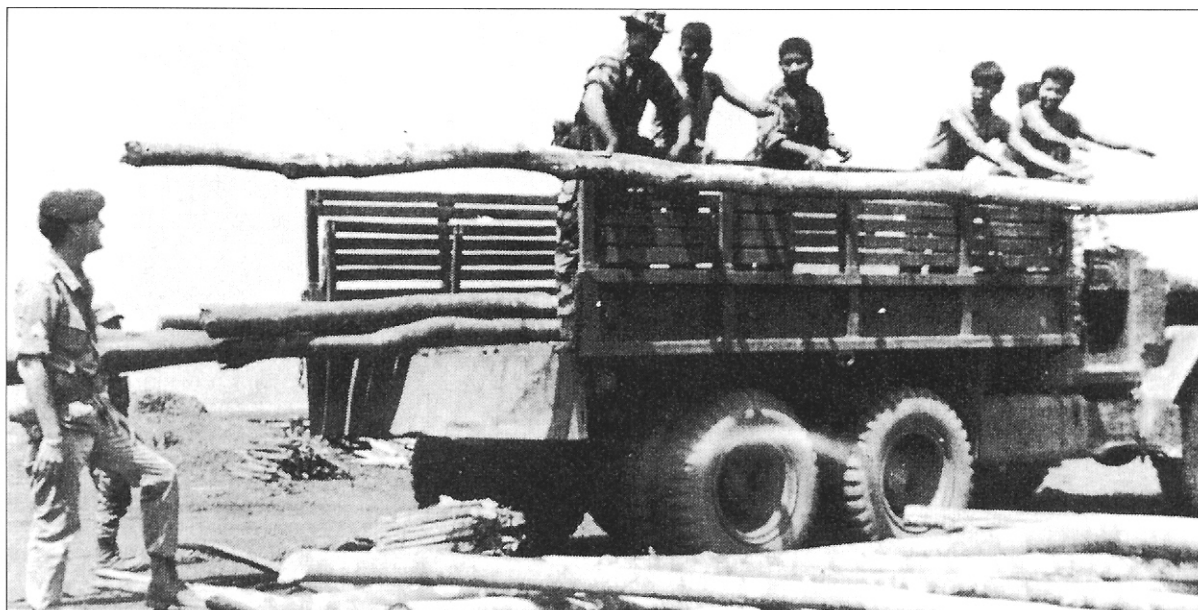
Construction costs were kept down by the use of local materials. These also substituted for standard materials that were frequently in short supply. Here a woodcutting crew delivers hardwood logs to be used for anti-sniper walls.

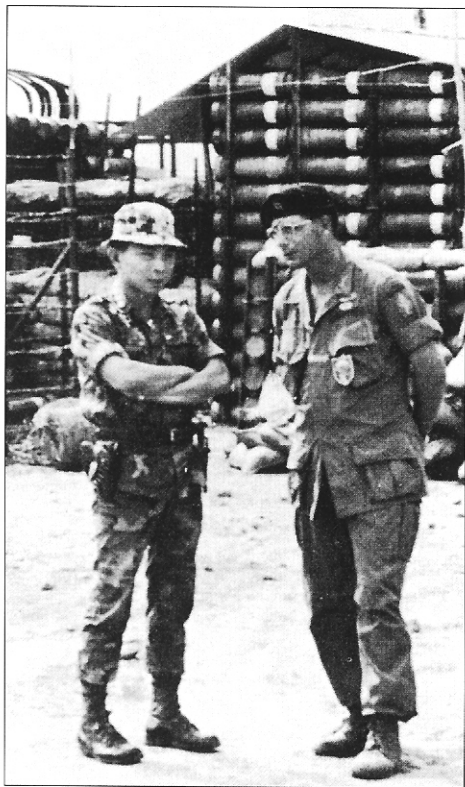
ABOVE LEFT The wood-frame building is protected from mortar fragments and sniper fire by soil-filled steel 8in. howitzer propellant charge tubes.

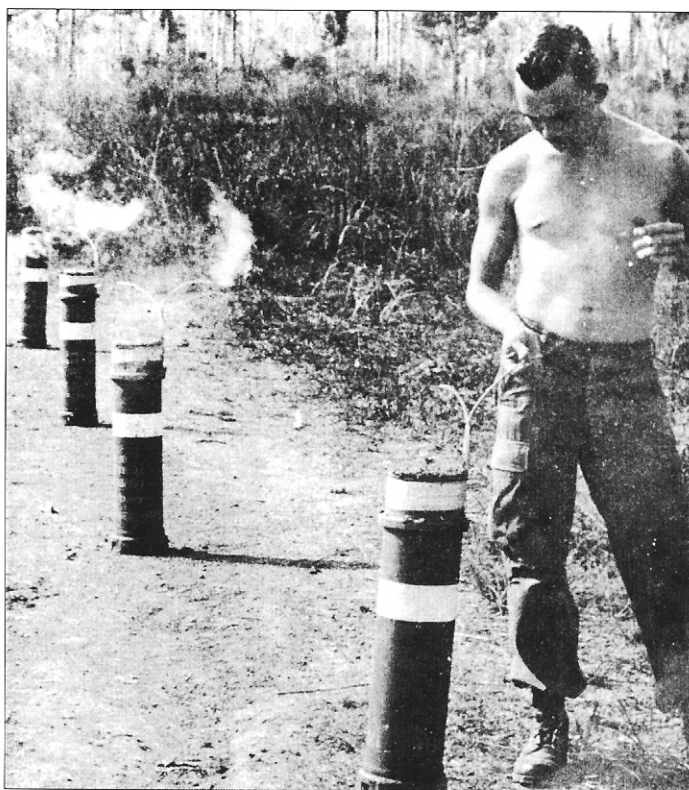
ABOVE RIGHT One loop of detonating cord is placed around the inside lip of a 155mm propellant tube and tamped with mud. This cuts out the bottom end, allowing the tubes to be welded together end-to-end for a drainage pipe.

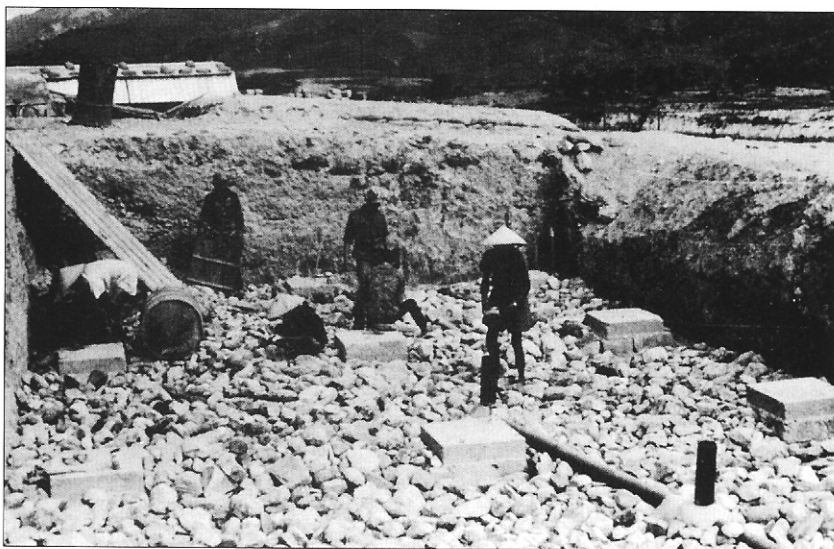
Concrete footings and plumbing have already been installed for this below-ground dispensary. Locally hired laborers dump rock fill before the concrete slab is poured.

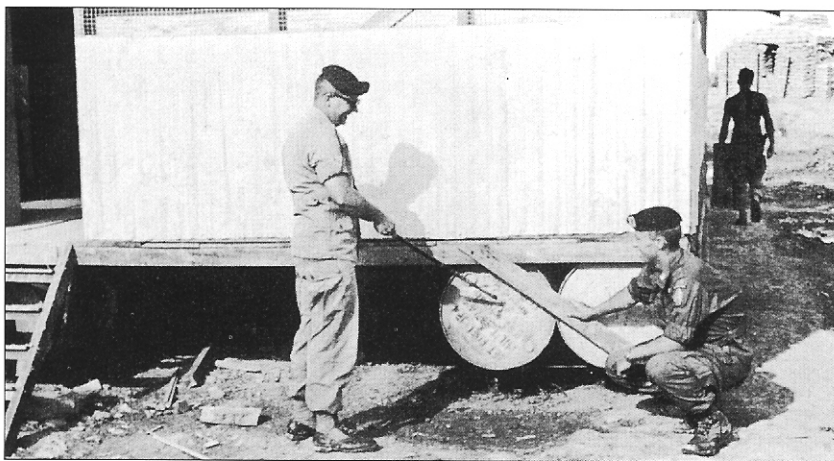
USSF officers examine the sealed 55-gallon drums attached to a floating barracks at Camp My An, IV CTZ. Floating buildings were provided with porches, which served as boat docks when the camp flooded. Travel between buildings was accomplished by using native dugouts, 16ft fiberglass assault boats, or simply swimming.

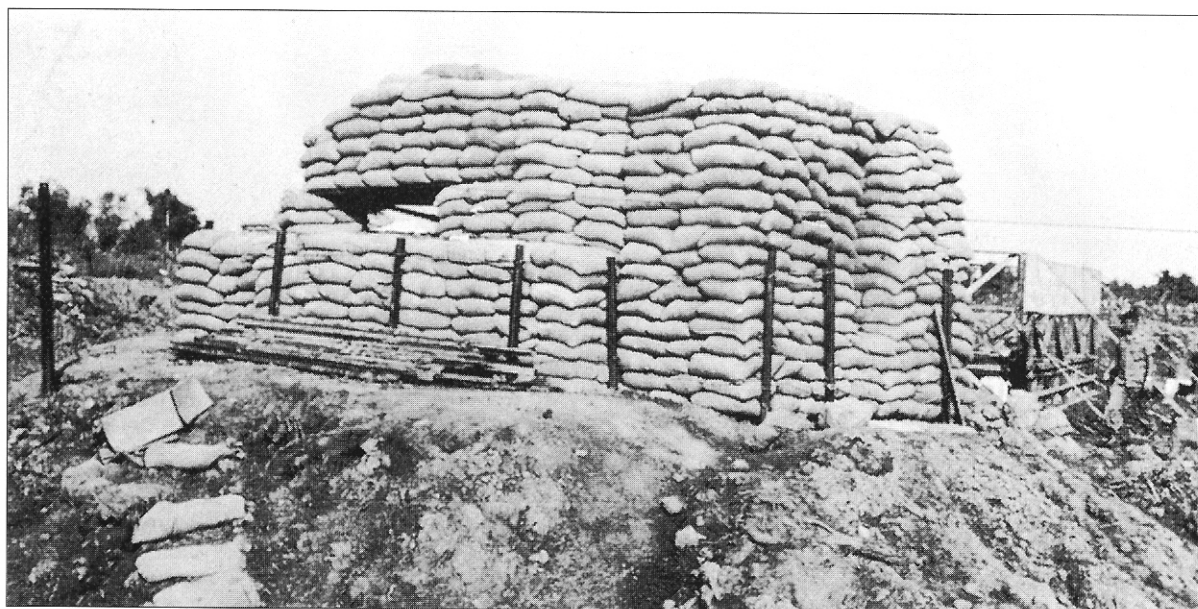
This newly constructed sandbag bunker at My An is built on an earth mound above flood level. The barbed wire pickets help retain the sandbags and will be reinforced with barbed wire strands, then concrete-capped.

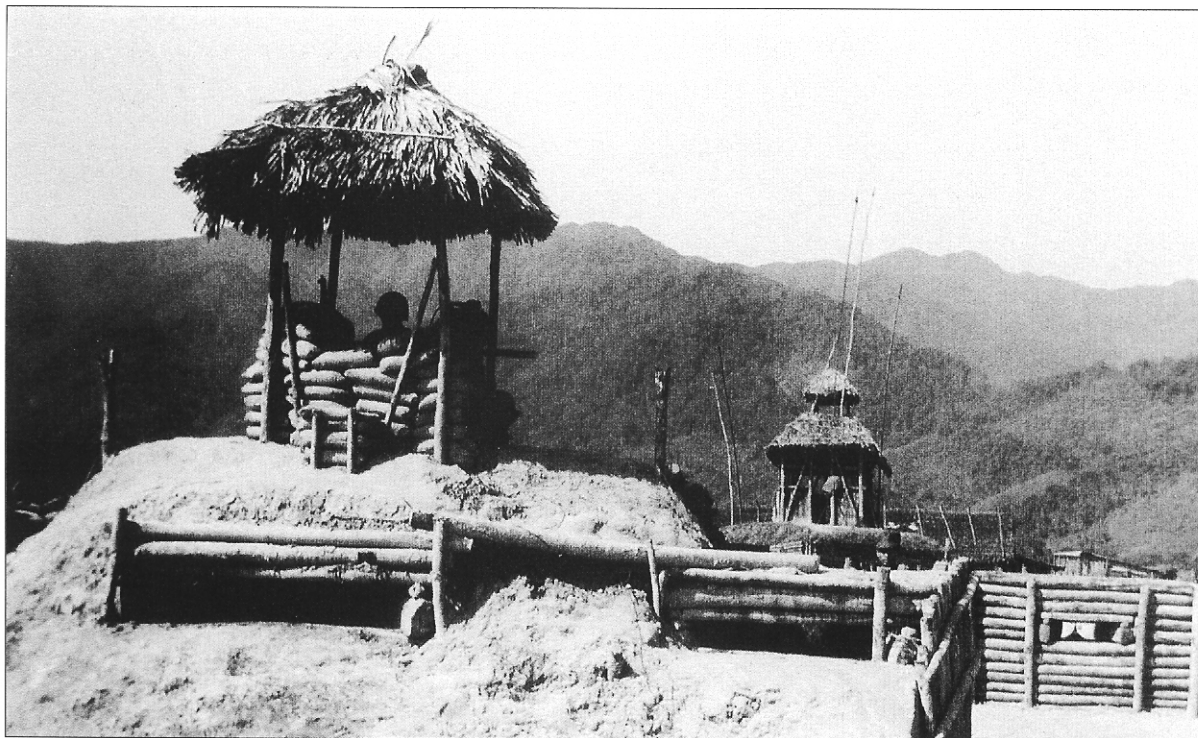
ABOVE This log and earth bunker was typical in early camps when sandbags were in short supply. Split logs are used for firing ports, as dimensioned lumber was scarce. The guard hut, protected from snipers by sandbags and from the sun by a thatch or corrugated steel roof, was a standard fixture.

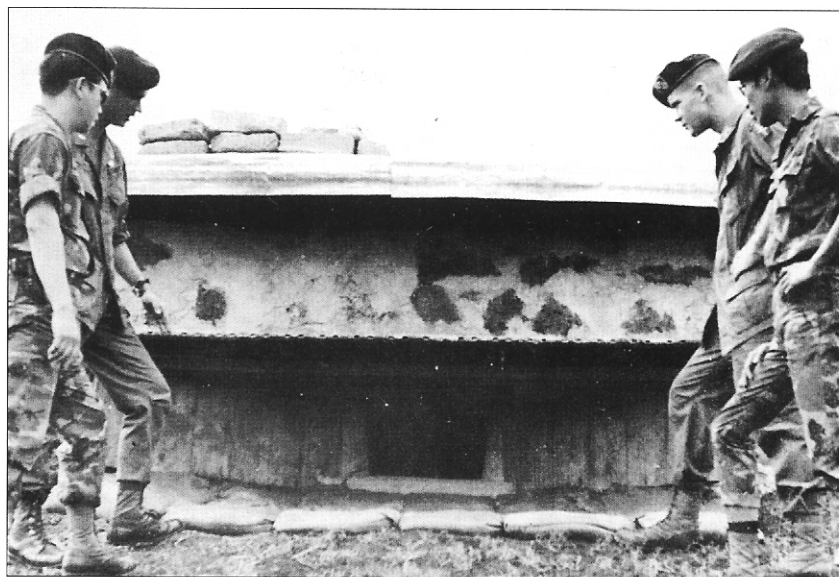
A camp's USSF and LLDB officers inspect a recently completed concrete bunker. The roof is several layers of sandbags contained by a concrete wall, covered by corrugated sheet metal for waterproofing, and topped by a burster layer of concrete blocks and rubble.

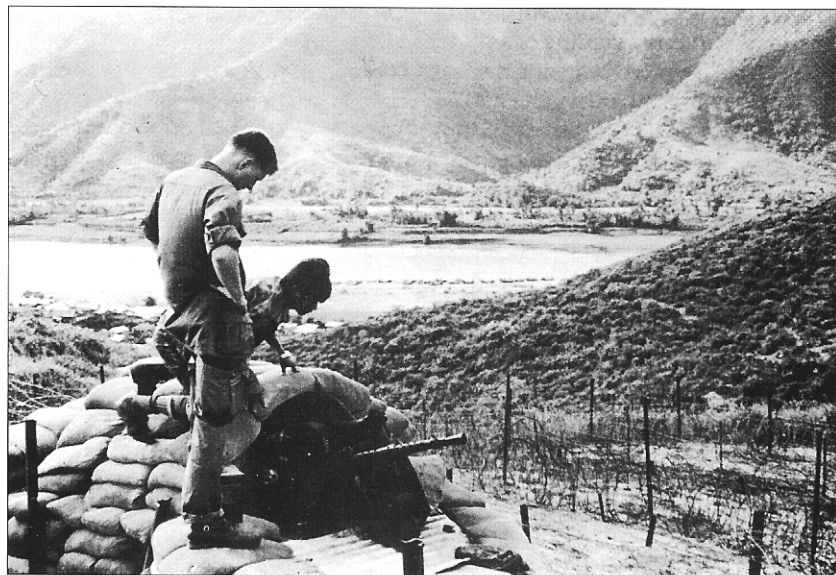
USSF and LLDB weapons NCOs check a .30-cal. M1919A6 machine gun position at an outlying outpost. The hastily constructed position is made from a half-section of 4ft-diameter corrugated metal pipe and covered with plastic sandbags.

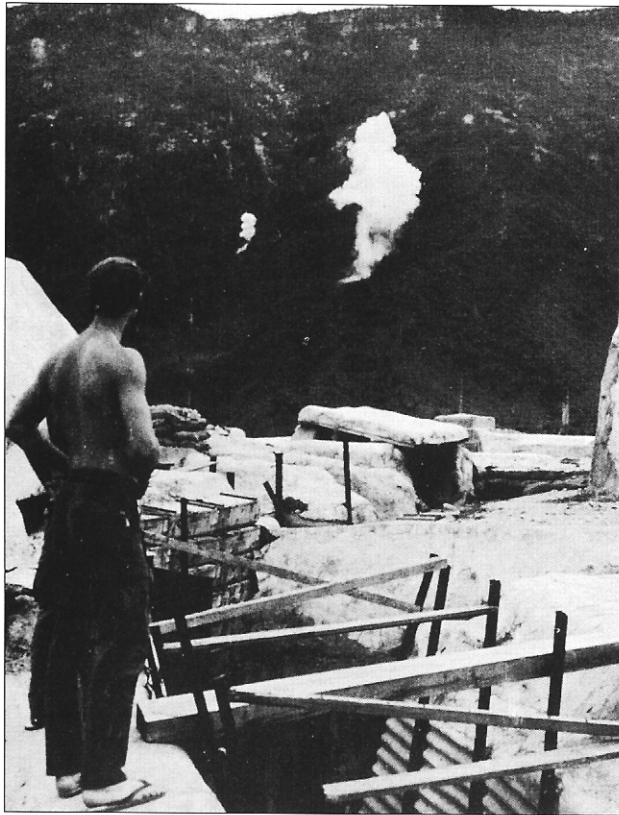
ABOVE LEFT A USSF NCO watches WP bursts from his camp's 4.2in. mortar. The entire trench and bunker complex is completely concrete-capped. Barbed wire pickets hold the corrugated trench revetting in place and are reinforced by plank spreaders jammed between them.

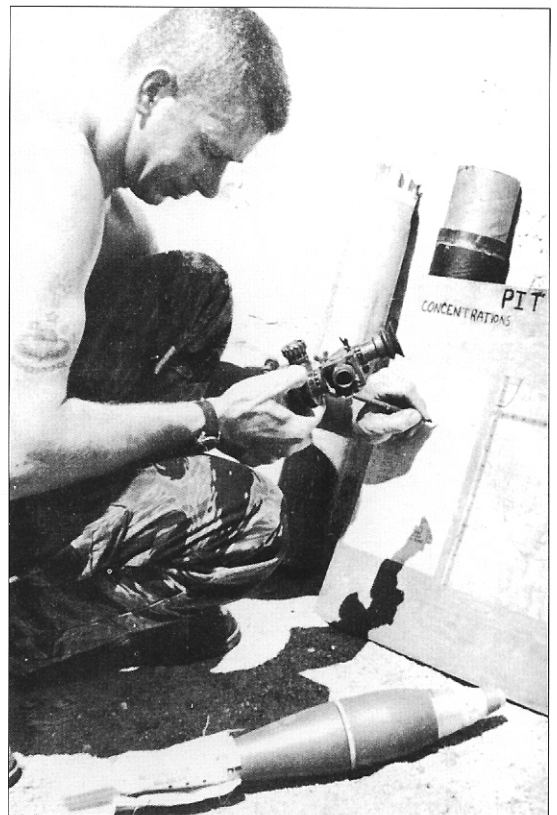
ABOVE RIGHT A USSF weapons NCO plots DEFCON sight elevation data on a mortar pit's firing data board. On the ground is an 81mm M374 HE round. Most of the charge bags on the fins will be removed because of the DEFCON's short range.

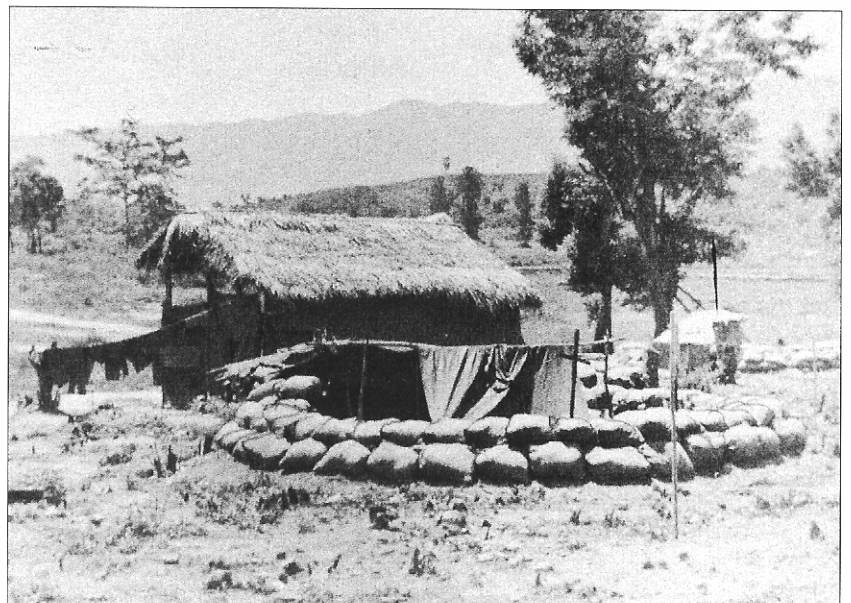
RIGHT This is an example of a very early camp's 81mm mortar pit: merely a pit dug in the ground with a low sandbag parapet. The hooch behind it is constructed of thatch and bamboo rattan; typical local materials.

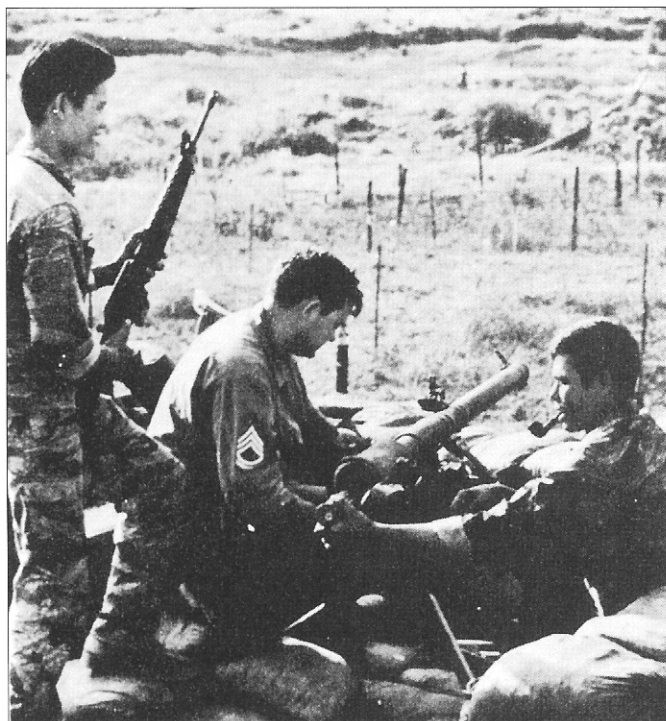
A 57mm M18A1 recoilless rifle is inspected. It is mounted on an M1917A1 tripod, originally designed for the Browning water-cooled machine gun. This position has a low sandbag parapet.

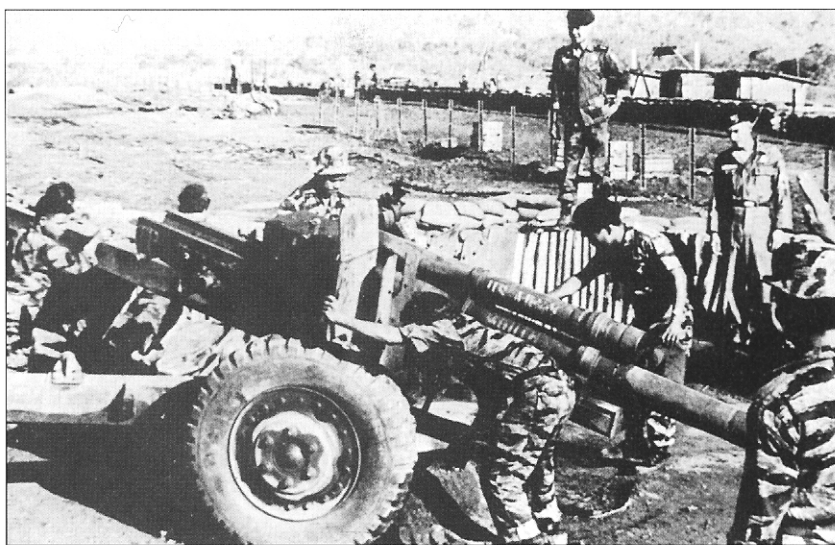
Strikers wheel a 105mm M101A1 howitzer into a newly completed firing position revetted by vertical stakes and sandbags. One or two ammunition bunkers were attached to each “gun pit.”

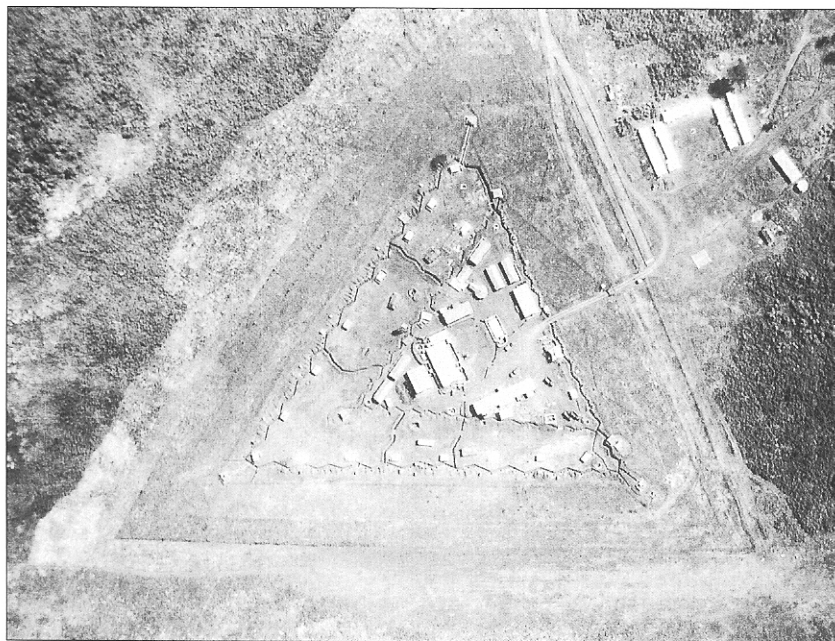
Camp Plei Me, A-255, II CTZ endured a grueling siege from October 19–27, 1965 requiring reinforcement by Project Delta and MIKE Force troops. The commitment of US troops to the battle saw their first major combat in Vietnam. The camp is a classic triangular shape, but with the inner perimeter abutting the right wall. Both perimeters consist of zigzag trenches with firing port-pierced parapets. Note the corner machine gun bunkers extending beyond the perimeter and backed by a large fighting bunker. In the center of the inner perimeter is the heavily sandbagged TOC.

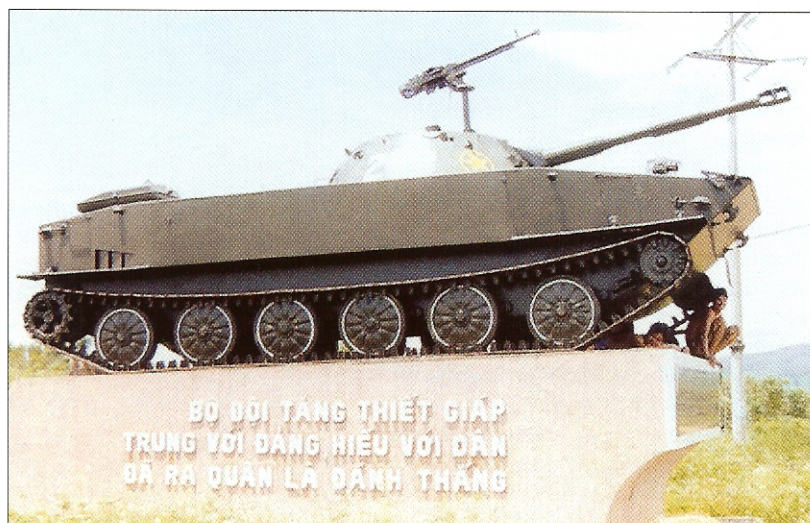
A PT-76 tank memorialized at Lang Vei. The legend reads: "The cadre [crew] of this tank inspired the people to rise up and fight to victory." All that remains of the camp is some broken concrete walls that were part of a bunker. (Danny Wright, Australian Army Training Team, Vietnam, attached to II Corps MIKE Force)
