ARMOR AT WAR SERIES

Panther

Text by Thomas Anderson
Color plates by Vincent Wai

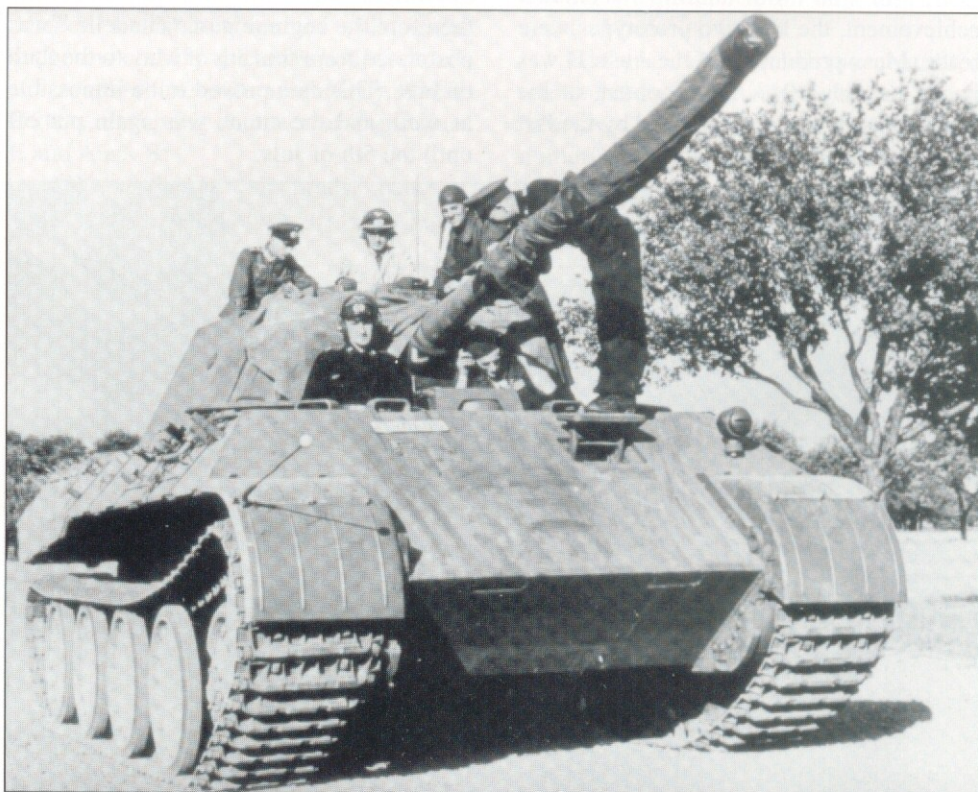
The Panther appeared in early 1943, and this photo gives a good impression of its shape. This vehicle shows a late Ausf. D, as evidenced by the fact that the right headlamp was deleted. The muzzle brake is not yet fitted, but the gun does show a protective cover. The Panther lacks all equipment, indicating that it is brand new. The unusual license plate shows a Berlin number (1A). Since the color of the vehicle appears to be dark grey, this well known photo has often been dated from 1942. (M.Green)

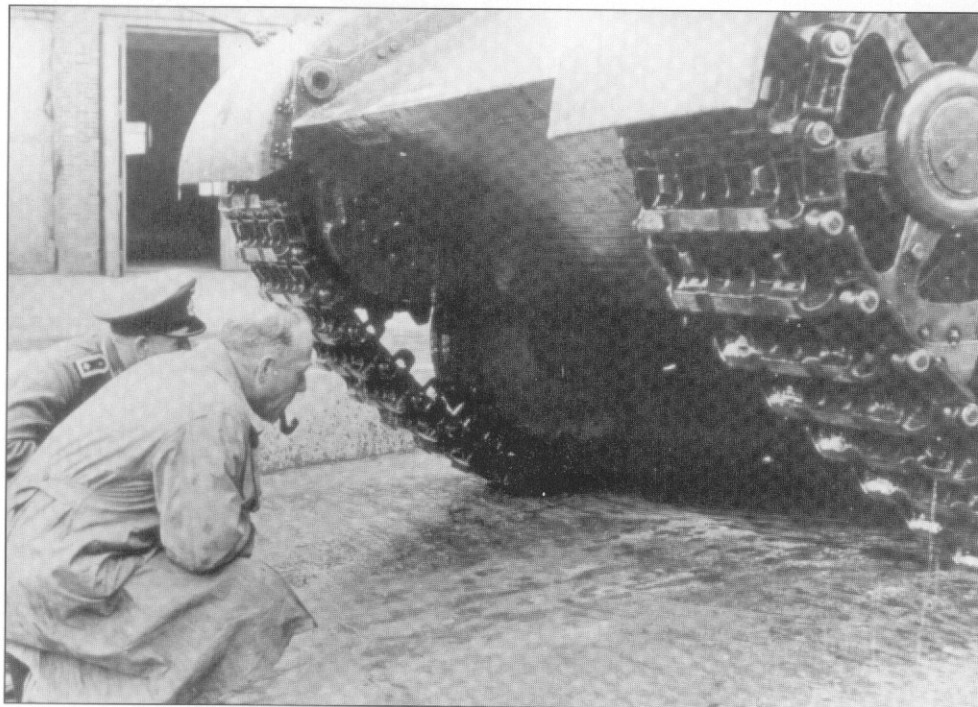
An officer and an engineer take a critical look at the bottom section after the tank left the pool. The drive sprocket and the track are of the early type. In September 1943 new tracks with ice cleats were introduced that offered better traction on muddy or frozen ground. (BA)

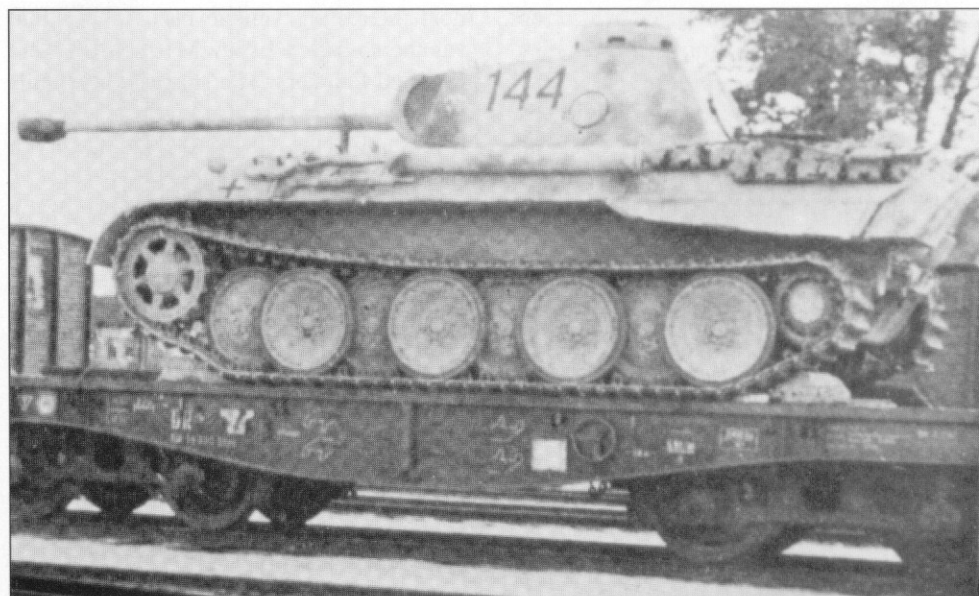
This obscure photo shows a Panther of Pz.Abt. 52 during Operation "Zitadelle". Since the power train was prone to breakdown, every opportunity was used to entrain Panther units. Note that the smoke grenade dischargers have been removed. The tanks of Pz.Abt. 52 display a roaring Panther's head as an unofficial unit badge. (M. Green)

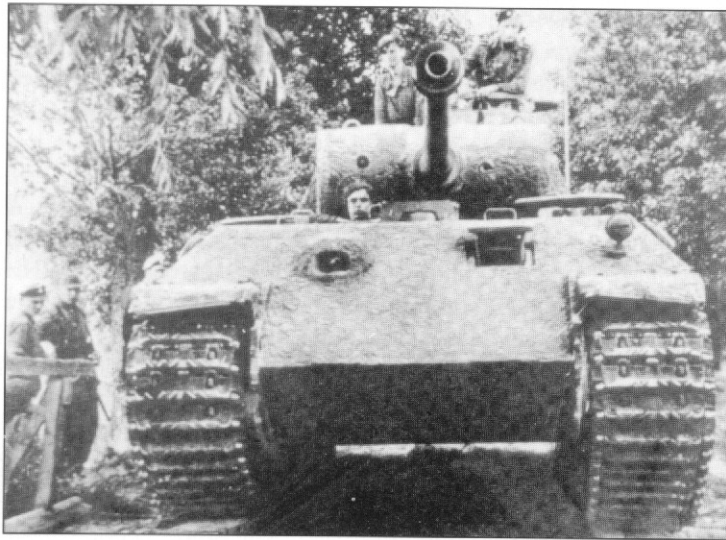
This Ausf. A, photographed in Italy, shows an unusually scruffy Zimmerit coating that was slovenly smeared over the vehicle without any rippled pattern being created. Note the ice cleats on the tracks. The gun sight is of the later monocular type. (W. Trojca)

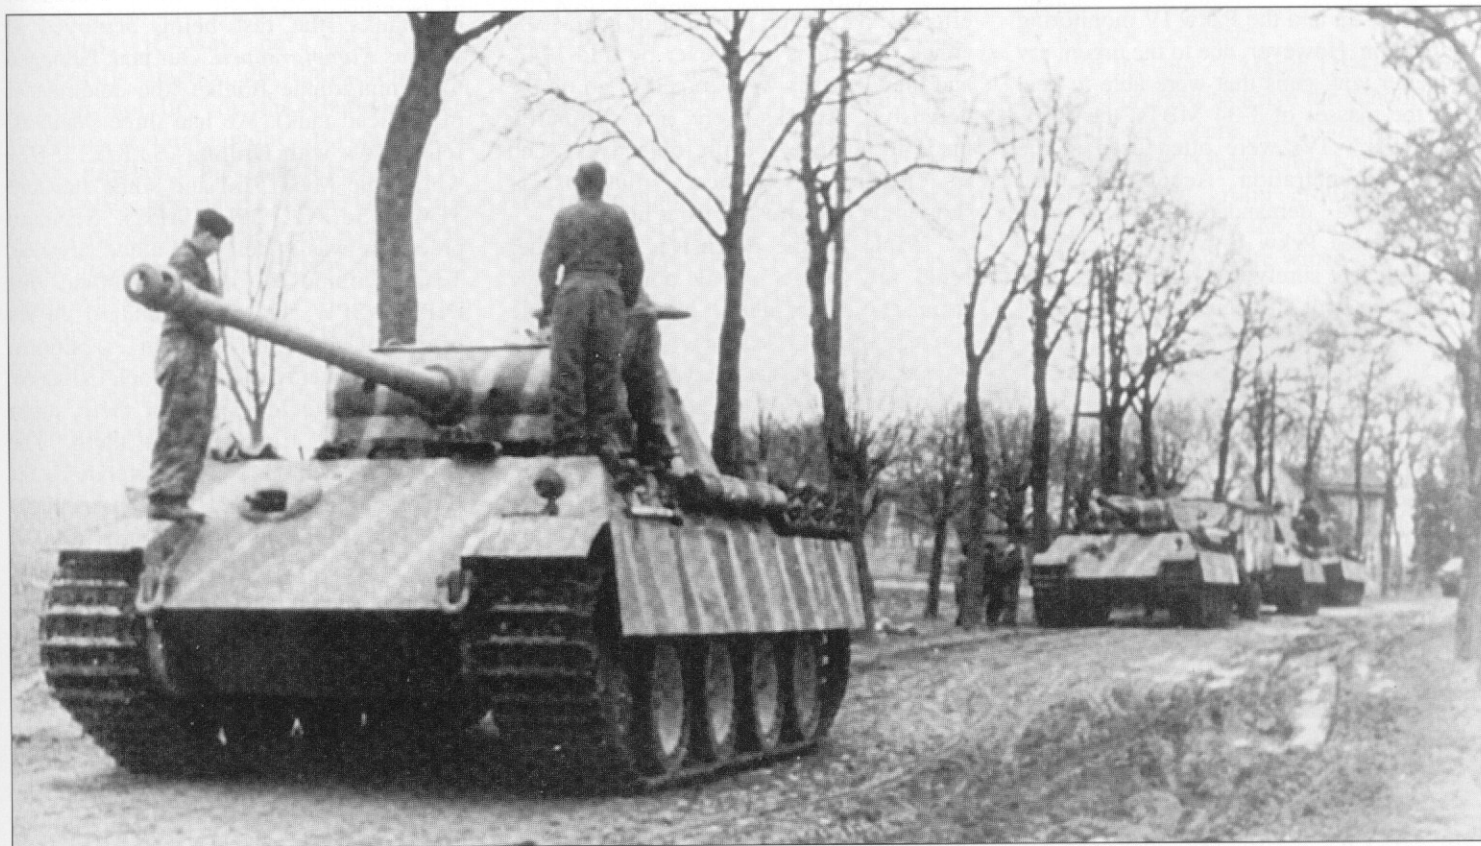
Photographed in February 1945, these late-model Panther Ausf. Gs move into defensive positions at the village of Ortwig near Küstrin. Here the Soviets had built up a bridgehead some 31 miles (50 km) east of Berlin. The Panthers show the distinctive reinforced gun mantlet. For camouflage, diagonal stripes were sprayed in broad lines over the dark yellow base color. (BA)

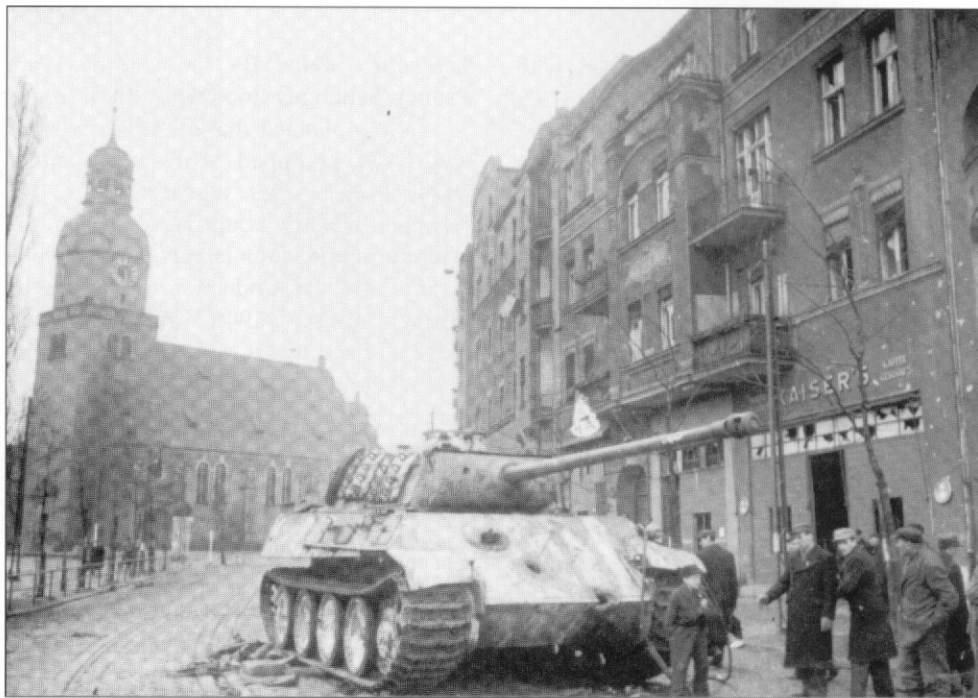
This Panther Ausf. G was destroyed in the town of Posen. It shows two penetrations at the hull front, probably from an 85 mm gun. Both shots were probably stopped by the transmission, allowing the crew to escape. As typical for late-war Panthers, the vehicle carries extra tracks and spare running wheels on the turret. The tank has been camouflaged with whitewash. (S. Netrebenko)

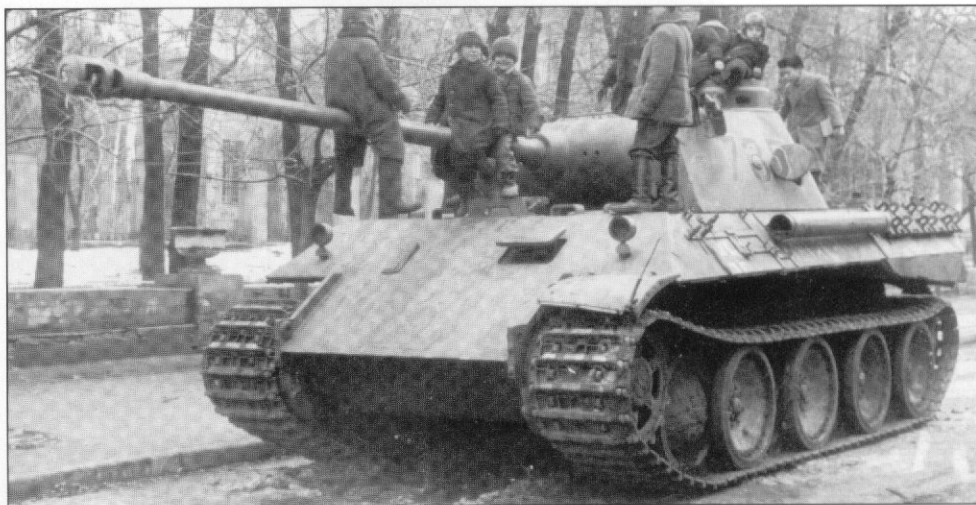
Russian children playing on an abandoned Panther Ausf.D of Pz.Abt. 52. Number "735" is in excellent condition, proving that it was lost to minor damage. The driver's visor is half opened. Although this hatch provided the driver with a good view, it weakened the front armor protection. Note that the reloading/communication hatch is also open. (S. Netrebenko)

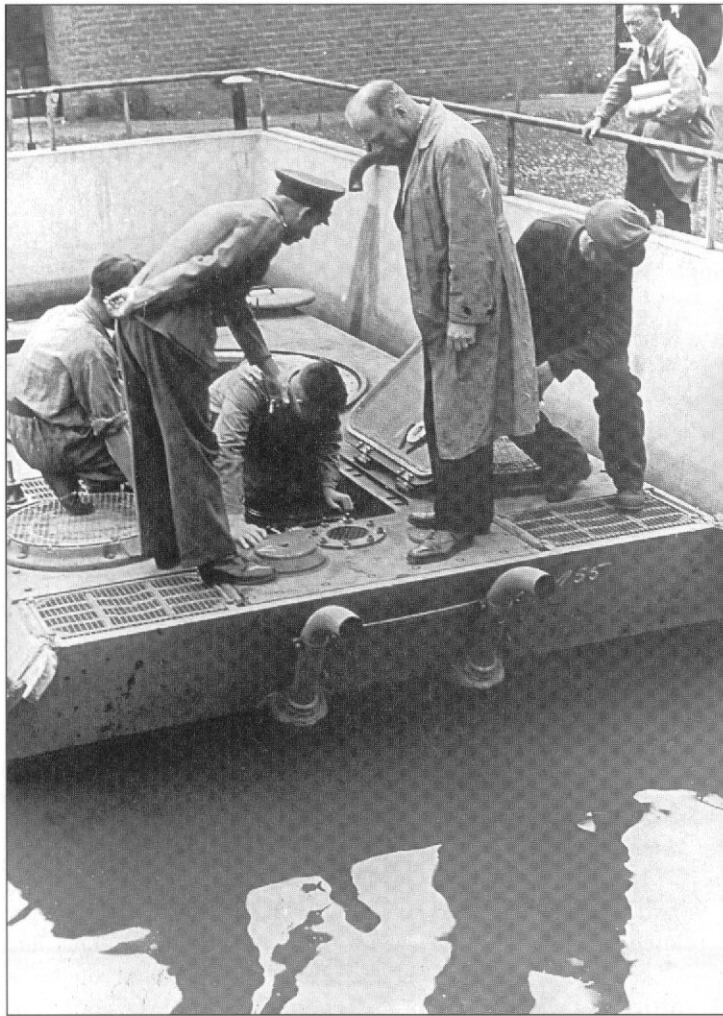
This Panther hull is being driven into a pool to check its watertightness. The dome behind the engine hatch covered the telescoping snorkel, which was intended for use during deep wading. The *Antennenfuß 1* antenna mount is visible on the engine deck. Since this early Ausf. D still lacks the gun rest used during travel that is normally fitted above the front ventilator, as well as all other equipment, it could be a prototype that was photographed during evaluations. (BA)

After being driven into the pool, the engine compartment undergoes an examination by mechanics and engineers. The dome has been removed, and the air intake (with its mesh screen) is now visible. The rear plate is bare except for the early exhaust pipe system. For deep wading, these pipes would have been replaced by a horizontally fitted muffler with a valve. (BA)

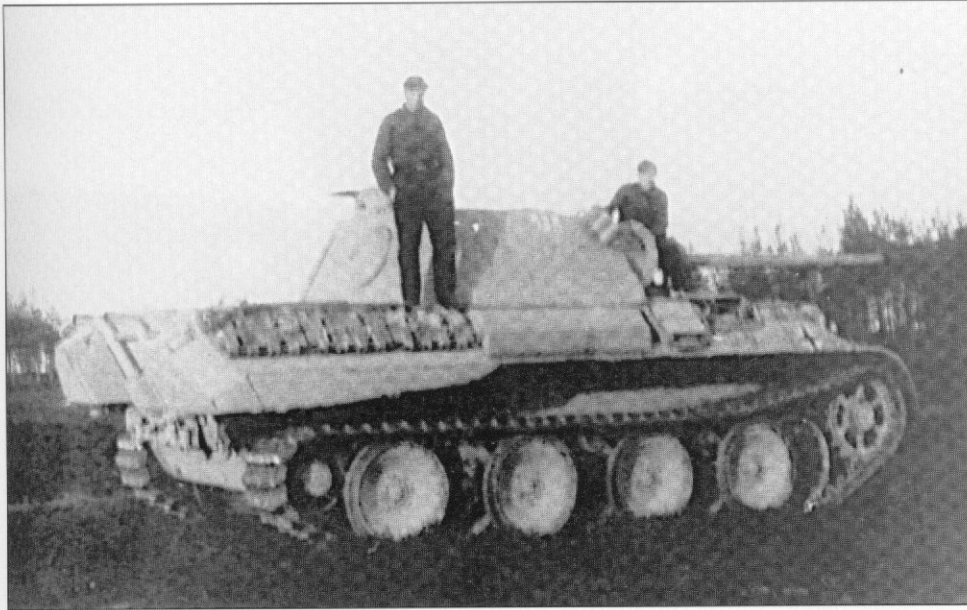
The following pictures show a Panther Ausf. D at Grafenwöhr training area in April 1943. This is one of the vehicles directly issued to Pz.Abt. 51; this is no driving school tank. Of special interest is the large box on the right side of the superstructure containing the track tools. This was only provided to the first batch of vehicles. The number "135" in plain white is just visible behind the smoke grenade discharger. (W. Kriegel)

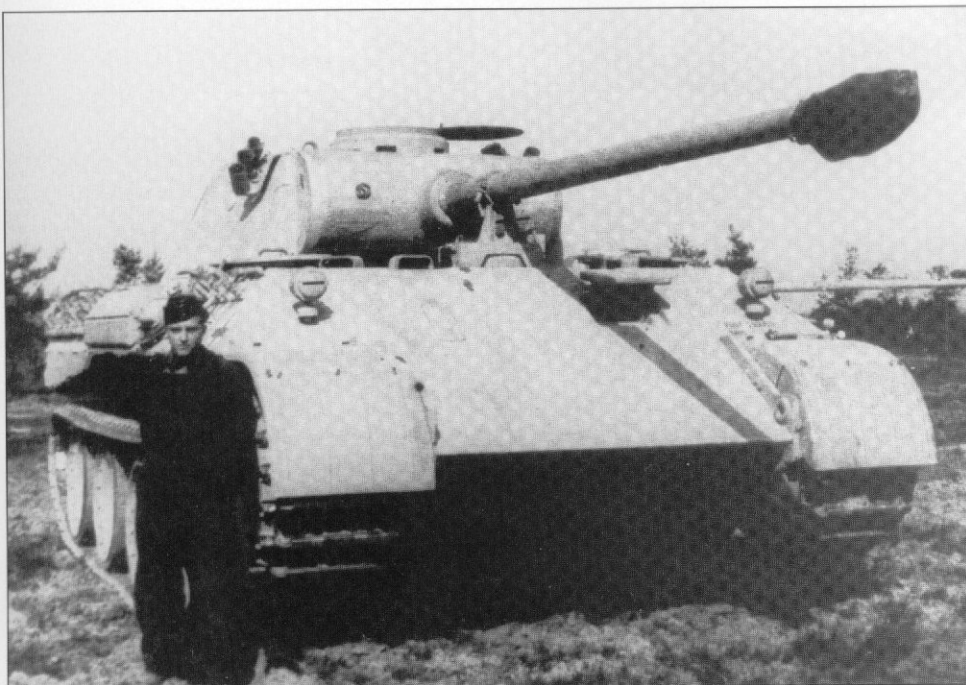
Proud Gefr. Kriegel standing in front of his tank, which is finished in plain dark yellow. Every feature of the early Ausf. D production is evident: the letterbox MG port, two headlights, smoke grenade dischargers, and the early commander's cupola. (W. Kriegel)

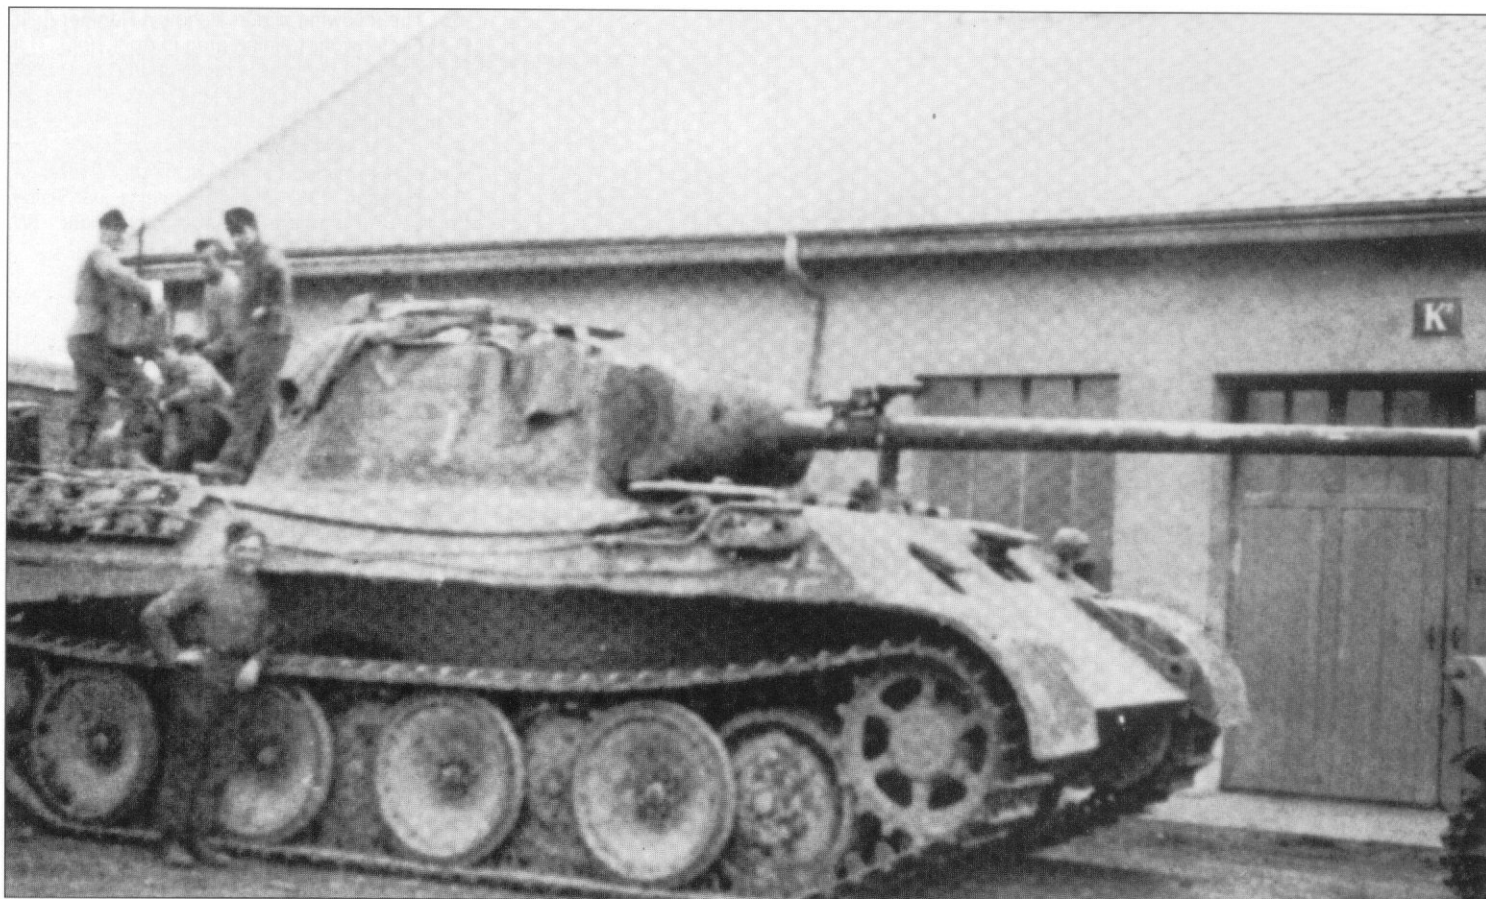
Pz.Rgt. 24 was established in 1943. After one year of hard fighting, it was sent to France for refitting. This photo was taken shortly after the invasion at a training area at Voussiers. This particular vehicle shows a mid-production Ausf. D. The commander's cupola shows an MG ring. The smoke grenade dischargers were already deleted. What makes this Panther interesting is the pyrotechnical gunfire simulator fitted onto the barrel just behind the travel rest. (E. Bernhardt)

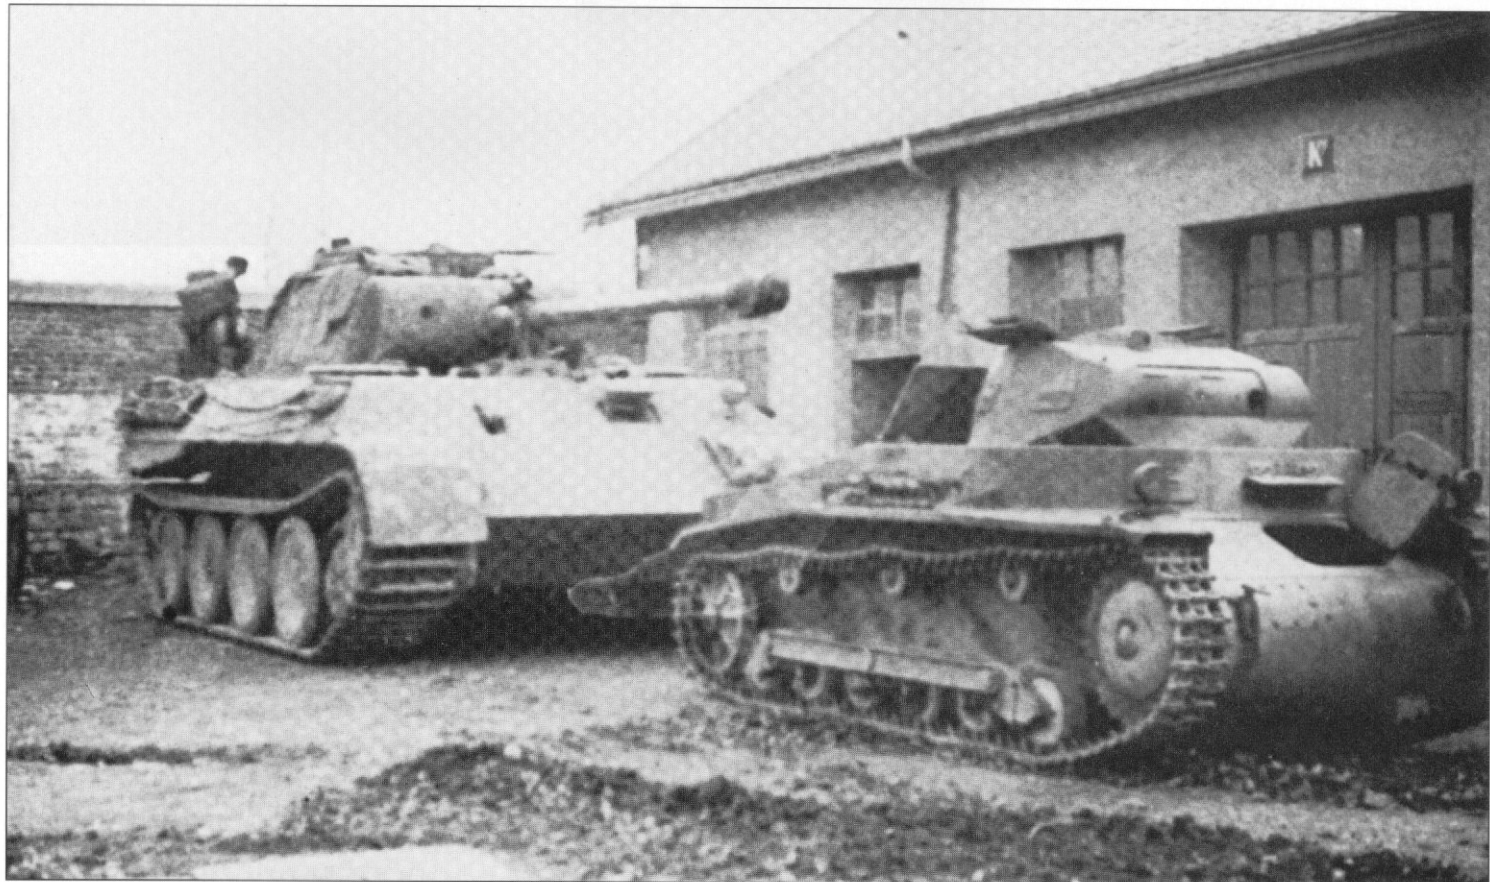
The same vehicle from a distance. In front of it an archaic vehicle, a Pzkw II Ausf. B, can be seen. Oldtimers like this were used for tank school driving purposes up to the end of the war. The tanks of Pz.Rgt. 24 received their *Zimmerit* coating at field workshops in September/October 1943, resulting in a scruffy and uneven pattern. (E. Bernhardt)

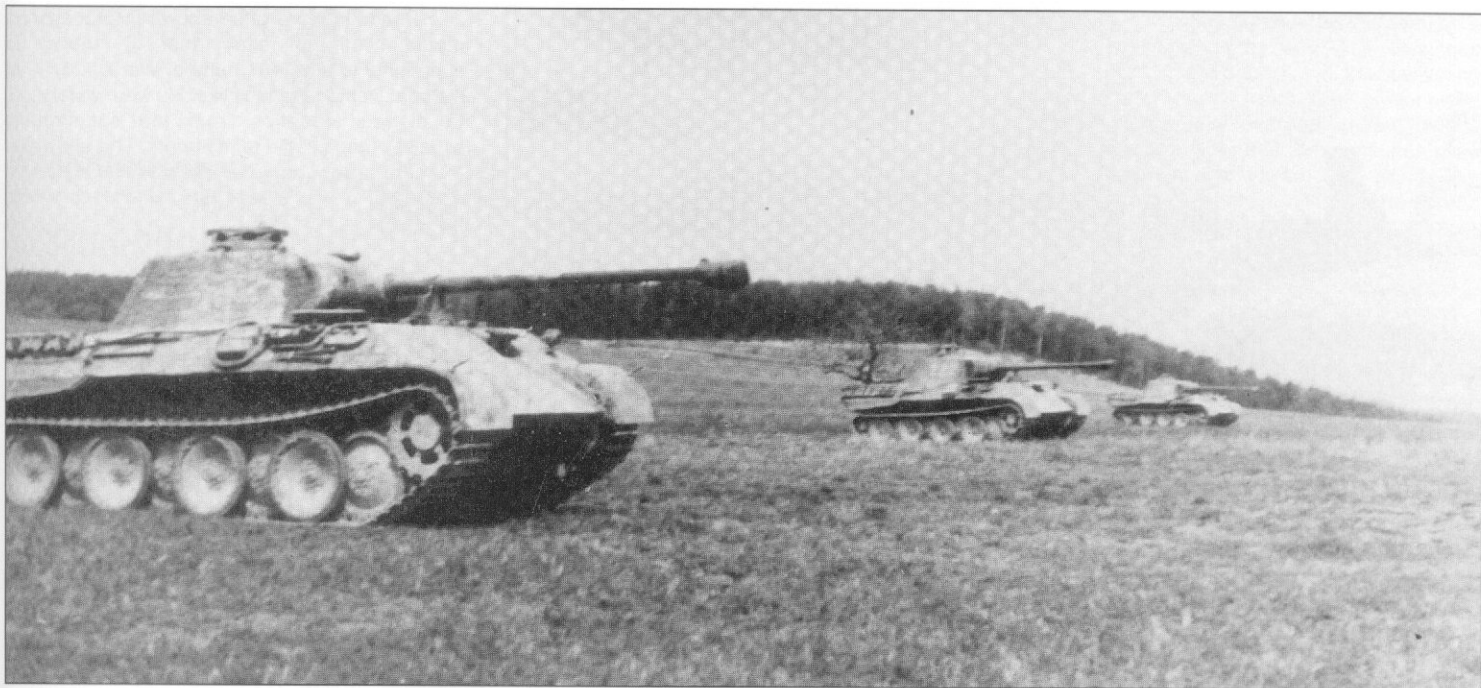
This shows 3rd Squadron of 1./Pz.Rgt. 24 during live fire training. The gunfire simulators have been removed. The vehicle in the foreground is a late Ausf. D, as shown by the late-style commander's cupola. (E. Bernhardt)

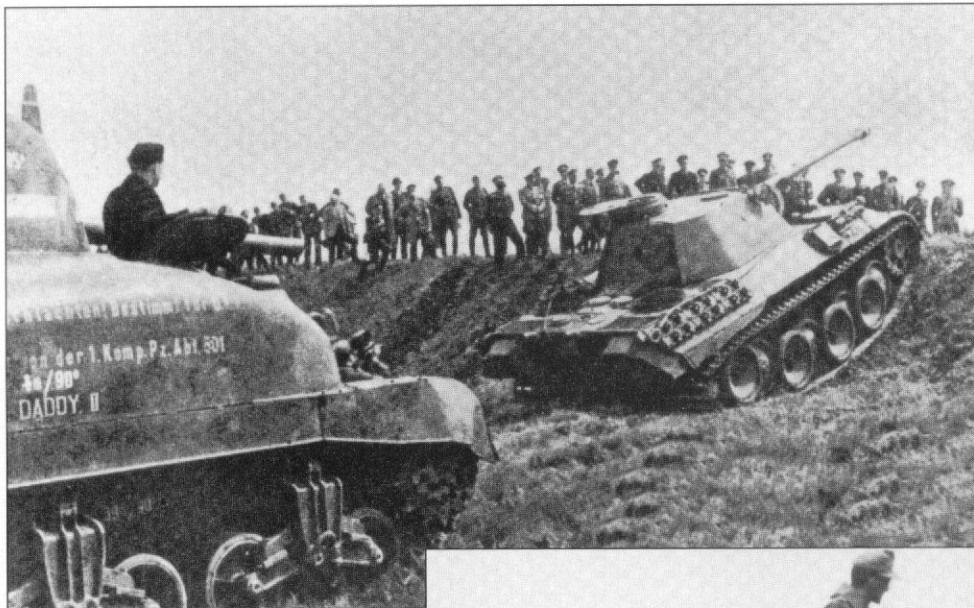
Panthers were often shown in propaganda media. Here an early Ausf. D shows its superiority to an M4A1 named "War Daddy II" at a slope. Demonstrations like this were widely used to distract attention from the catastrophic situation that existed on all fronts. The text says: "General Sherman fell back. His German opponent, a new heavy tank, succeeds where the Yankee failed". (BL)

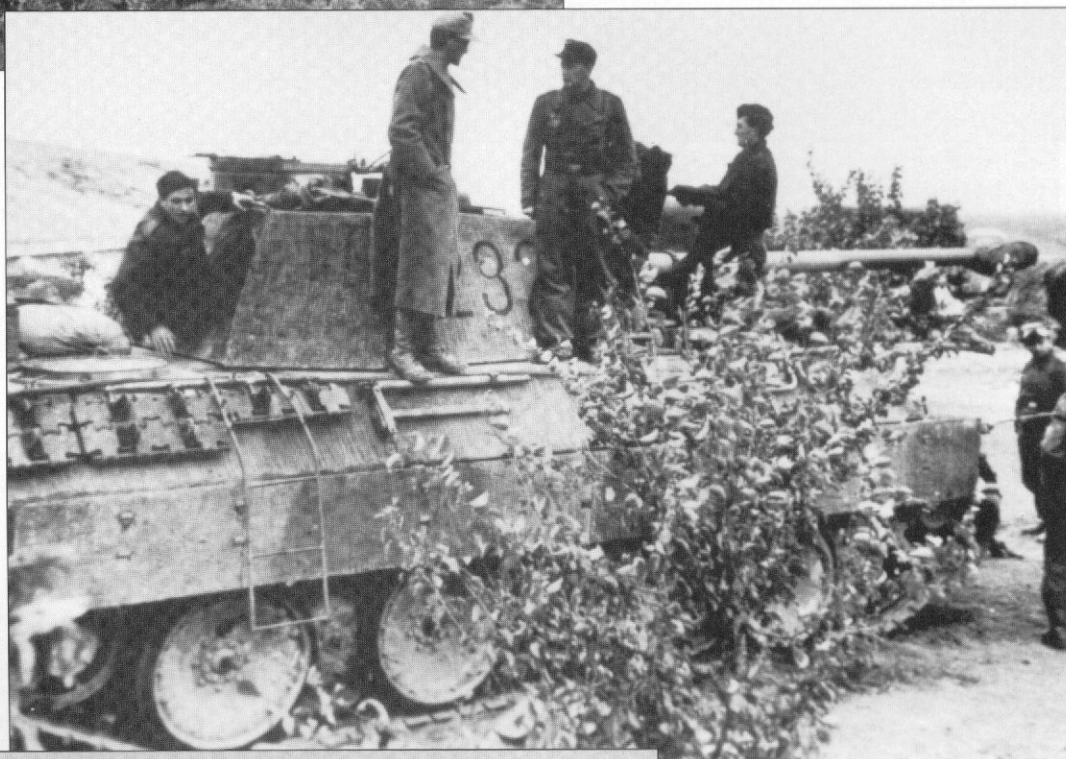
This mid-production Panther Ausf. D was provided with an improvised ladder to make it easier to mount the large tank. The *Zimmerit* coating was applied in a more precise way. Note the MG ring on the cupola. (F. Schulz)

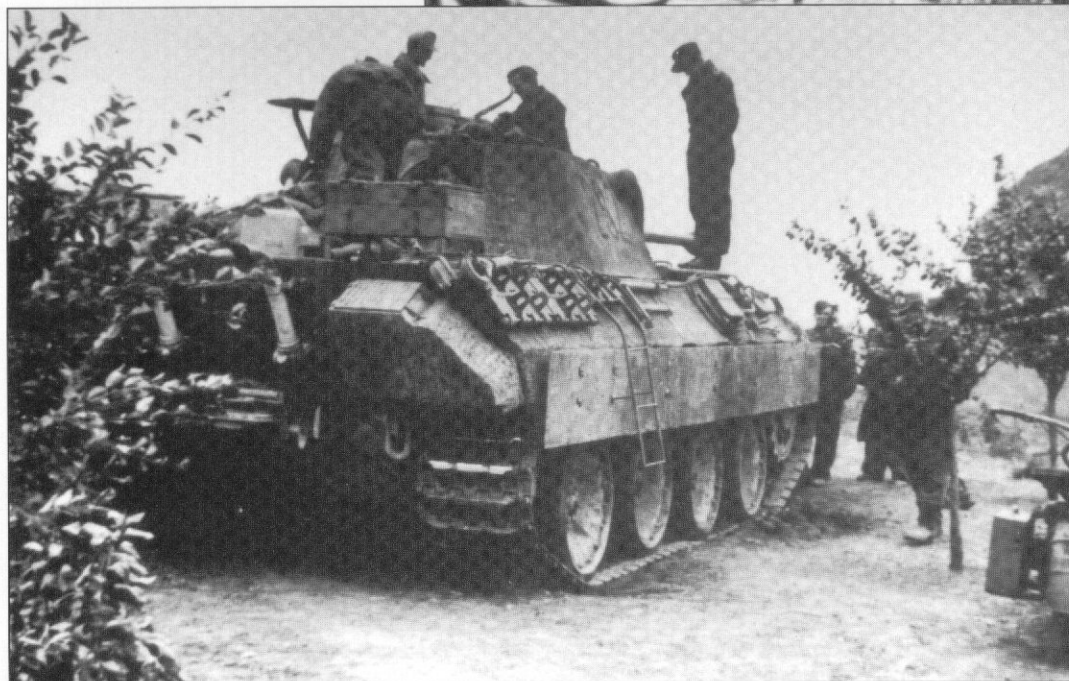
The rear view of the same tank shows two boxes mounted on the engine compartment. In order to keep from blocking the cooling system, the boxes were carried on raised platforms. The exhaust pipes show the bright color of annealed metal. The Panther's exhaust reached very high temperatures, and the pipes often glowed. The jack is still mounted below the cast exhaust covers. (F. Schulz)

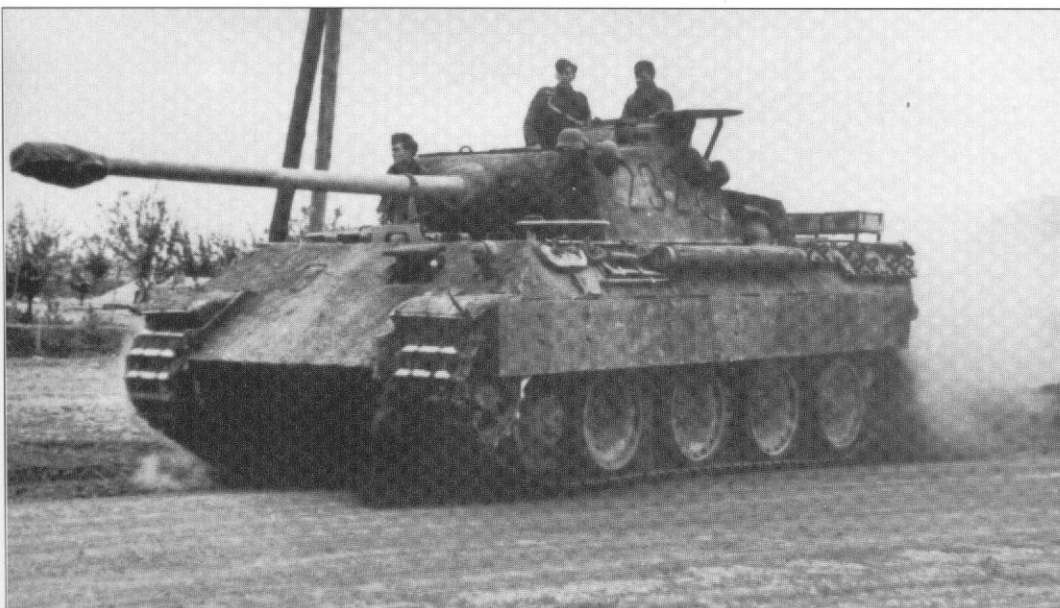
Panther number "232" is seen here speeding on its way. The crew has added a support for the swiveling commander's hatch. (The swivel hinge occasionally warped during rough driving.) Note that *Zimmerit* has even been applied to the side skirts. The crew's five steel helmets are stored outside the vehicle. (F. Schulz)

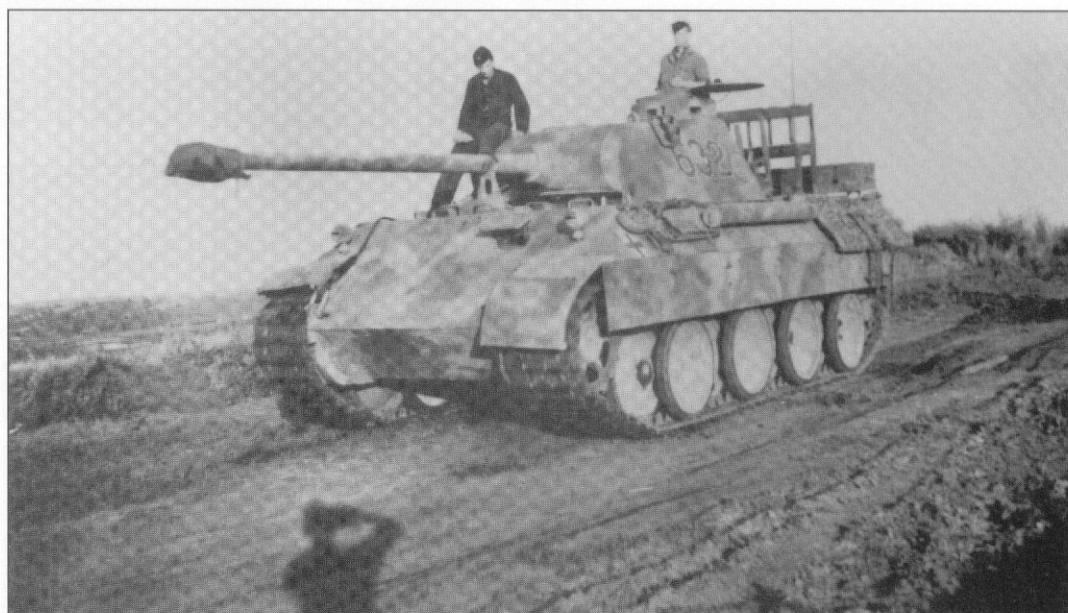
This early Panther Ausf. D shows no *Zimmerit*. Apparently, its crew added a ladder and supply crates. The vehicle is painted in an elaborately applied three-tone camouflage scheme. In 1943 this job was done by the troops, who could choose the scheme that was best suited to the respective vegetation or season. (K. Münch)

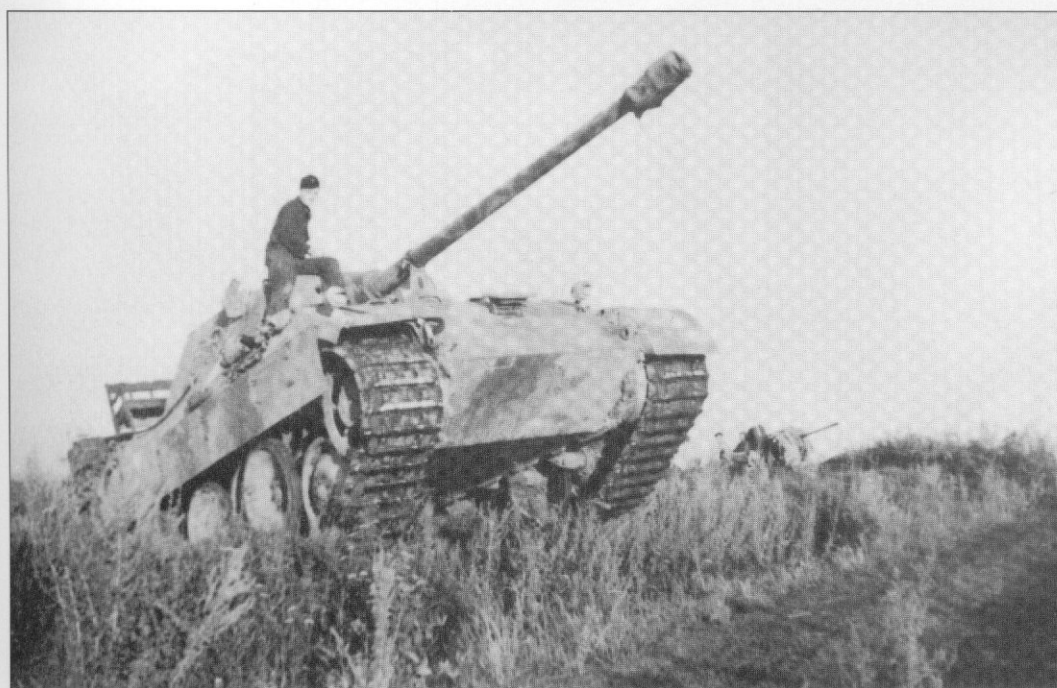
Panther "632" negotiates a slope. These situations could become serious, as the bottom of the tank featured only weak armor. Additionally, enemy shells would hit the plates at 0 degrees, making penetration very likely. This tank was converted to a mobile veranda by adding what looks to be quite a comfortable bench. (K. Münch)

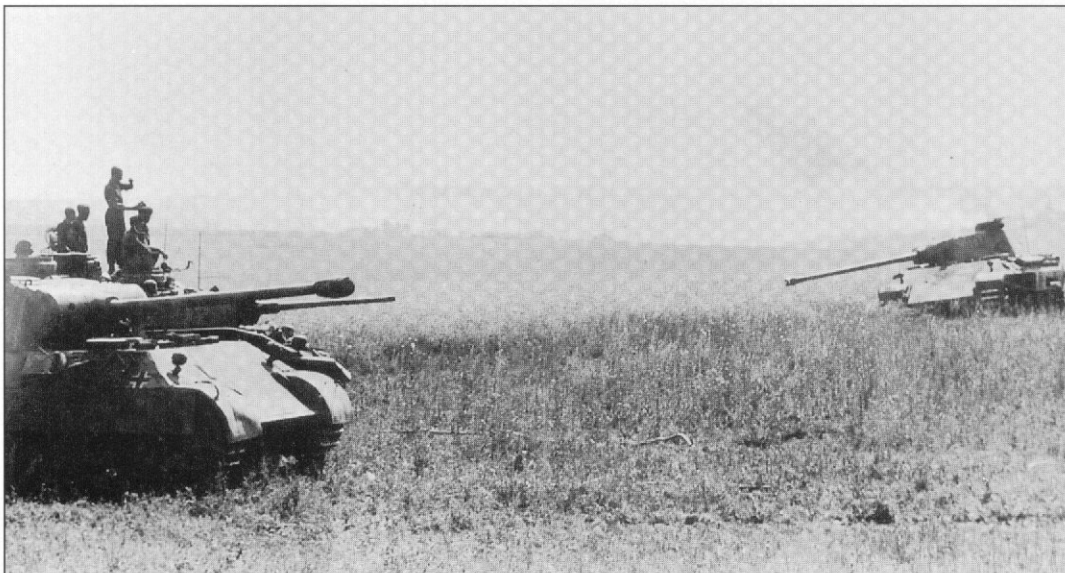
The same unit waiting for enemy contact. Behind the Panther Ausf. D (early production lot) is hidden a Pzbfswg III. A lot of these older command tanks were used with Panther units. Though they were prime targets for the enemy, the one in the background seems to be intact. (K. Münch)

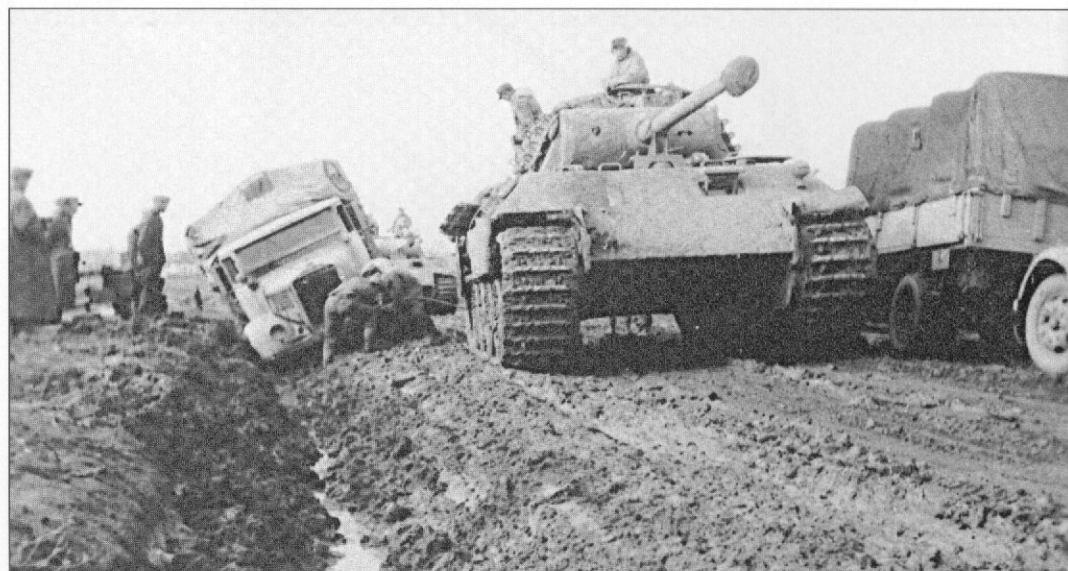
A late-model Ausf. D in or near Uman, Russia in early 1944. The tank lacks the right headlamp and is provided with the cast commander's cupola. Ice cleats have been added to the tracks. To the right of the gun barrel are visible the two openings for the early binocular tank sight. This photo gives a good example of the problems the muddy seasons created for the German transport units. The Panther is ready to tow a disabled vehicle. (K. Münch)

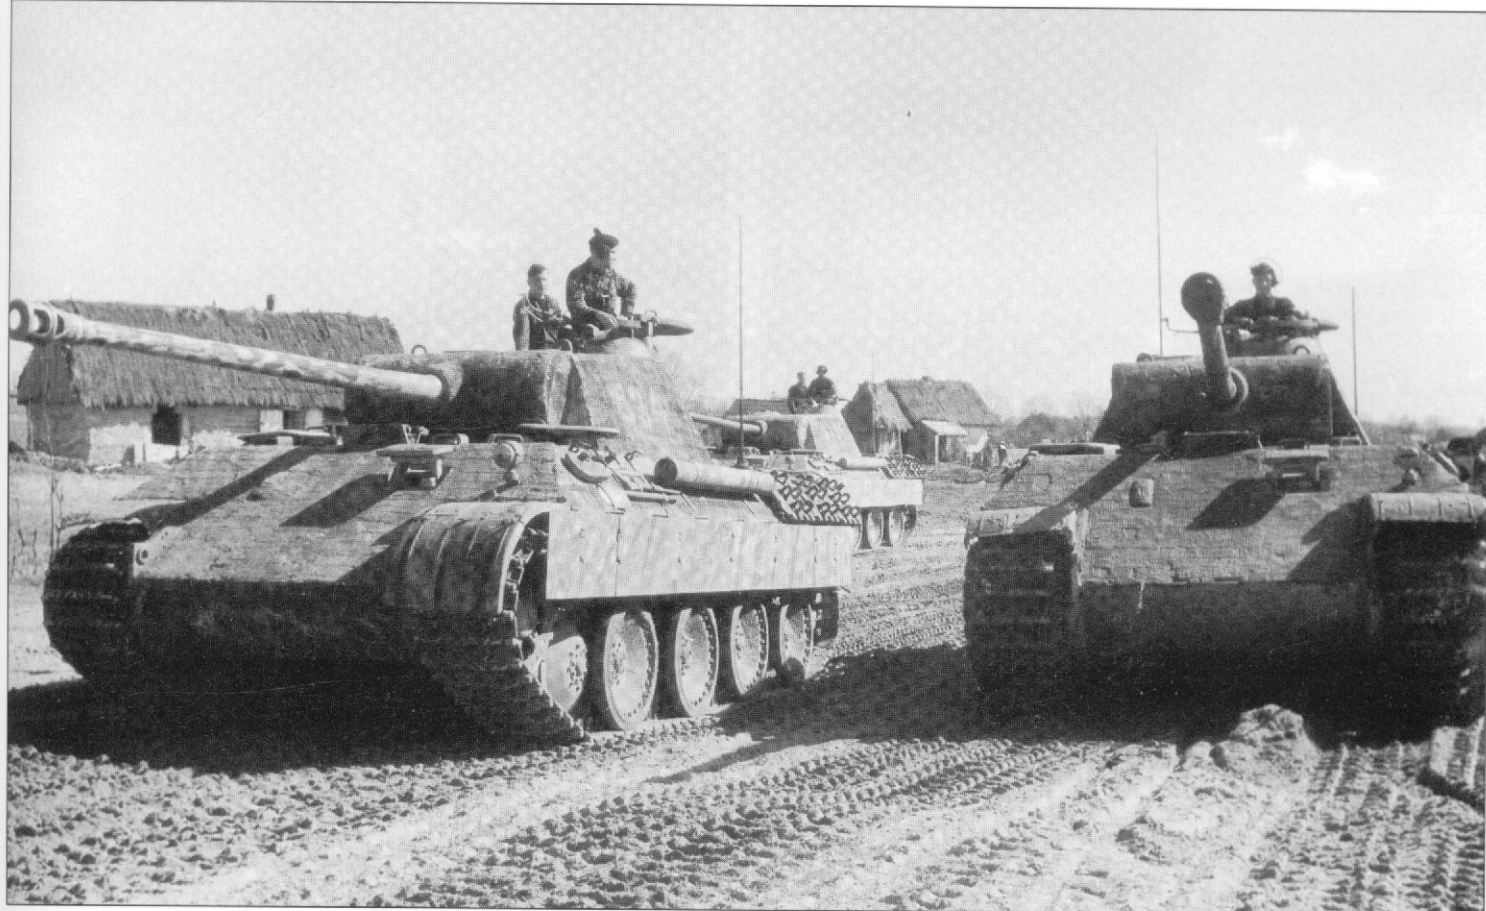
Tanks of 5.SS-Pz.Div. "Wiking" prior to combat near Kovel in April/May 1944. This unit played an important part in breaking through the pocket around that city. Both vehicles, late Ausf. Ds, show partly damaged *Zimmerit* coatings. The camouflage consisted of narrow stripes of dark green and brown over the dark yellow base, which were probably applied with brushes. The Panther at right shows a 6.5-ft (2 m) rod antenna fitted on its roof and a 4.5-ft (1.4 m) rod antenna on the standard mount behind the turret. That means this could be a *Flivo* tank (Sd.Kfz. 268 ground-to-air liaison vehicle). (W. Schneider)

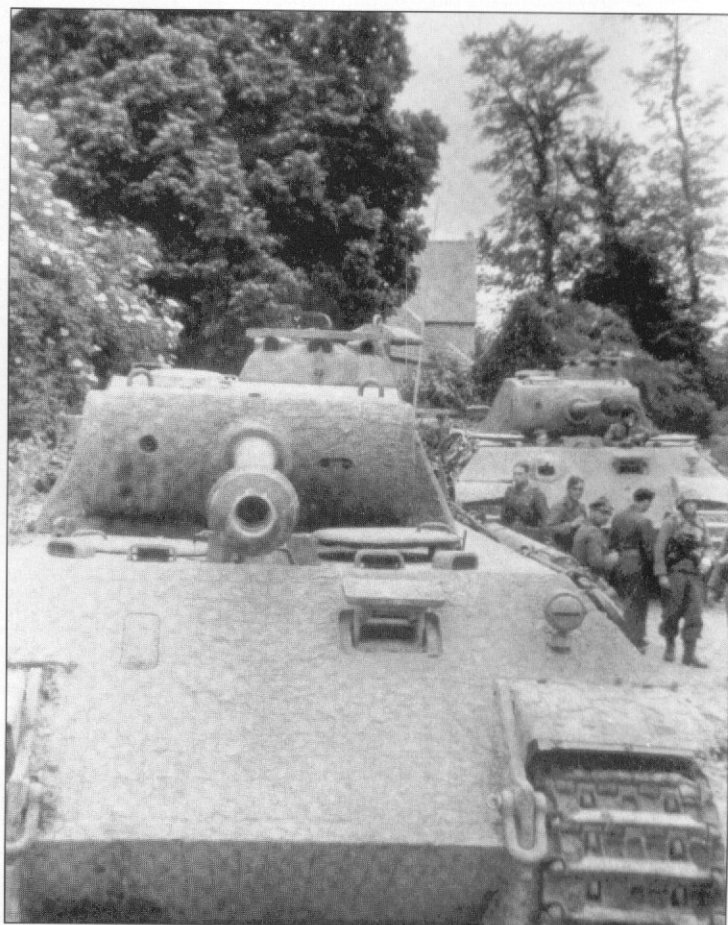
Moving on to France now, we see a late Ausf. D of Panzer-Lehr Division waiting for action. The early Panthers had a binocular tank sight, as is indicated by the two apertures to the right of the gun. *Zimmerit* on this tank is of the "handmade" style that was added by front line troops. Note that even the mud guards have been smeared over with it. (F. Schulz)

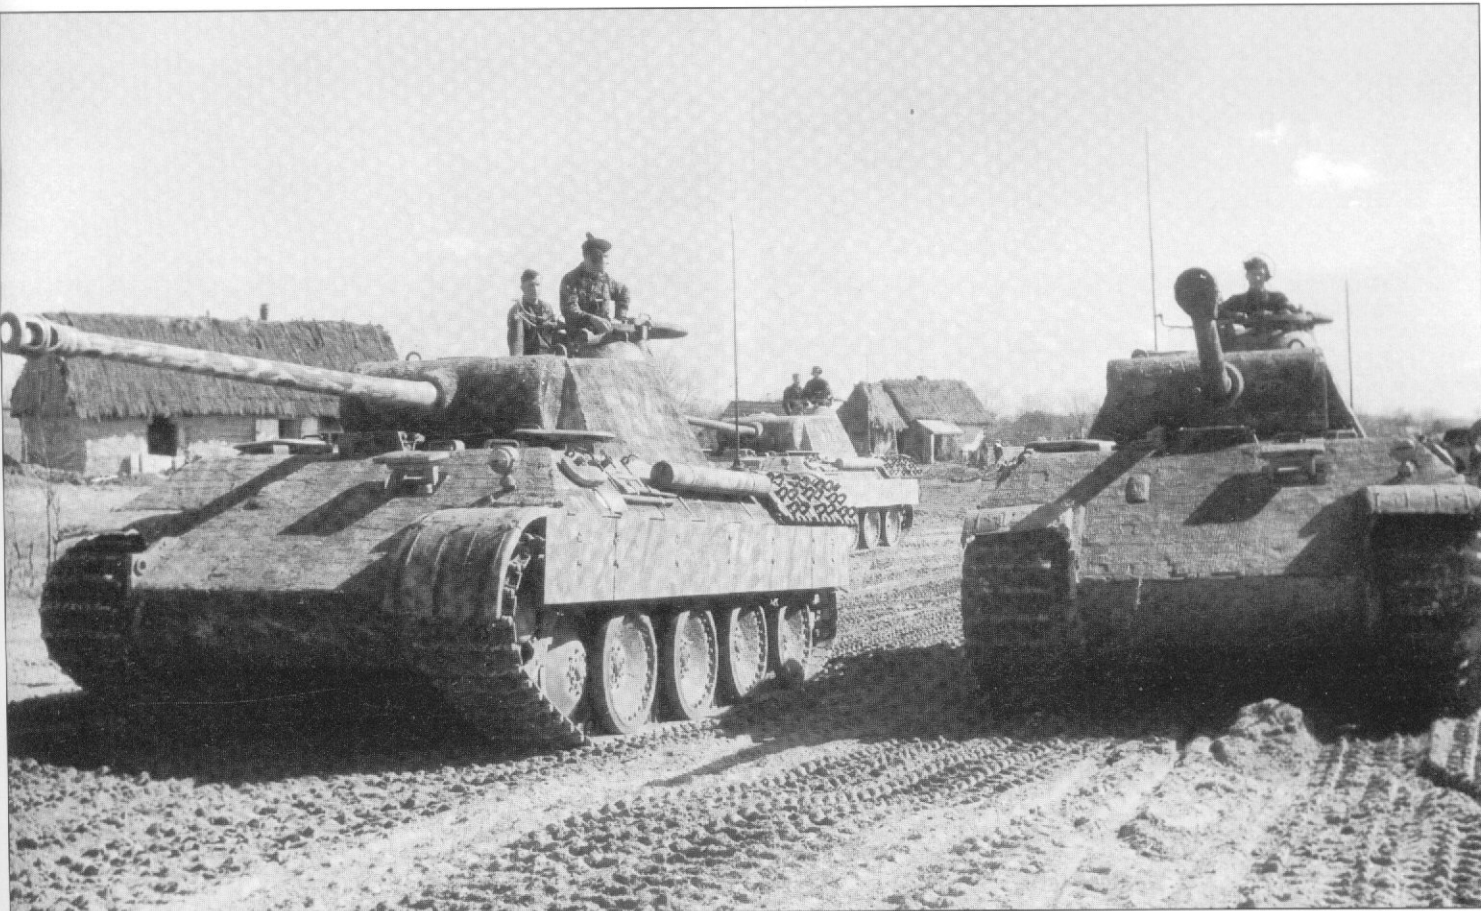
Tanks of 5.SS-Pz.Div. "Wiking" prior to combat near Kovel in April/May 1944. This unit played an important part in breaking through the pocket around that city. Both vehicles, late Ausf. Ds, show partly damaged *Zimmerit* coatings. The camouflage consisted of narrow stripes of dark green and brown over the dark yellow base, which were probably applied with brushes. The Panther at right shows a 6.5-ft (2 m) rod antenna fitted on its roof and a 4.5-ft (1.4 m) rod antenna on the standard mount behind the turret. That means this could be a *Flivo* tank (Sd.Kfz. 268 ground-to-air liaison vehicle). (W. Schneider)

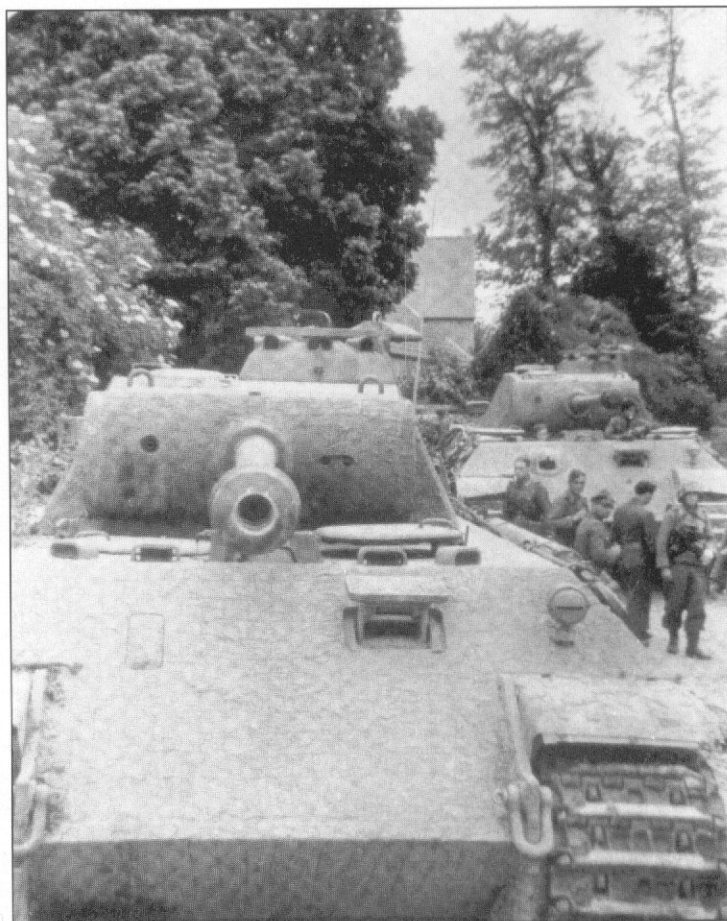
Moving on to France now, we see a late Ausf. D of Panzer-Lehr Division waiting for action. The early Panthers had a binocular tank sight, as is indicated by the two apertures to the right of the gun. *Zimmerit* on this tank is of the "handmade" style that was added by front line troops. Note that even the mud guards have been smeared over with it. (F. Schulz)
