ARMOR AT WAR SERIES

Panther

Text by Thomas Anderson
Color plates by Vincent Wai

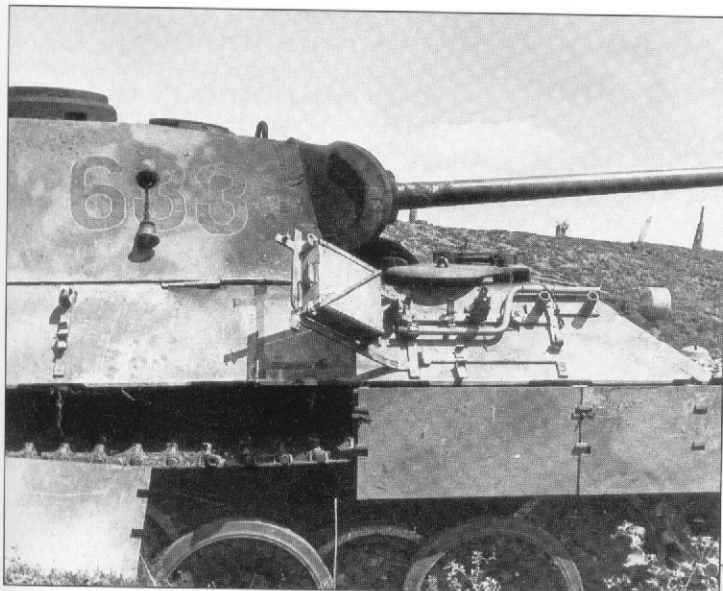
Moving on to France now, we see a late Ausf. D of Panzer-Lehr Division waiting for action. The early Panthers had a binocular tank sight, as is indicated by the two apertures to the right of the gun. *Zimmerit* on this tank is of the "handmade" style that was added by front line troops. Note that even the mud guards have been smeared over with it. (F. Schulz)

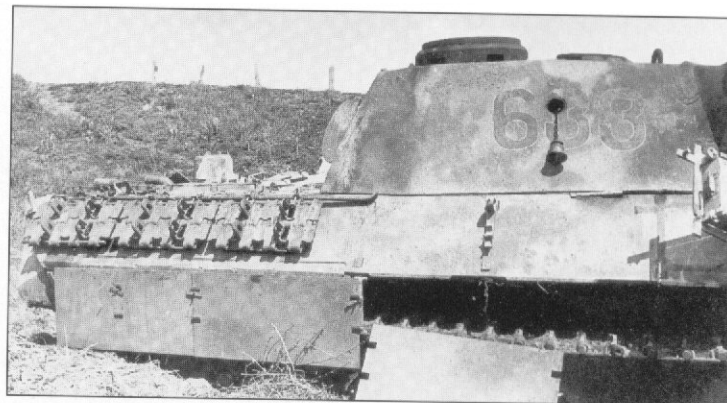
The rear of the same Panther shows the deep-wading dome on the air inlet. This could be proof that Pz.Abt. 51 and/or 52 still had this equipment at the baggage train. The smoke grenade dischargers, however, are missing. Camouflage probably consisted of dark green blotches over dark yellow. (S. Netrebenko)

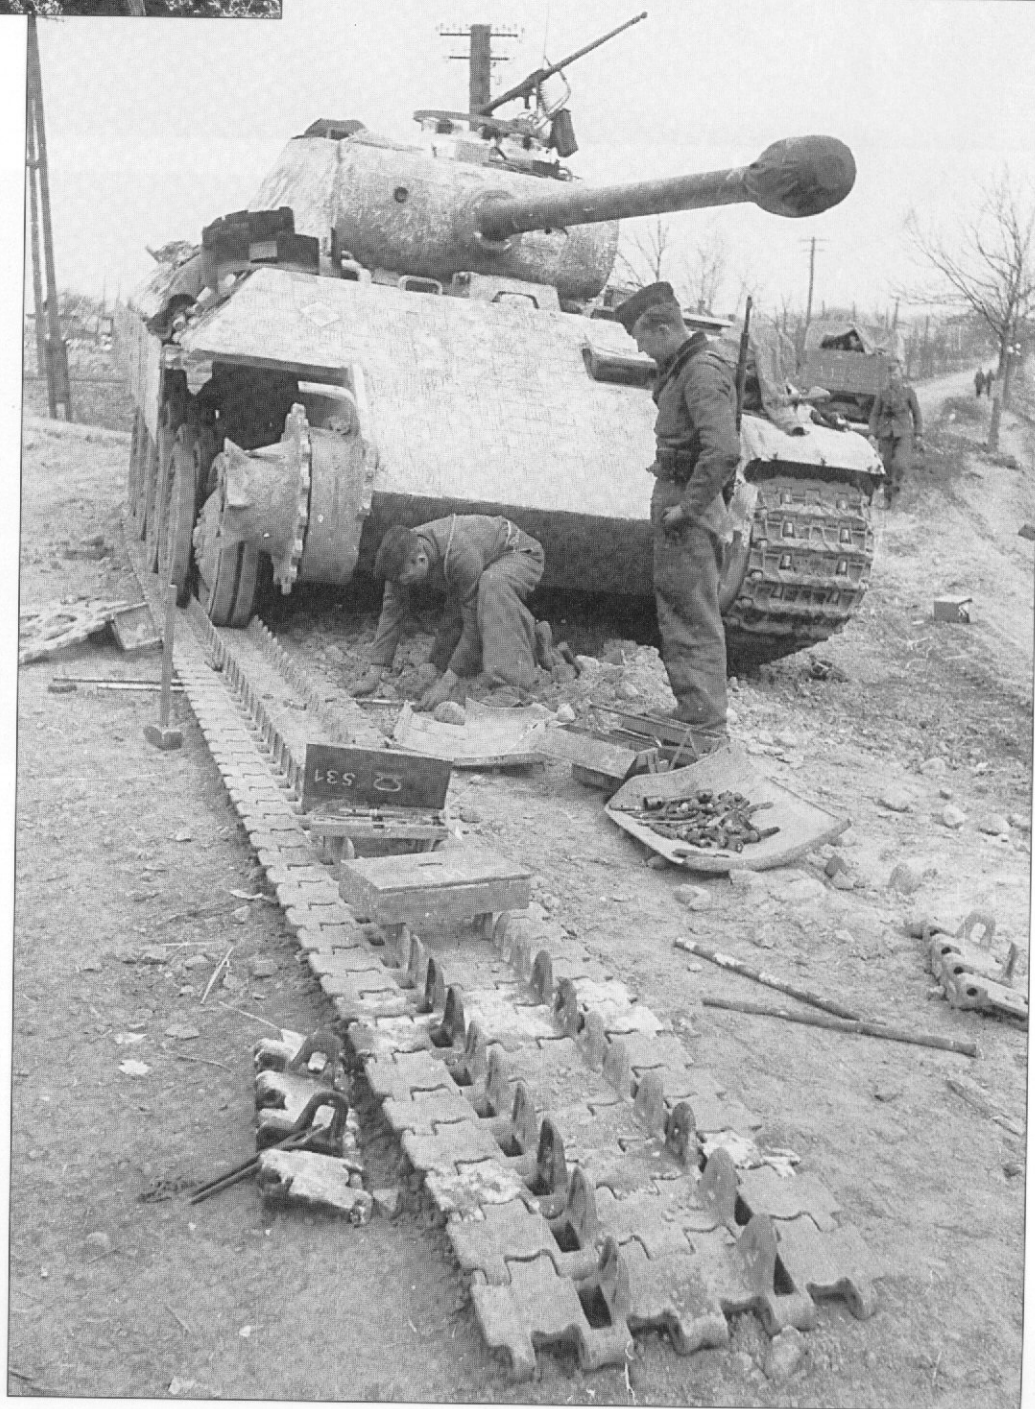
Crew members perform maintenance on the track of a Panther Ausf. D (late production). They are exchanging the track pins, which is the weakest point of any running gear. Since the Panther is fitted with a monocular gunsight and the loader's periscope, this could very well be an early Ausf. A. This photo was taken in early 1944 so the tank's whitewash is still just visible. The unit symbol on the glacis plate is unknown. Note the machine gun mounted on the commander's cupola. (W. Schneider)

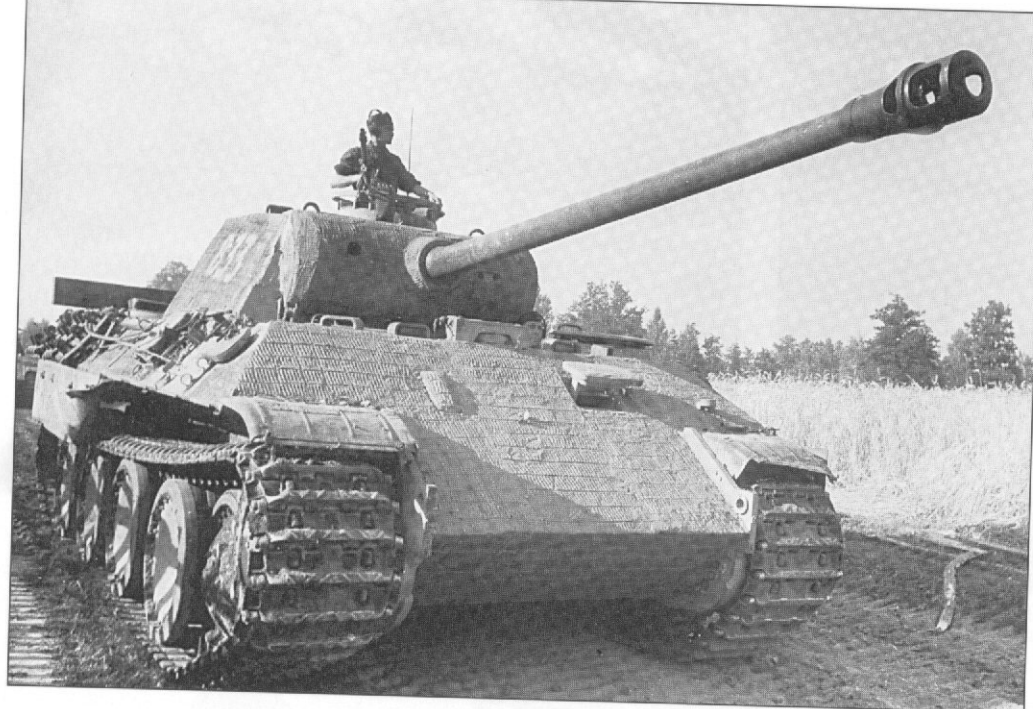
This photo shows the impressive side of the Panther MBT. This late Ausf. D (binocular gun sight) is covered with a factory applied *Zimmerit* coating. The turret number "833", was handpainted in white. Note that the front sections of the side skirts and parts of the mudguards are missing. (W. Schneider)

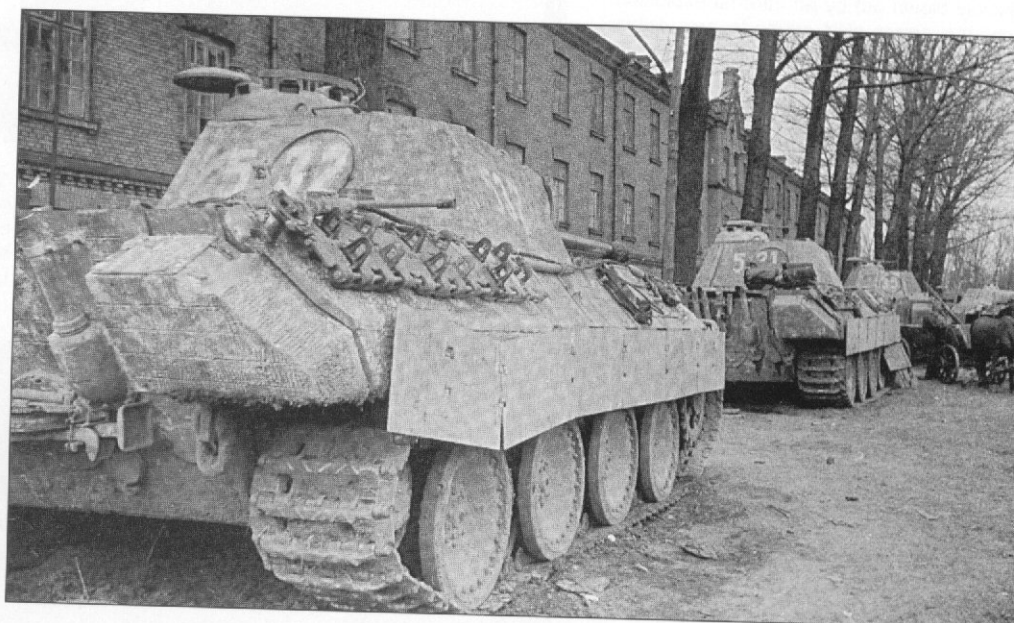
Panthers of 5. Company (probably of "Wiking") assembled at a factory yard. The first vehicle, which is probably an Ausf. D, illustrates the original horizontal position of the jack. The next Panther is an Ausf. A, as is evident by the vertical jack and the cooling pipes attached to the left exhaust. The tanks display a very scruffy camouflage of dark brown and dark green stripes. Covered in mud and dust as all of them are, the tanks blend in perfectly with their surroundings. (W. Schneider)

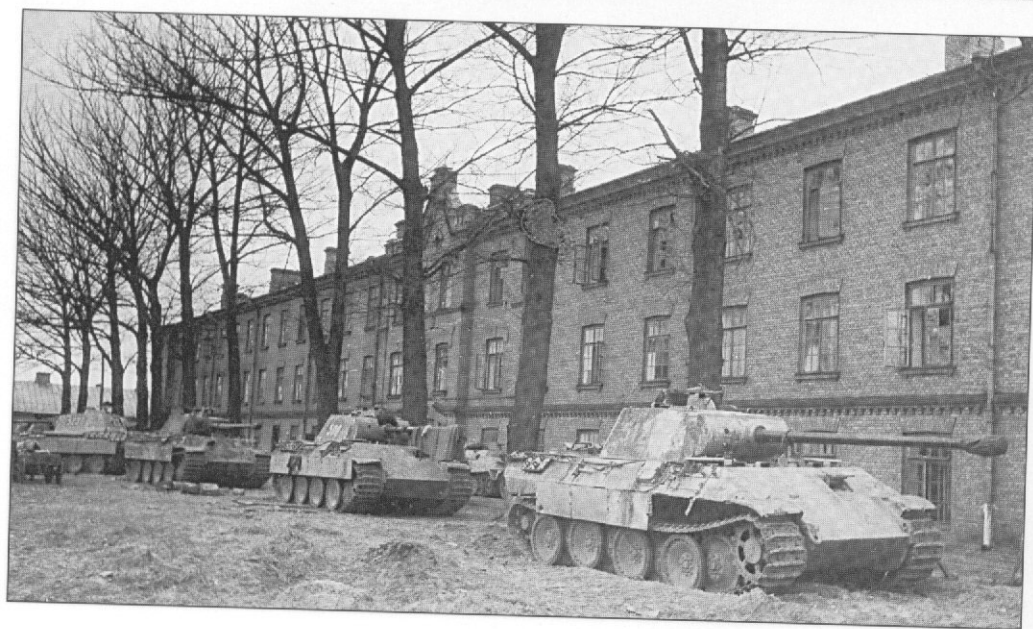
The late-model Ausf. D at right shows remnants of winter whitewash on its turret and hull. Of interest is the gun, which has apparently been replaced recently. The color of the Panther appears to be dark gray or green. The second vehicle, number "500", is the company leader's tank. (W. Schneider)

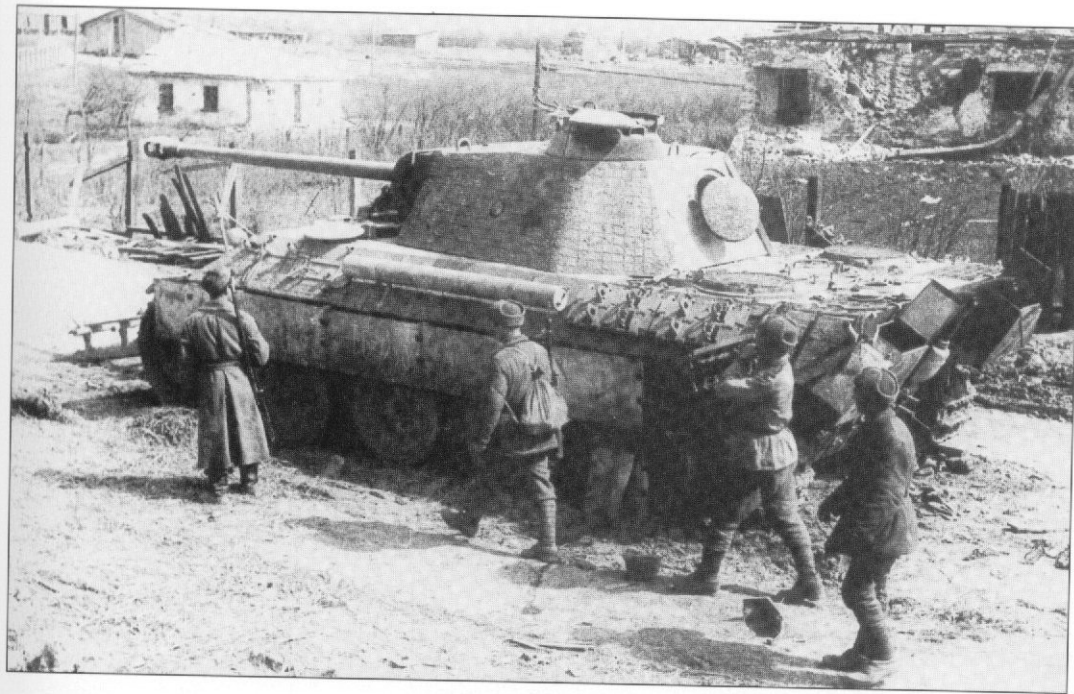
A Soviet infantry squad passes by a destroyed Panther Ausf. D (late production). Both the communication port and the smoke grenade dischargers were deleted during production. The tank is fitted with the later cast commander's cupola. Since all hatches are open, the crew probably managed to escape. (S. Netrebenko)

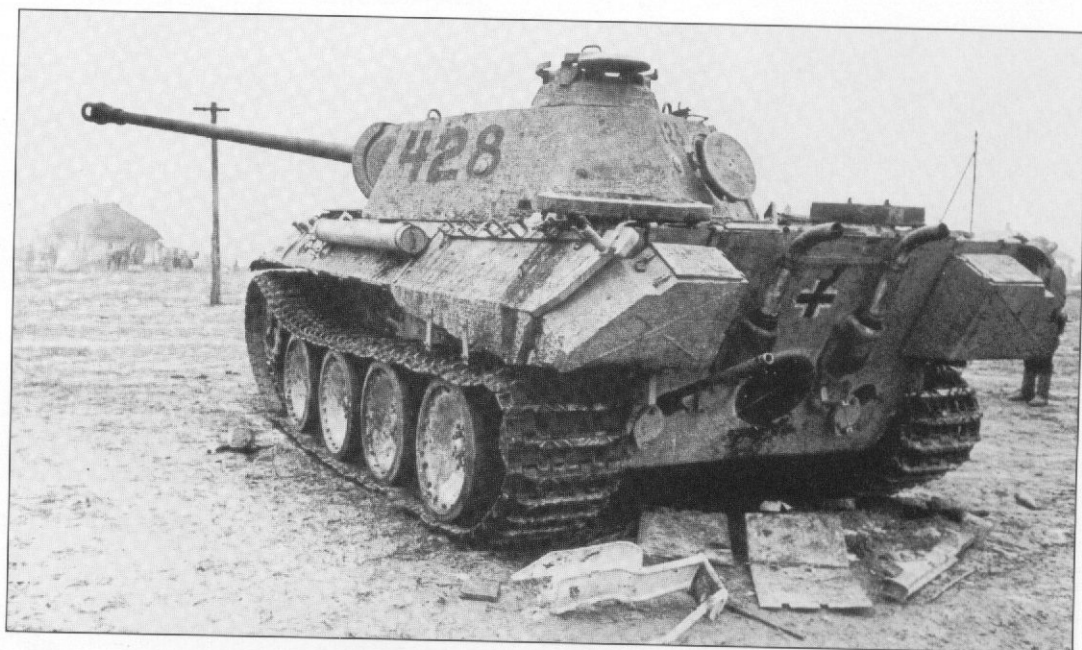
Panther "428" was painted over with whitewash. The large numbers on the side of the turret and the smaller one at the rear were painted very crudely in red. An iron cross is visible between the exhaust tubes. The Zimmerit was probably applied by a field workshop. Note that both track tension ports are opened, and the tension tool is still fitted in the left one. (S. Netrebenko)

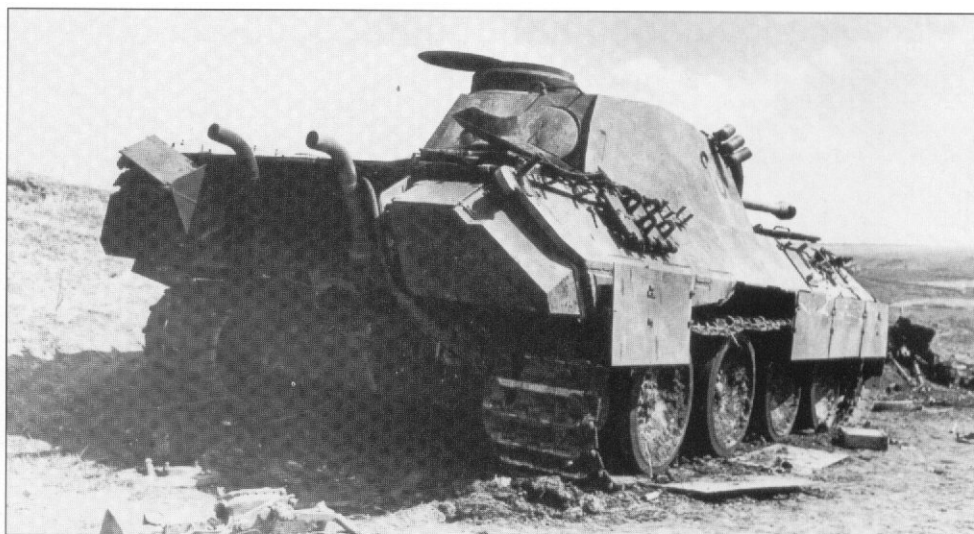
This early Panther Ausf. D was lost during "Zitadelle" as well. Two side skirts have fallen off, completely destroying their brackets. (S. Netrebenko)

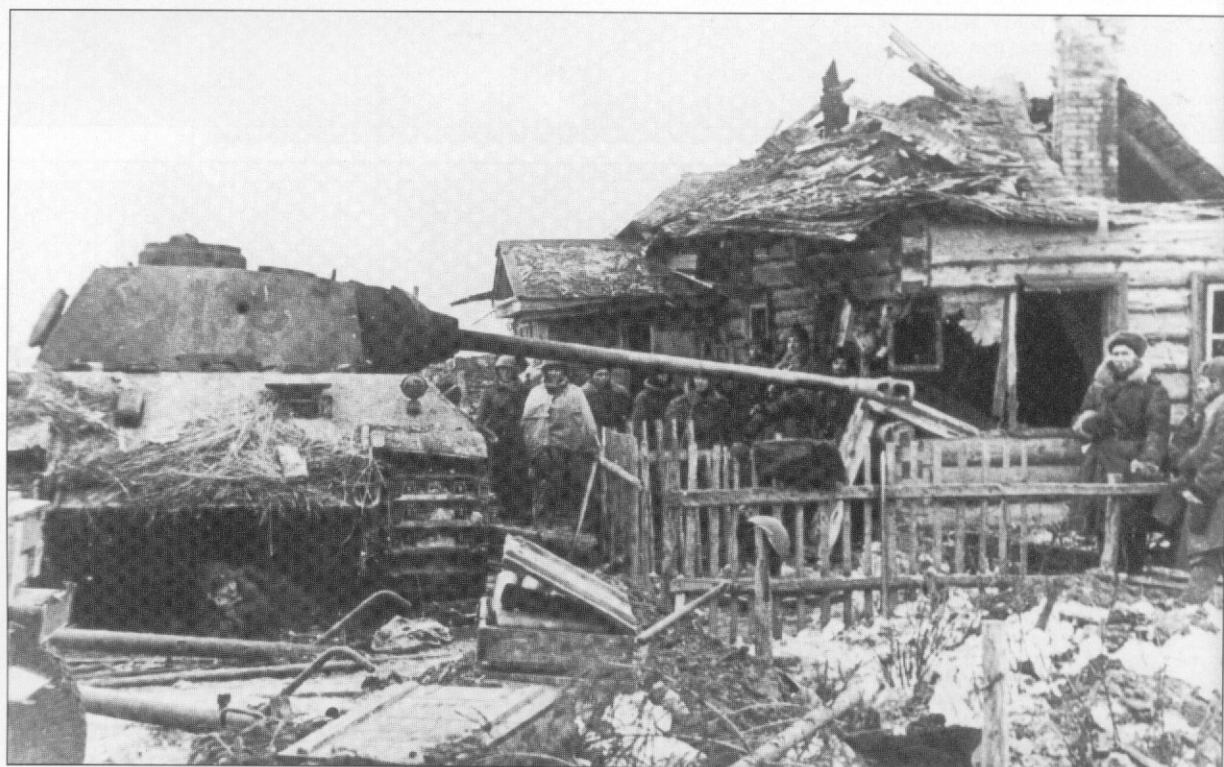
Destroyed by a well-aimed shot that penetrated the turret, this early Ausf. D was abandoned at a farmhouse. The bracket for the smoke grenade discharger is still visible. The MG port and driver's hatch are open. (S. Netrebenko)

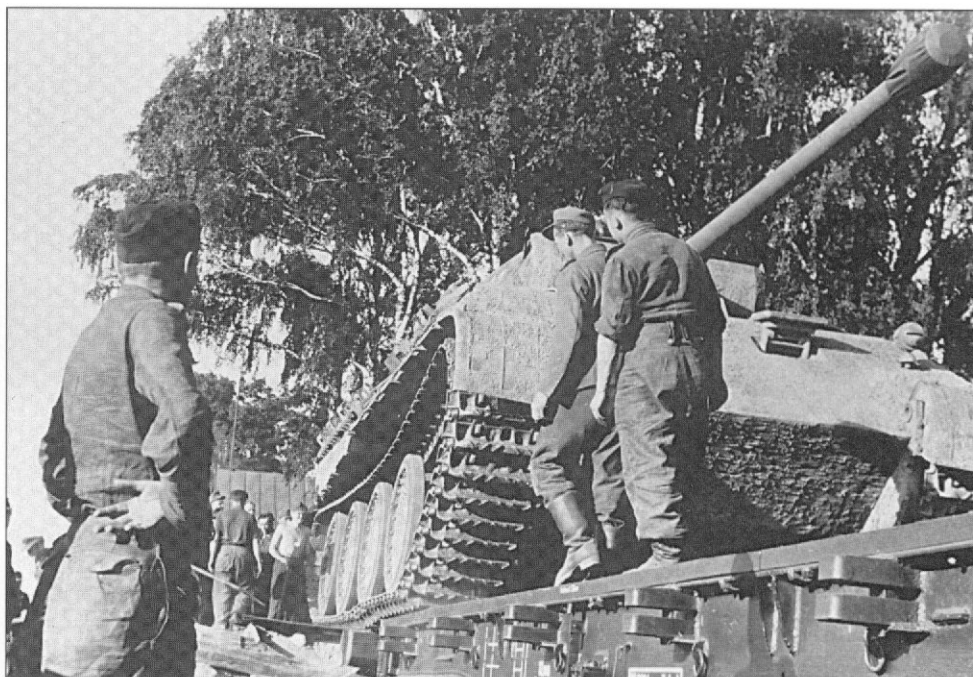
A Panther Ausf. D is loaded onto a flatbed wagon. The crew will soon wedge the tracks. During railway transport, all side skirts were removed. The tank shows a very rough coating of *Zimmerit* that is typical of early Panthers. (M. Green)

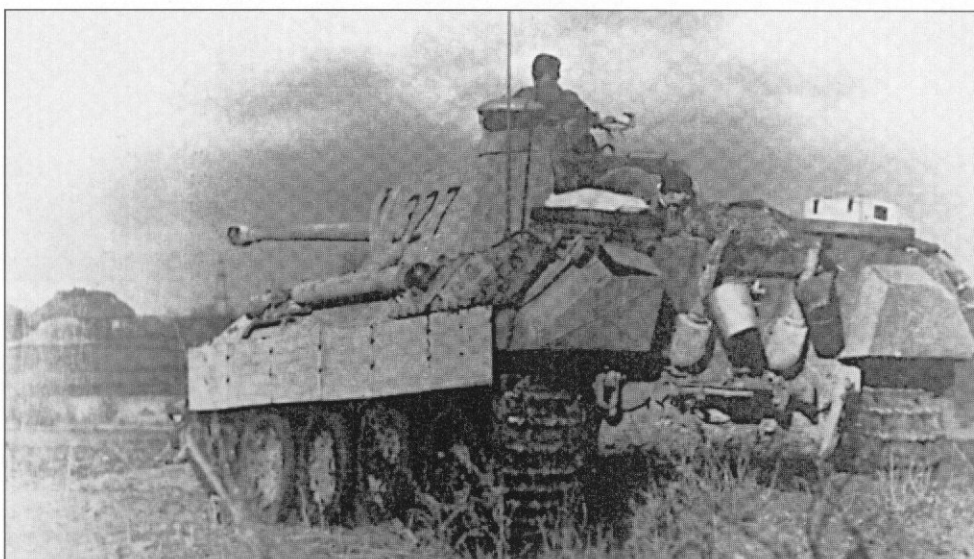
This Panther Ausf. D of "Wiking" carries a pair of double running wheels on the engine deck. These were used in the center of the interleaved running gear. The turret number is painted in plain black. (P. Kammann)

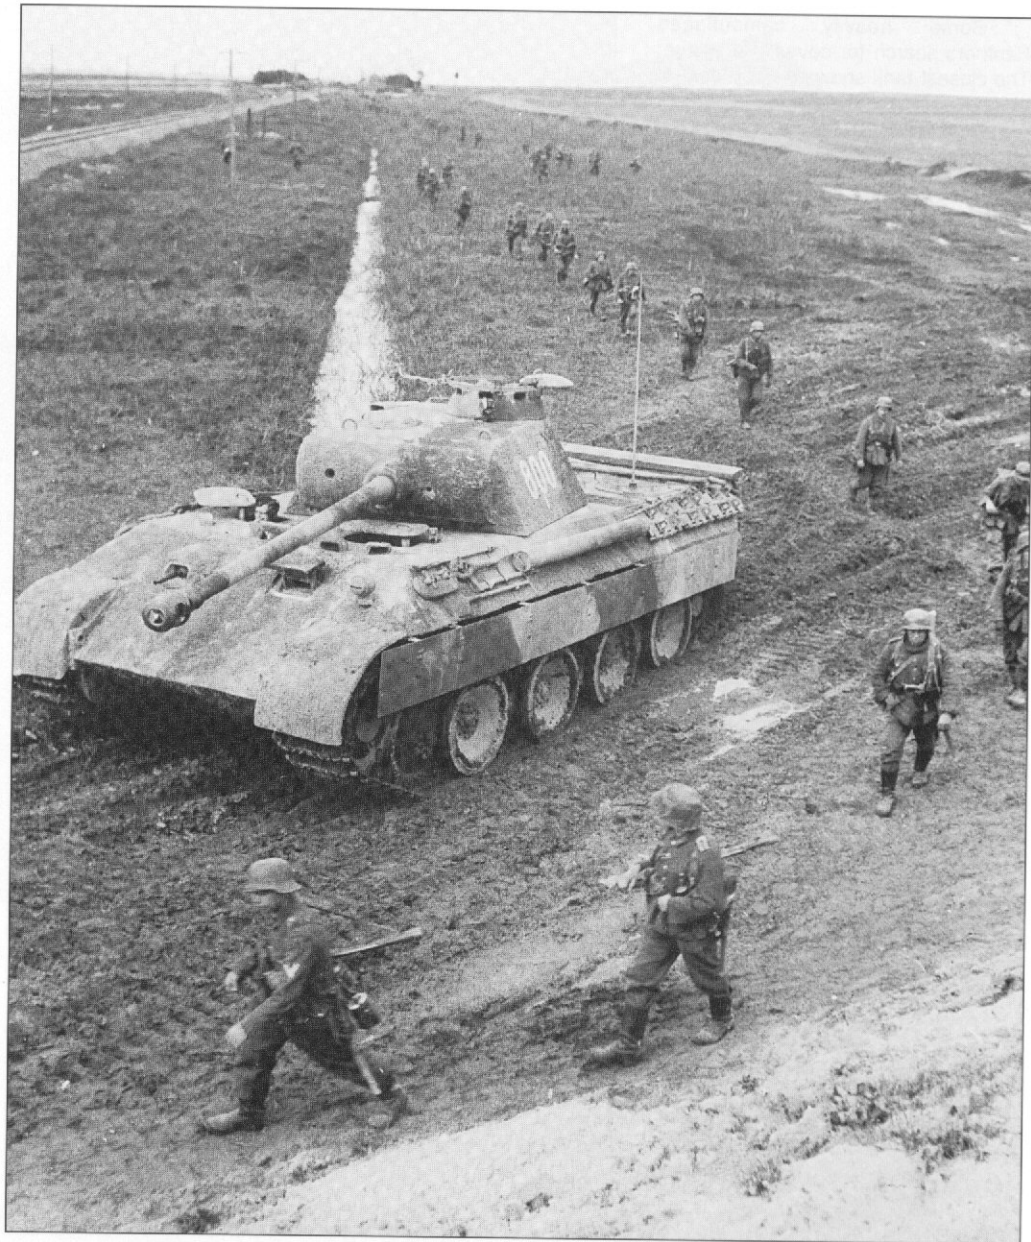
This photo shows the impact of enemy fire on a Panther Ausf. A. The turret was penetrated by three (visible) rounds, probably of 7.62 cm caliber. Large portions of *Zimmerit* have fallen off. The roof plate over the transmission was blown off by an internal explosion. Beginning with Ausf. A, the loader was provided with a periscope. The square block welded behind the gun mantlet limited elevation of the gun. (W. Schneider)

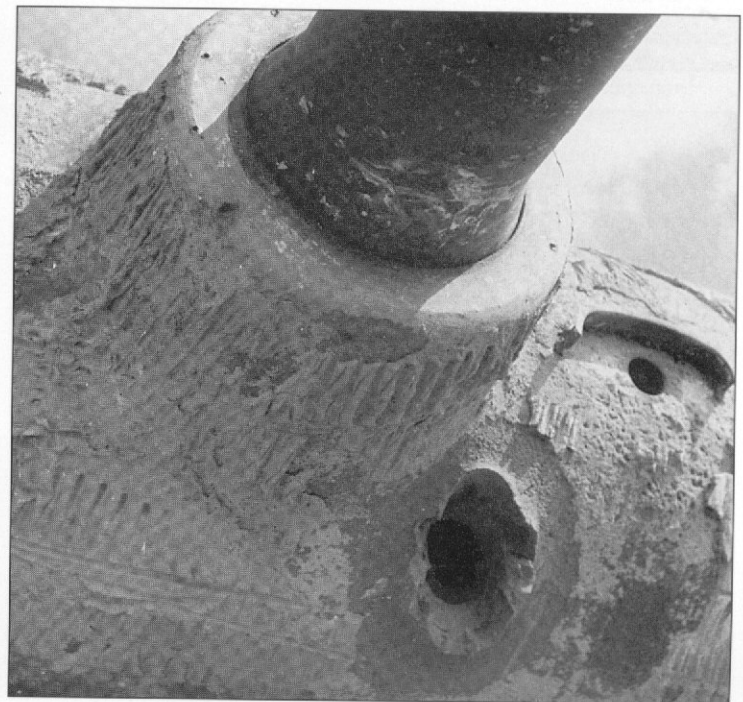
The gun mantlet of the same tank was penetrated as well. The pattern of the *Zimmerit* coating is shown to advantage here. Note that the monocular gun sight is still provided with the wide rain cover used with the earlier binocular gun sight. (W. Schneider)

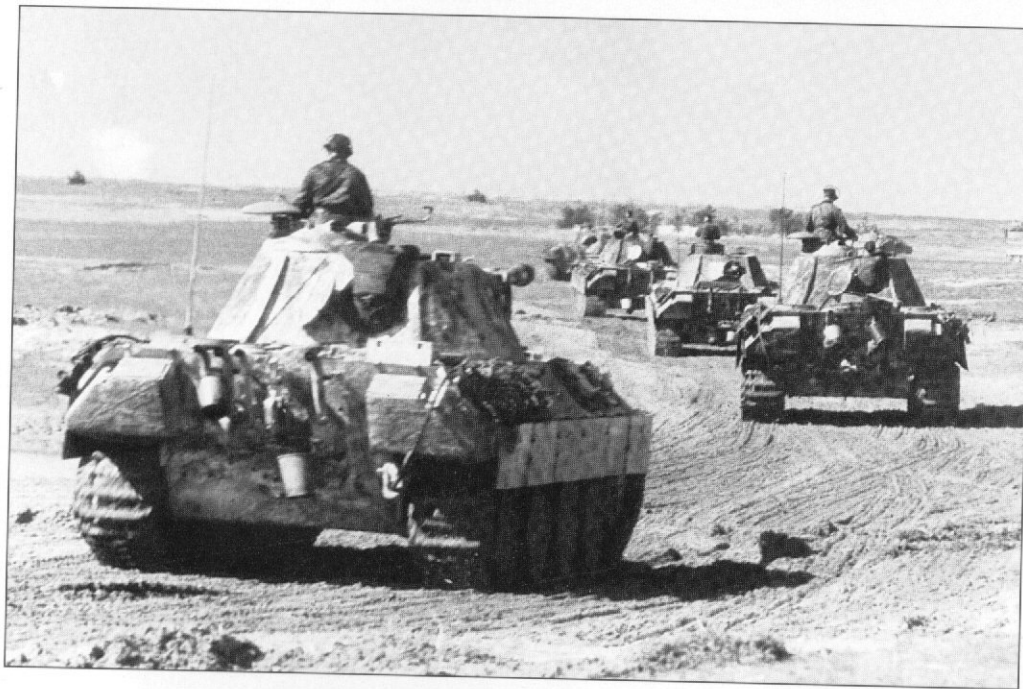
A platoon of Panther Ausf. As of "Wiking" moves to the front. The Panther in the foreground is fitted with ventilation pipes at the left exhaust. The jack is fitted between the exhaust tubes. Note the loader sitting in the rear hatch. (W. Schneider)

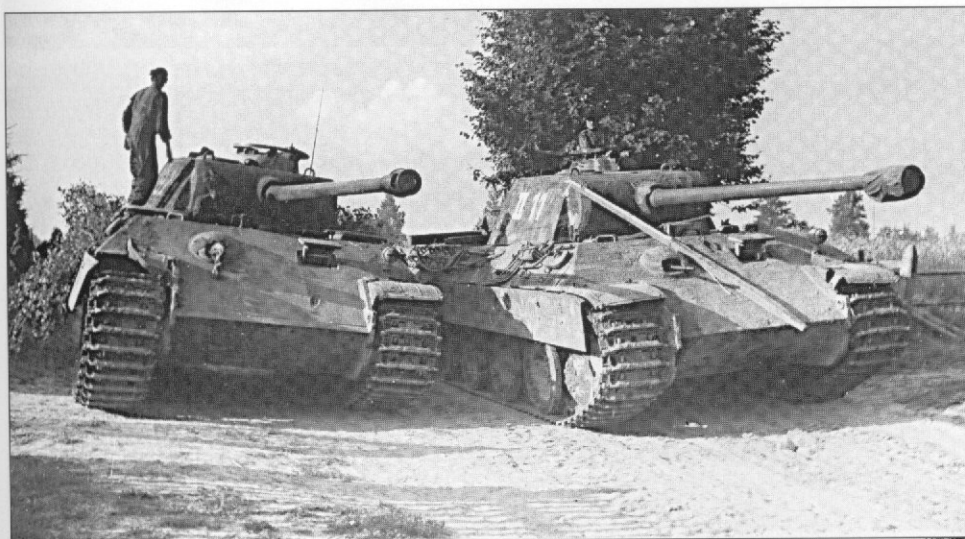
Panther "II 11" passes by a battered Ausf. A. Visible below the driver's hatch is a large dent, which doubtless caused some interior problems. However, the tank remained unharmed by this direct hit from a 76.2 mm gun, though some torsion bars on the left side might be broken. It is noteworthy that the complete *Zimmerit* coating on the glacis plate fell off as a result of the impact of the shell. It is possible that the tank's crew was waiting nearby for recovery. (W. Schneider)

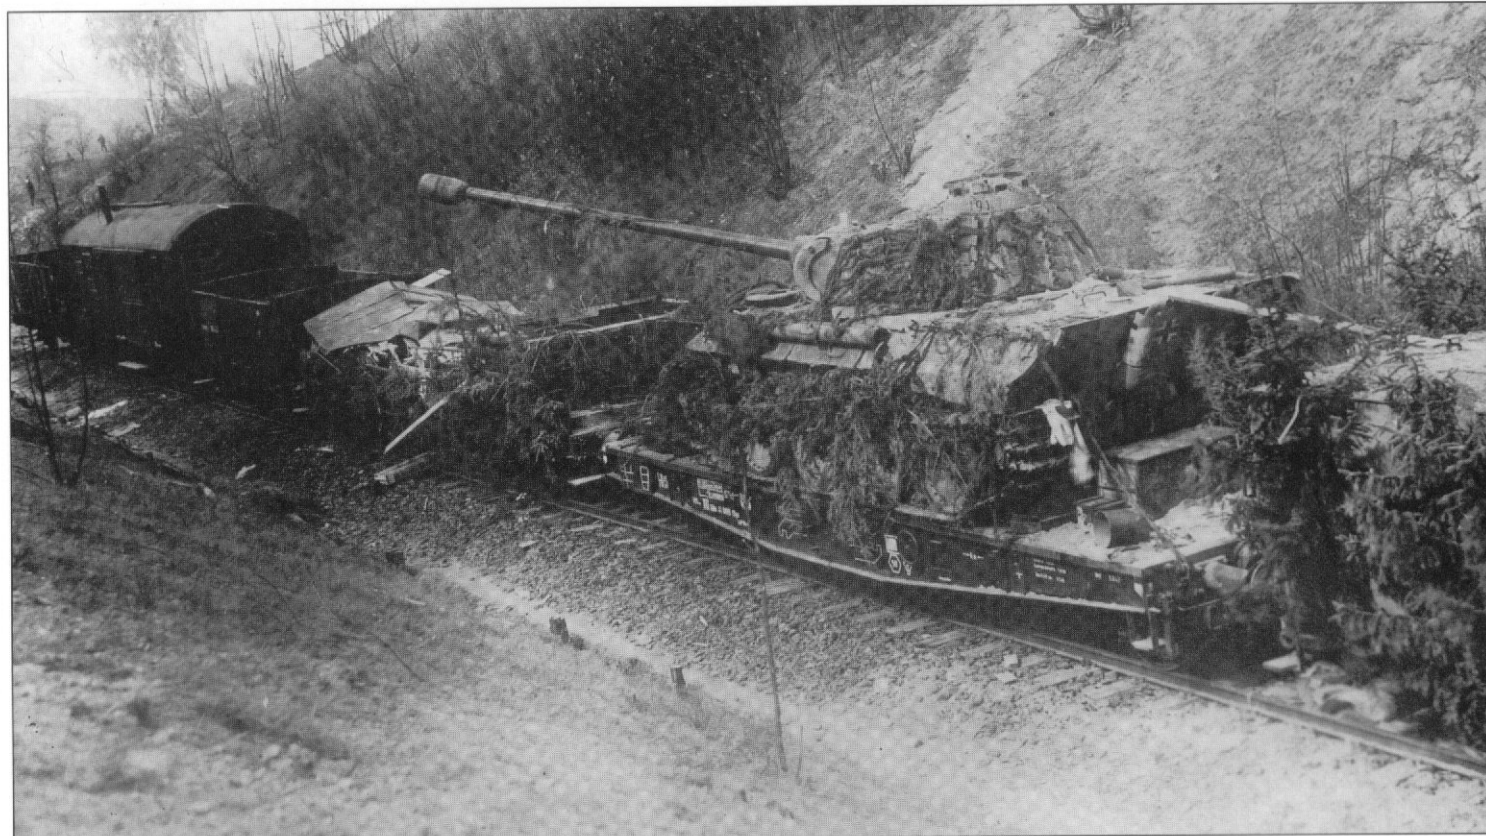
This transport train was hit either by artillery fire or an air strike. The Panther Ausf. A shows another variation of the exhaust system, with both pipes being fitted with a metal cover. The turret is provided with extra track links for added protection. Note that the number "191" was painted on the commander's cupola. The tank has been concealed by foliage. (S. Netrebenko)

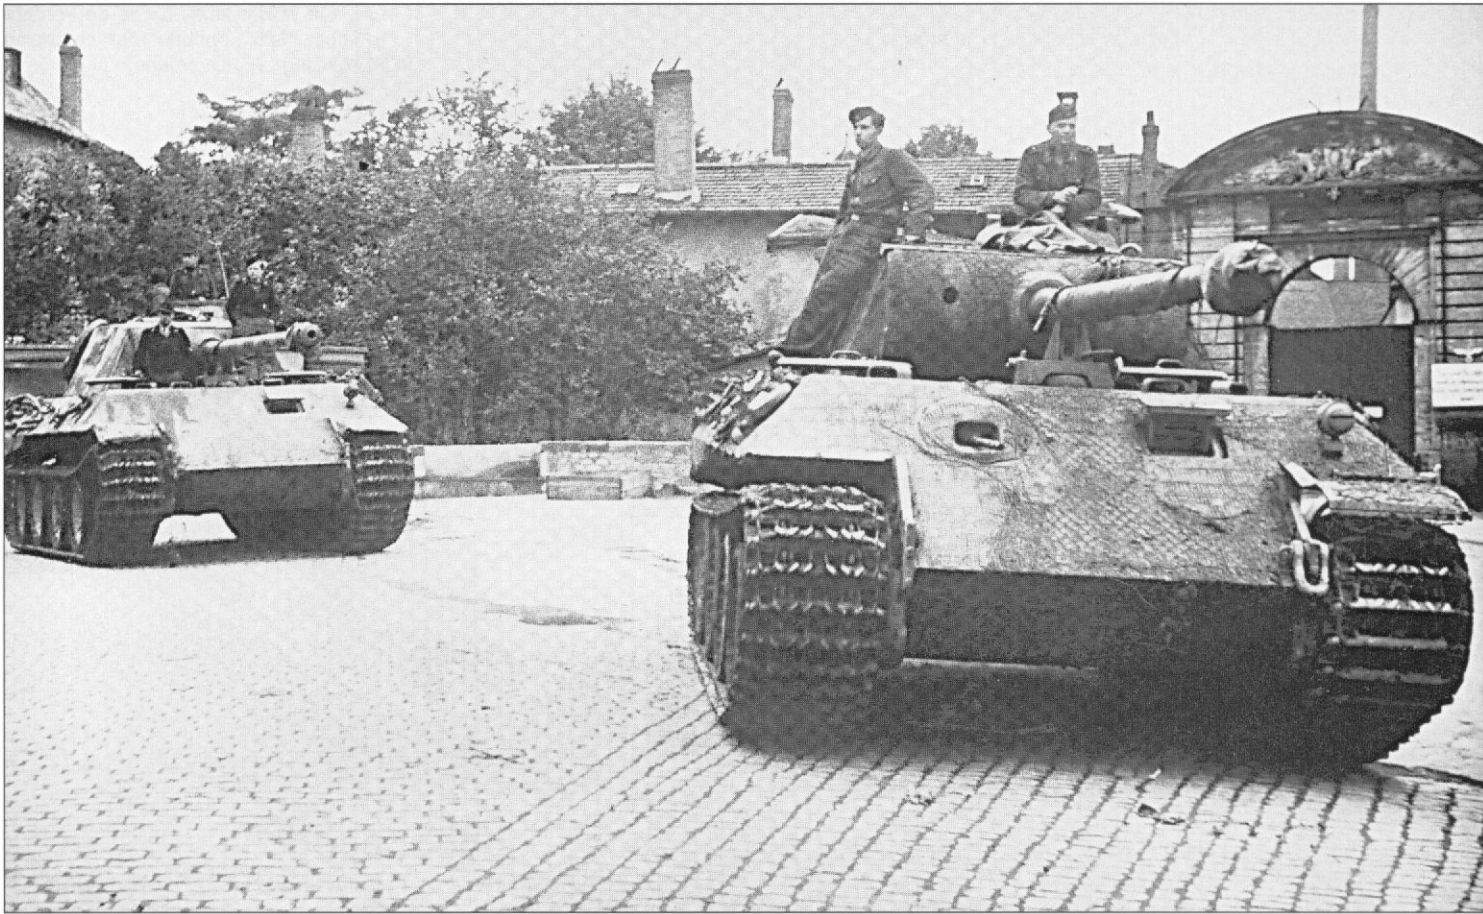
A late-model Panther Ausf. D follows an Ausf. A into a French town. The nearer vehicle is in marching order, its gun being fastened in the travel rest. A protective cover has also been pulled over the muzzle brake. (F. Schulz)

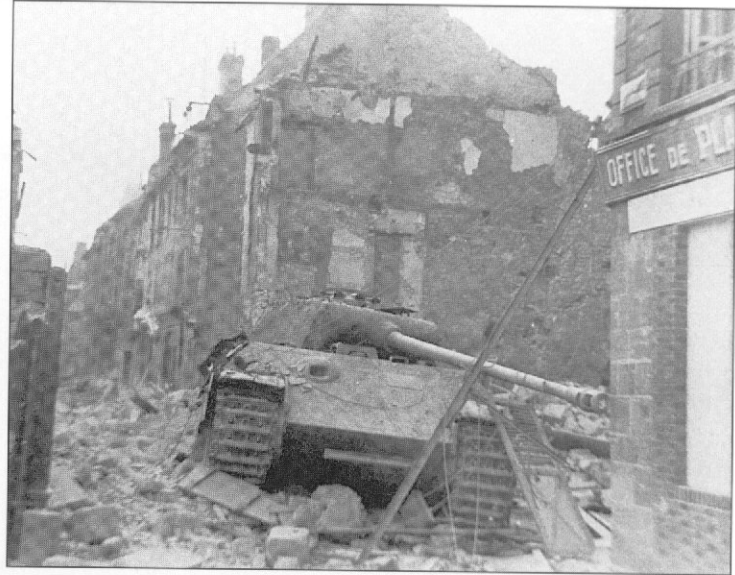
This Ausf. A, a very early production vehicle, is still fitted with the binocular gun sight. The bow MG is protected by a muzzle cover. The tankers wear "Schiffchen" field caps. Note the rough texture of the Zimmerit coating. (F. Schulz)

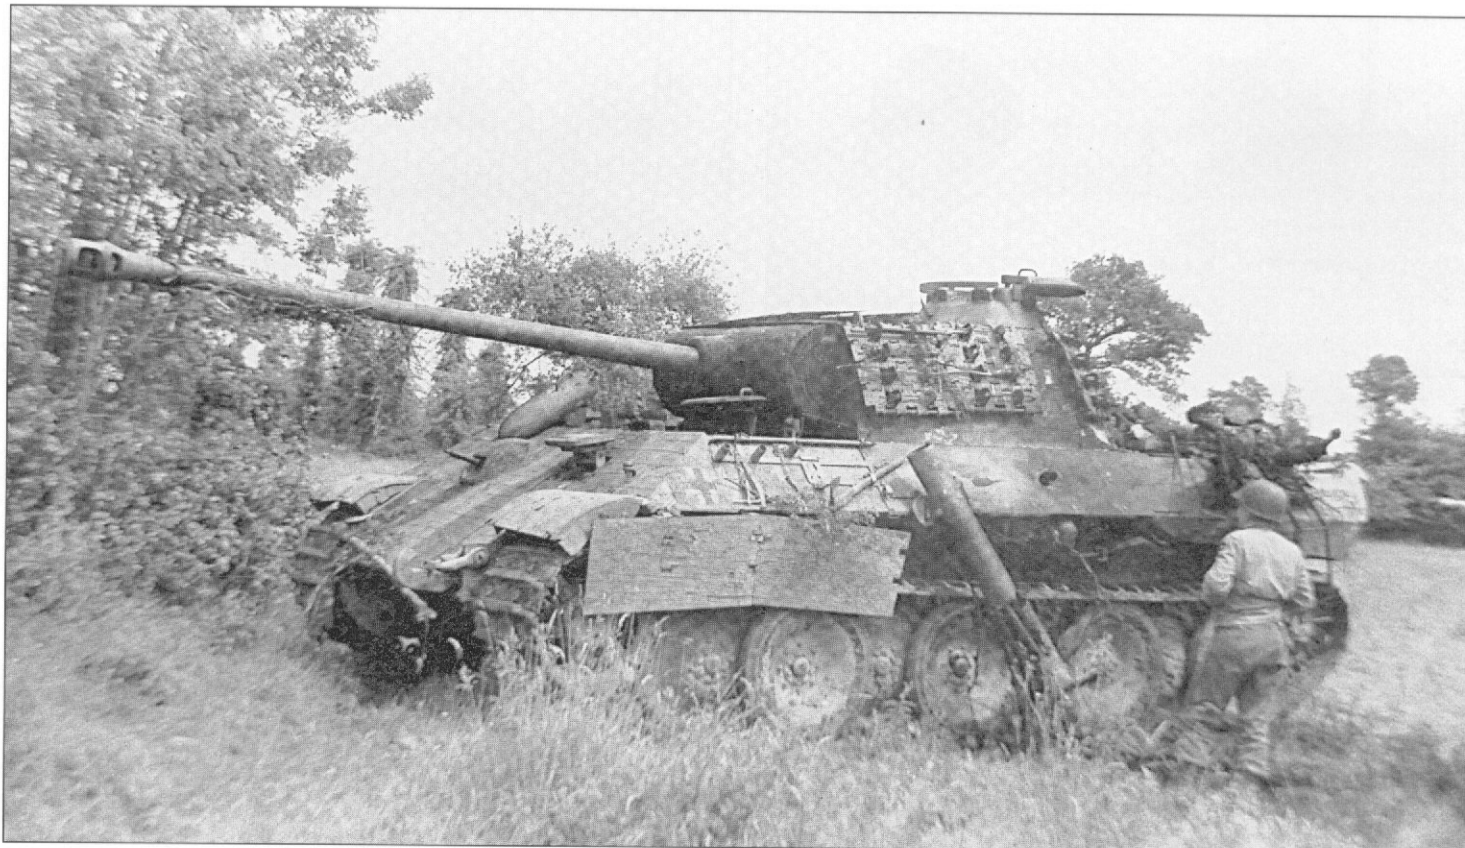
Destroyed by a round fired into its weak 1.7-inch (45 mm) side armor, this Panther lies abandoned in a French field. The turret's armor was reinforced by extra track links. (A. Geibel)

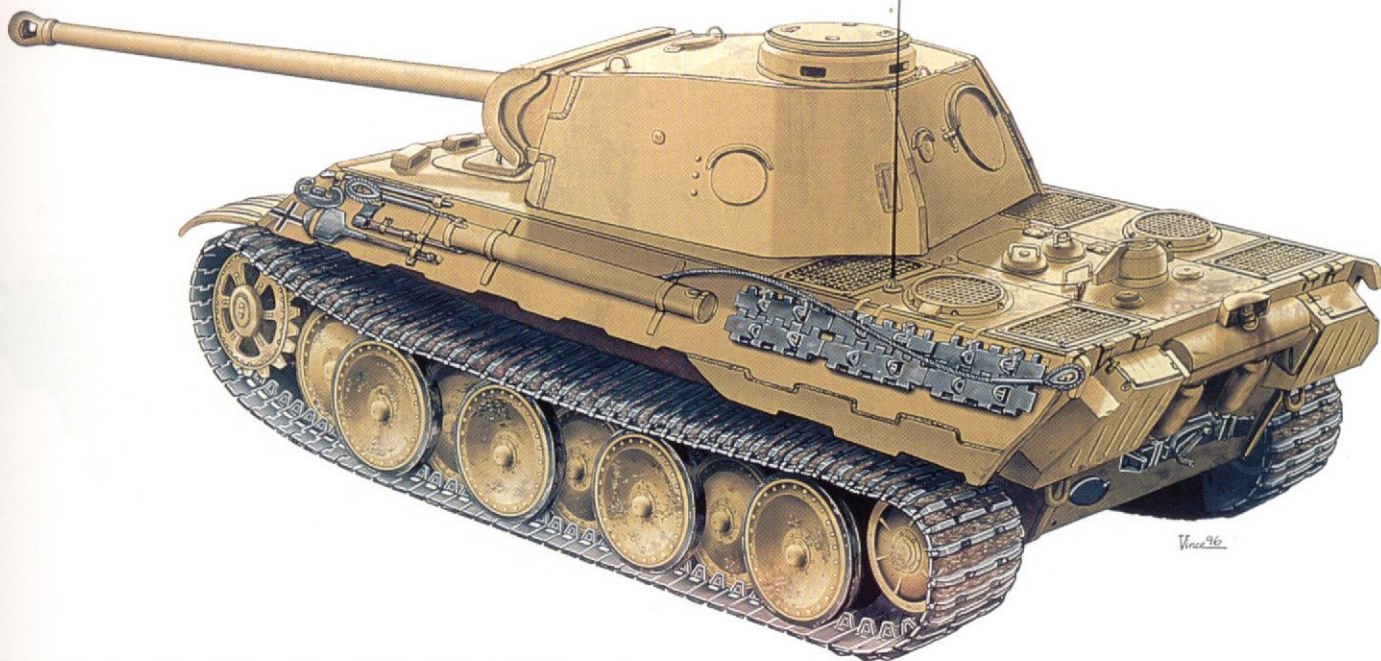
Panther Ausf. D, first production version, Grafenwöhr, spring 1943

This early Panther Ausf. D represents a training vehicle at Grafenwöhr exercise area. It belonged to the first production lot, which was used entirely for driving school purposes. According to veteran tankers, some vehicles were prepared for diving/deep wading, thus they exhibited a horizontally fitted exhaust muffler with a one-way valve. The dome on the air inlet behind the engine hatch contained a telescopic snorkel, which could be erected to a 10-13 ft (3-4 m) height. All hatches were sealed, and watertight covers could be slipped over the muzzle brake, commander's cupola and gun mantlet. Apparently, a few vehicles were provided with the single baffle muzzle brake as used with the Pzkw IV Ausf. F2.

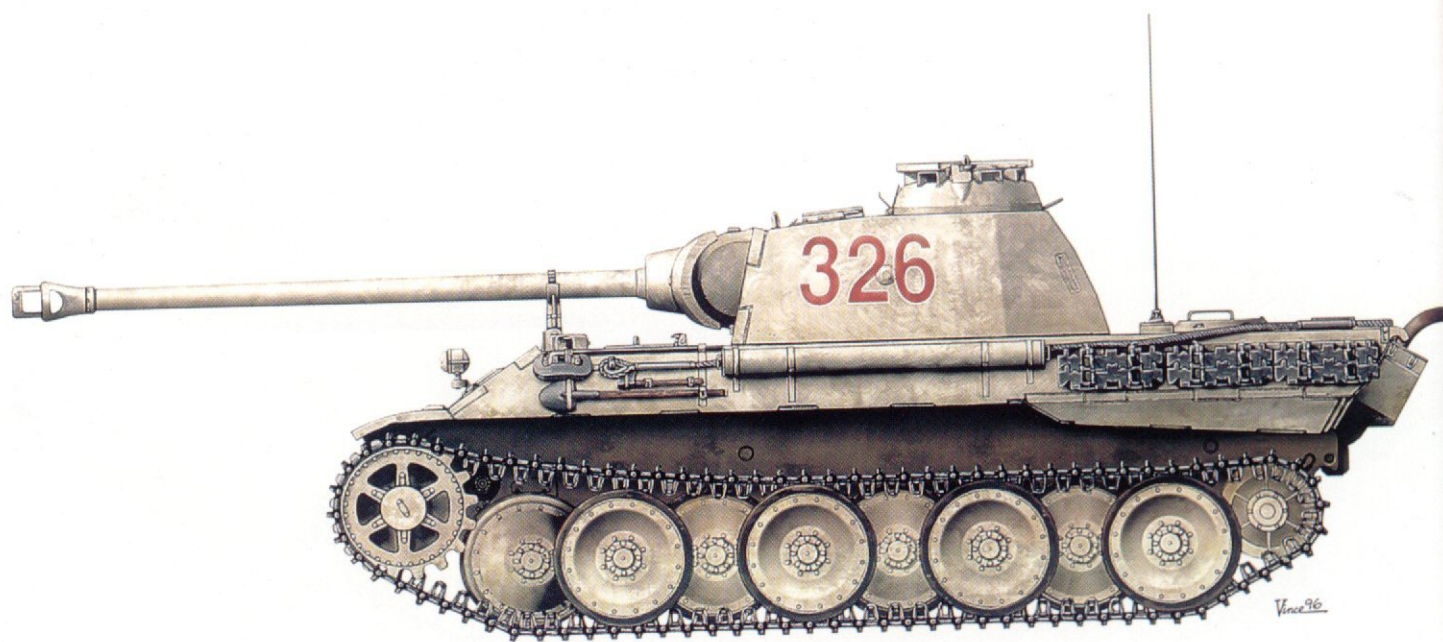
Panther Ausf. D, middle version, Pz.Rgt. 24, Voussiers, France, autumn 1944

Pz.Rgt. 24 used a number of Ausf. Ds during basic training in Voussiers near Reims in 1944. These vehicles were standard Ausf. Ds with the early commander's cupola. During production, AA MG rings were introduced. Of great interest is the pyrotechnical gunfire simulator, which was fitted to the gun just in front of the mantlet. The Panthers produced before August 1943 had no *Zimmerit*; this was applied by field workshops by official order. This, however, resulted in a very rough coating that was not comparable to that applied by the factory.

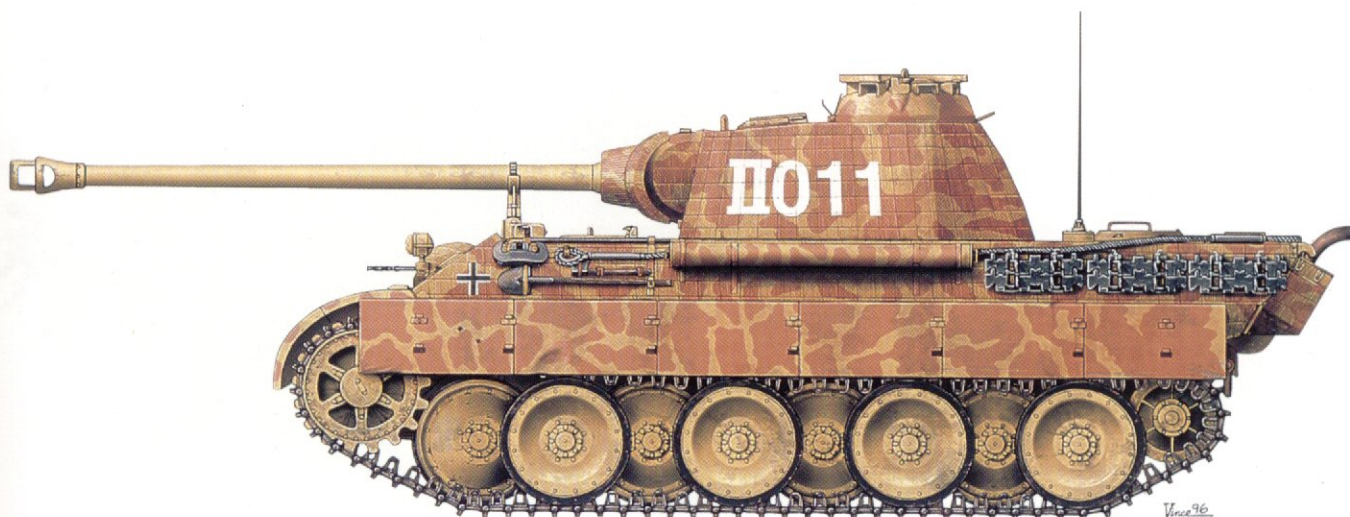
Panther Ausf. D, winter wash, winter 1943/44

This late-model Ausf. D. shows the newly introduced commander's cupola, which offered improved sight and protection. The large reloading/communication hatch was no longer provided. The vehicle shows no *Zimmerit*, and its equipment is standard. The tank was whitewashed, so only small portions of the base color are visible. This particular tank displayed a German iron cross at the rear plate between the exhaust pipes.

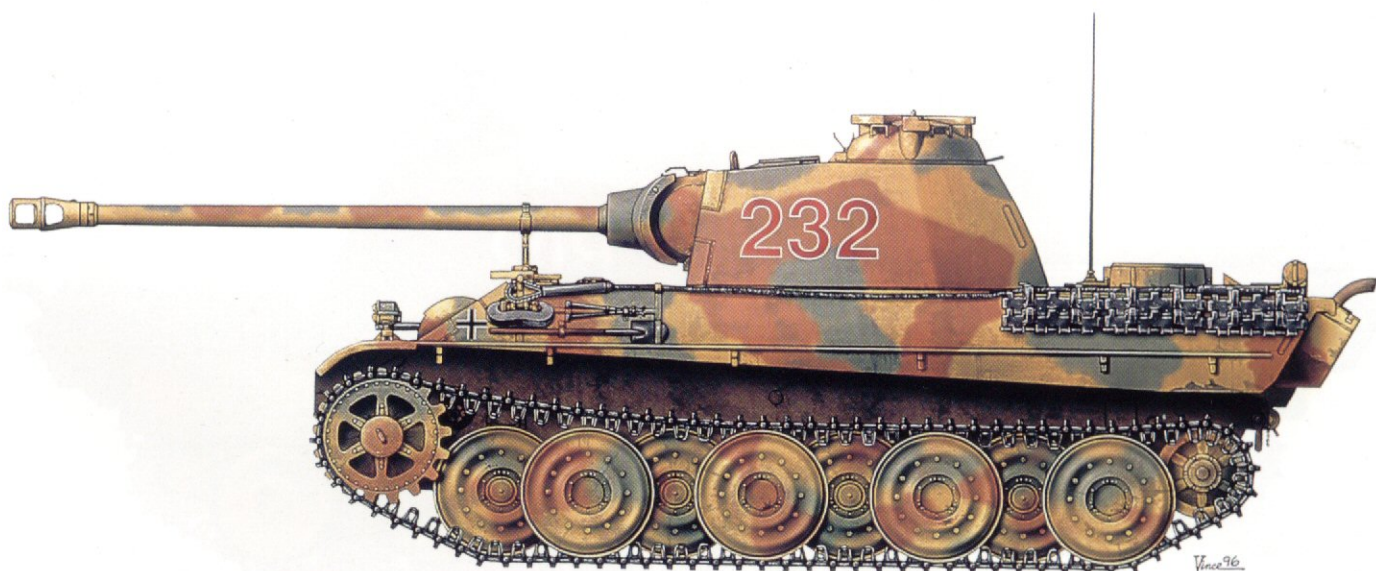
Pzkw Panther Ausf. G, splinter camouflage, Poland, autumn 1944

This Ausf. G shows a lot of extra equipment. The mantlet has a reinforced lower edge called a chin mantlet. This was introduced to prevent rounds from penetrating the driver's roof. Turret protection was further enhanced by adding spare track links. The vehicle number was painted directly onto the links. Of special interest is the sharp-edged camouflage that was applied with stencils, probably by the crew.

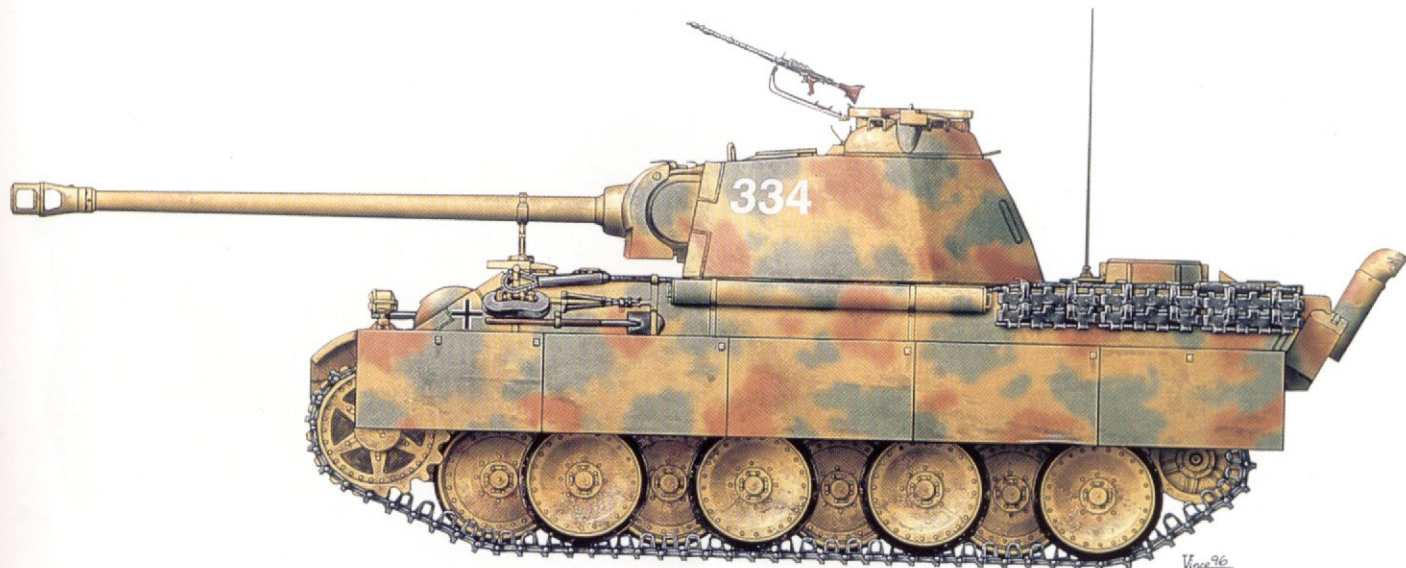
Panther Ausf. G (0-series), Pz.Rgt. 24, near Aachen, November 1944

This vehicle is one of the few Panthers fitted with rubber-saving steel-rimmed running wheels. Apart from the running wheels, this is a standard Ausf. G. In late 1944 the camouflage scheme changed. As the front lines reached the German borders, the base color of dark yellow proved to be too bright, so the camouflage colors of dark green and dark brown were expanded to cover wider areas. Large portions of the running gear were camouflaged, which left a smaller amount of dark yellow visible.
