ARMOR AT WAR SERIES

Panther

Text by Thomas Anderson
Color plates by Vincent Wai

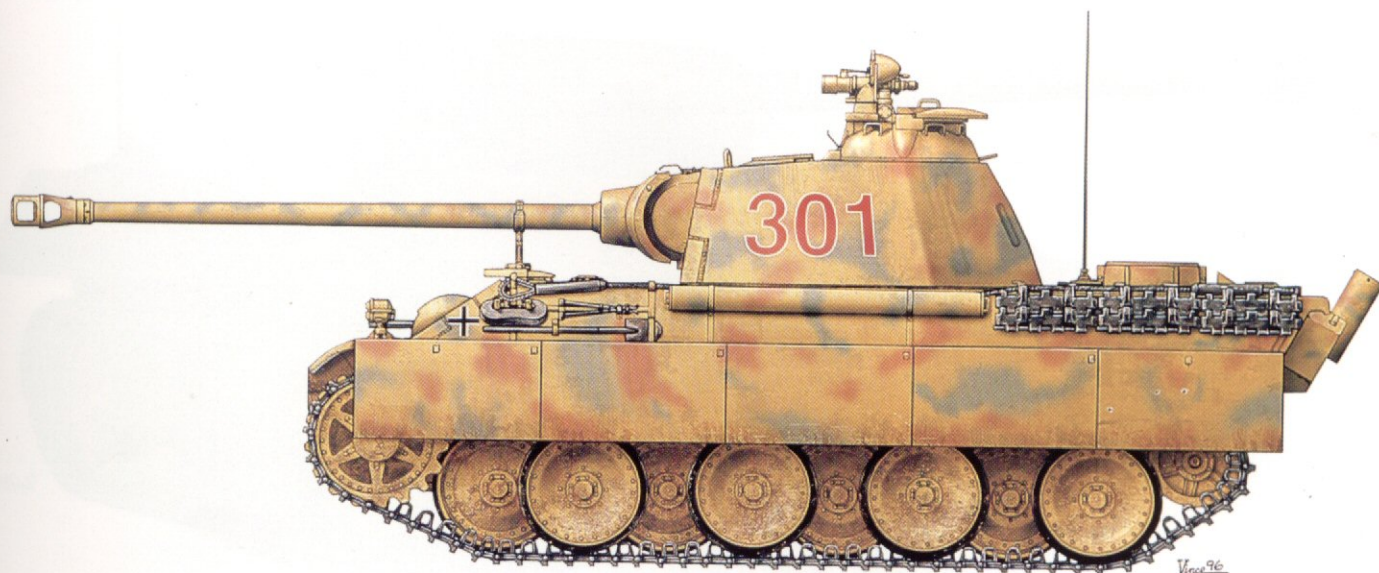
Panther Ausf. G, Kampfgruppe Pz.Brig. 106 FHH, Bonn, March 1945

This vehicle represents a very late version of the Ausf. G. All side skirts are fitted and the mantlet shows the reinforced chin. *Flammenvernichter* exhaust mufflers, which were designed to prevent the exhaust from glowing, have been fitted. (In some cases, Soviet tankers used to aim at the exhausts at night.) These also prevented backfires. (Panthers occasionally caught fire from exhaust problems.) The numbers on the turret were small, thereby creating somewhat of a low-visibility marking.

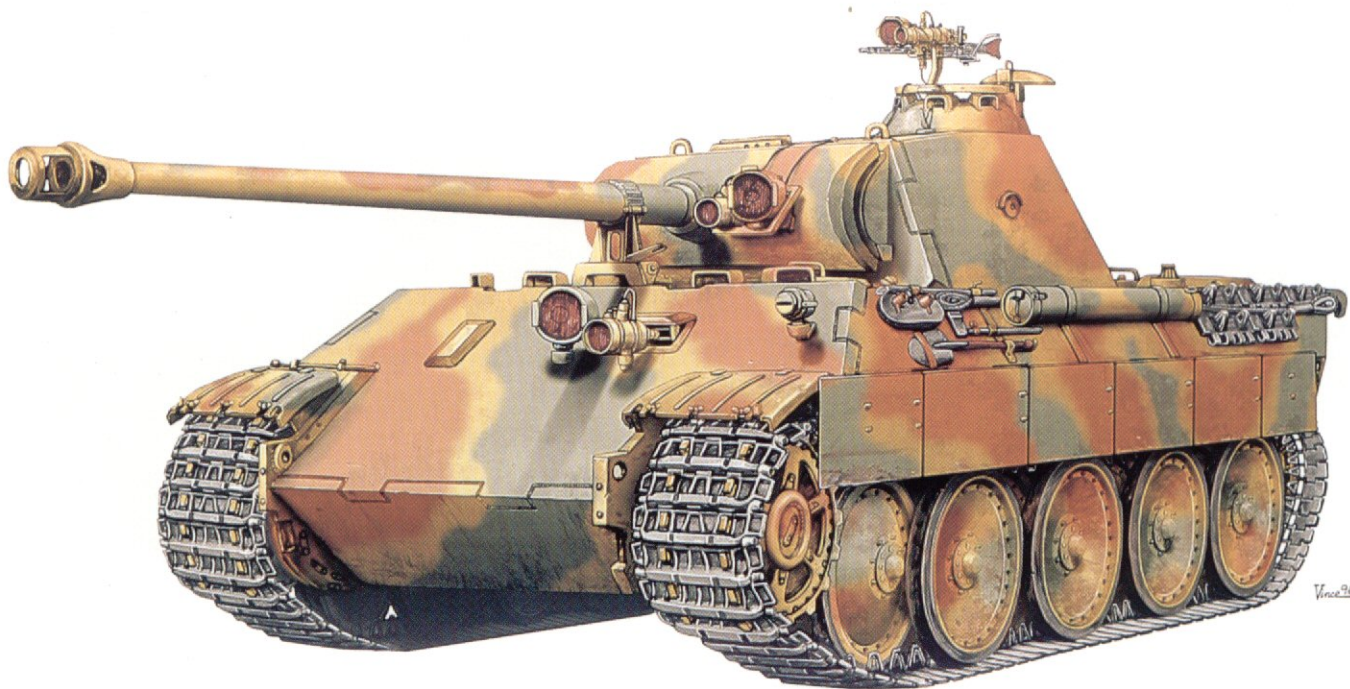
Panther Ausf. G with IR equipment (Solution A), 3./Pz.Rgt. 24, Fallingb., December 1944

An unknown number of Panthers of 3rd Squadron, 1st Battalion, 24th Tank Regiment were provided with infrared equipment in December 1944. This set consisted of an IR searchlight with an image converter mounted inside the commander's cupola. This simple set made possible successful combat at night. One vehicle was sent to Stuhlweißenburg, where it was tested with "Wiking". Although successful, widespread use was still delayed for some unknown reason. The base vehicle was a standard Ausf. G with the *Flammenvernichter* flame trap exhaust.

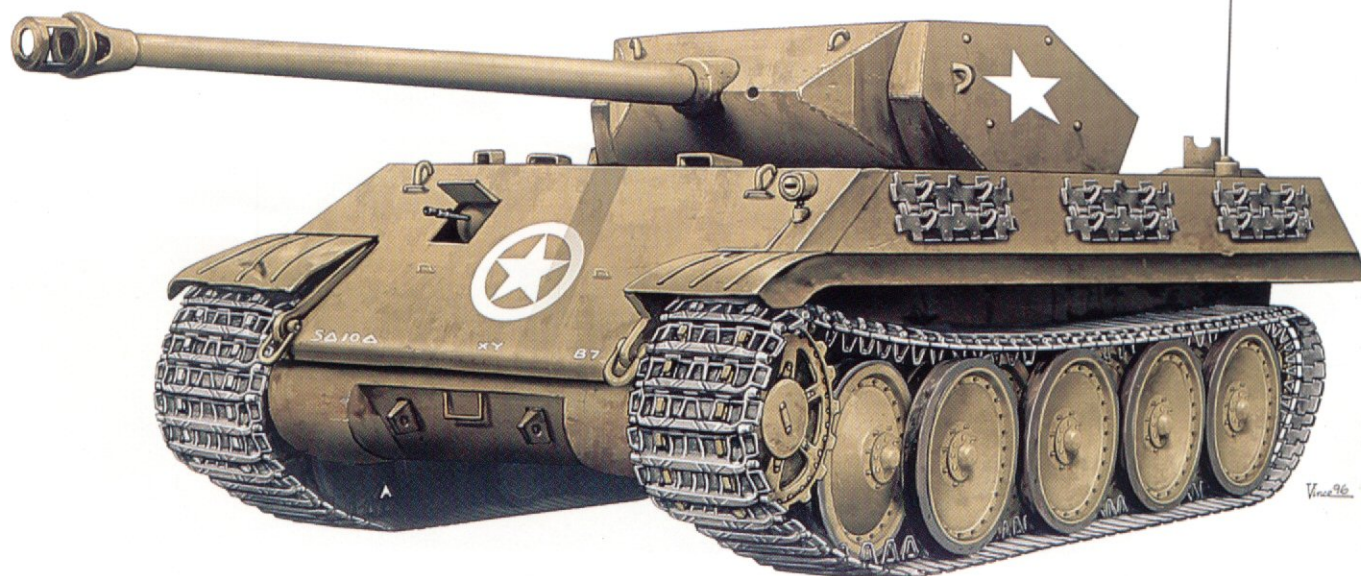
Ersatz M10, Panther Ausf. G disguised as M10 TD, Pz.Brig. 150, La Falize, 1944/45

Pz.Brig. 150 converted about 10 Panther Ausf. Gs to imitations of the US M10 tank destroyer. Sheet metal was used to disguise the shape of the turret and hull. Even the commander's cupola was removed, leaving the commander without proper sight in combat. These ersatz (substitute) M10s failed during combat due to unsuitable tactics: the vehicles were sent out on normal assaults rather than being used for commando raids.

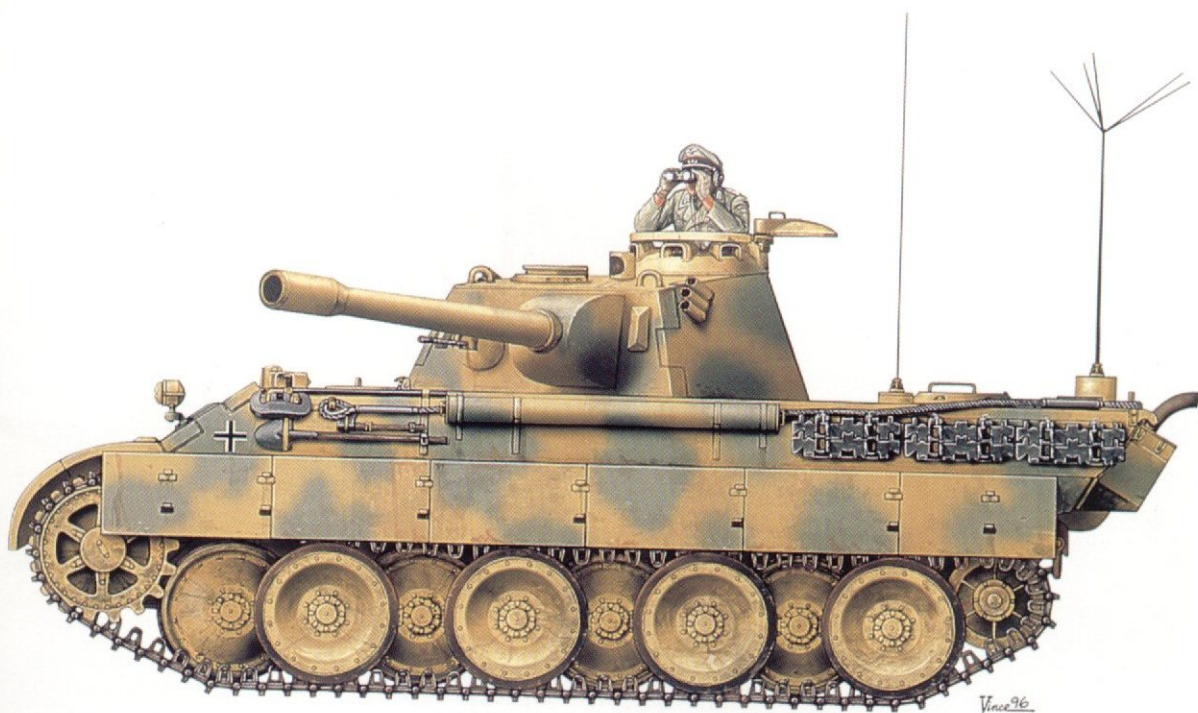
Pzbeobwg Panther Ausf. D (artillery observer's tank)

This artillery observer's vehicle was a highly specialized tank. Although no combat photo of the vehicle is known to exist, several sources speak of about 50 of them being produced. The main gun was replaced by a short dummy gun. A rangefinder was mounted inside the turret, and sight was provided via two flaps on the front. Further, an observation periscope was mounted on the roof of the turret. These vehicles were provided with extended radio equipment similar to the Pzbfswg Panther Command tank.

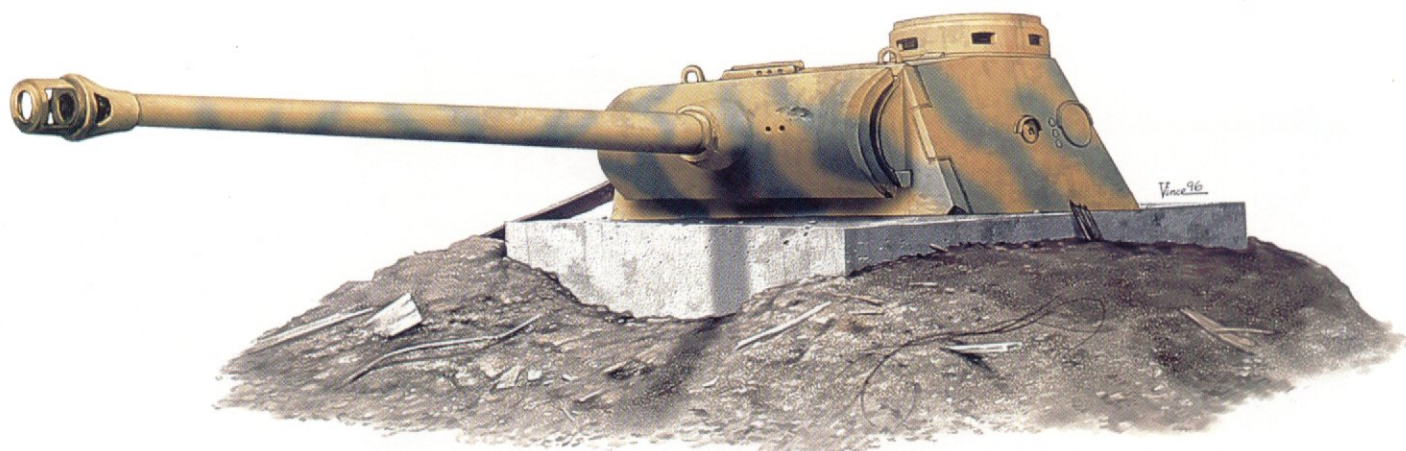
Panther turret in improvised defensive position, Berlin, 1945

This turret was one of many used in fixed positions to protect strongpoints or cities. Normally such turrets were taken from destroyed vehicles that were beyond repair. This particular turret is one of a dozen which would defend the city of Berlin against the advancing Soviet troops.

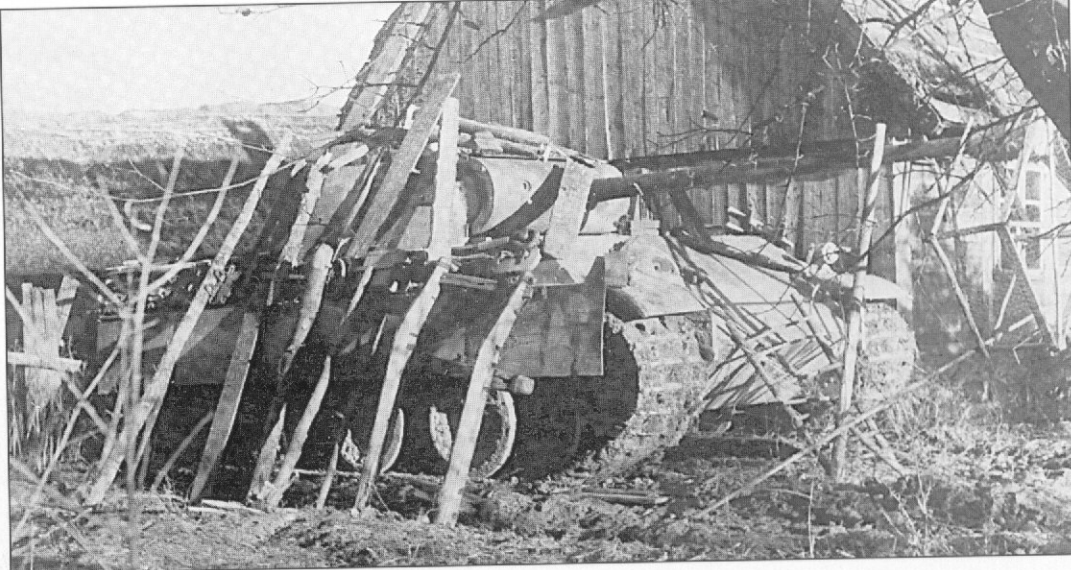
This Panther Ausf. G has been thoroughly concealed in anticipation of a Soviet attack. The wooden planks that were leaned against the tank would fall off when the tank moved. This Ausf. G was produced after September 1944, as is indicated by the lack of a *Zimmerit* coating. The larger side skirts are clearly visible. (BA)

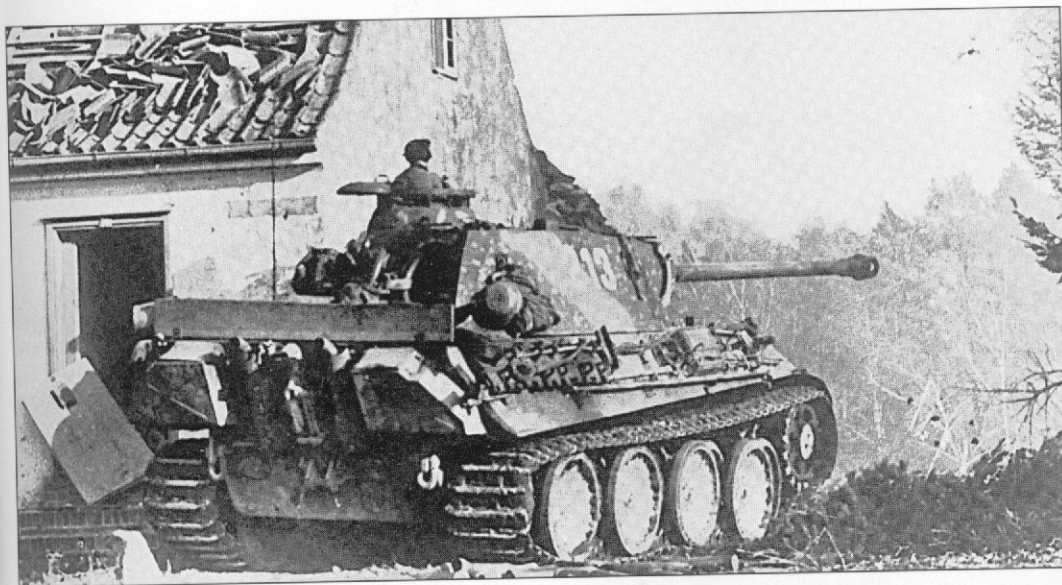
Defending the East Prussian town of Goldap in early 1945, this Panther clearly displays the revised side plates of the Ausf. G. Due to production of the Jagdpanther, the hull's side angle was changed and the armor increased to nearly 2 inches (50 mm). The camouflage was called *Licht und Schatten Tarnung*, more commonly known as the ambush scheme. The number "213" was applied in white. (BA)

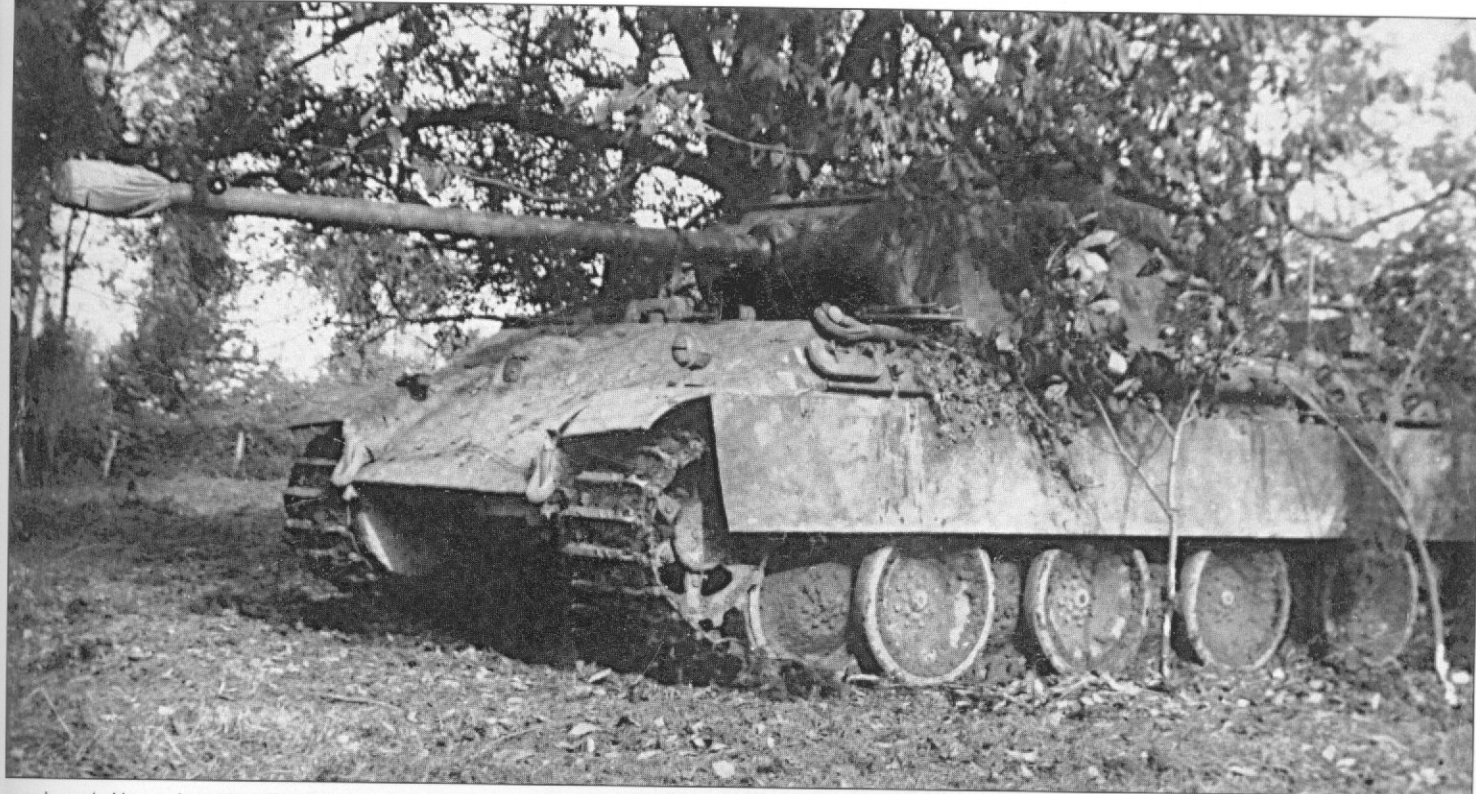
In early November 1944 Pz.Rgt. 24 lay in defensive positions on the German border near the city of Aachen. The era of large-scale operations was gone, and it was now up to hastily established battle groups to try to slow the Allied advance. This Ausf. G waits well-concealed in an oak forest. Note the protective cover on the muzzle brake. (E. Bernhardt)

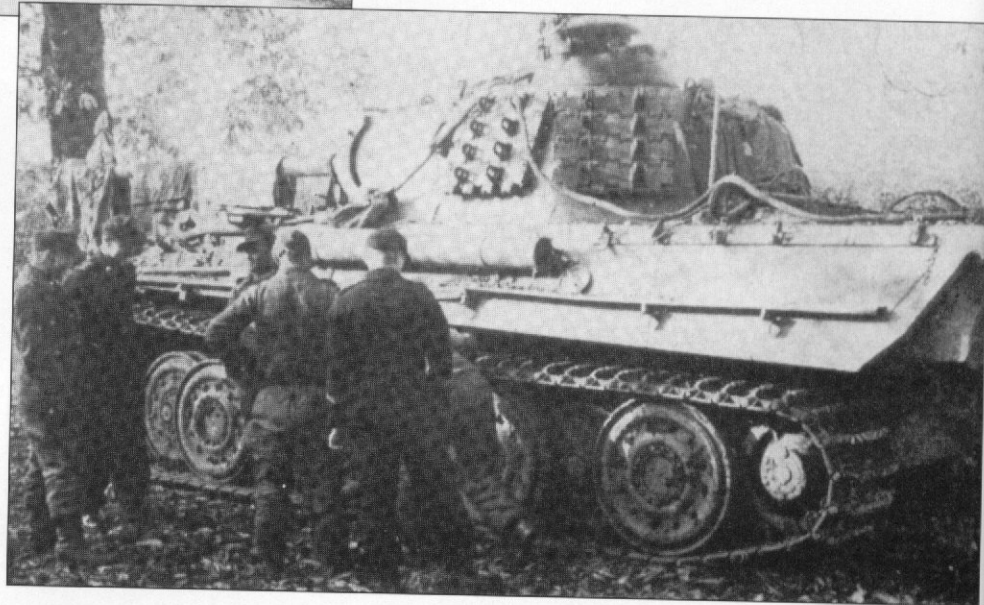
Back from combat near Aachen. This interesting photo shows a Panther Ausf. G of Pz.Rgt. 24 with steel-rimmed running wheels. An O-series was provided with these rubber-saving wheels, probably due to the good experiences the Tiger tanks had with them. This tank also shows a lot of extra equipment. Note how blankets have been hung out to dry from the gun barrel. (E. Bernhardt)

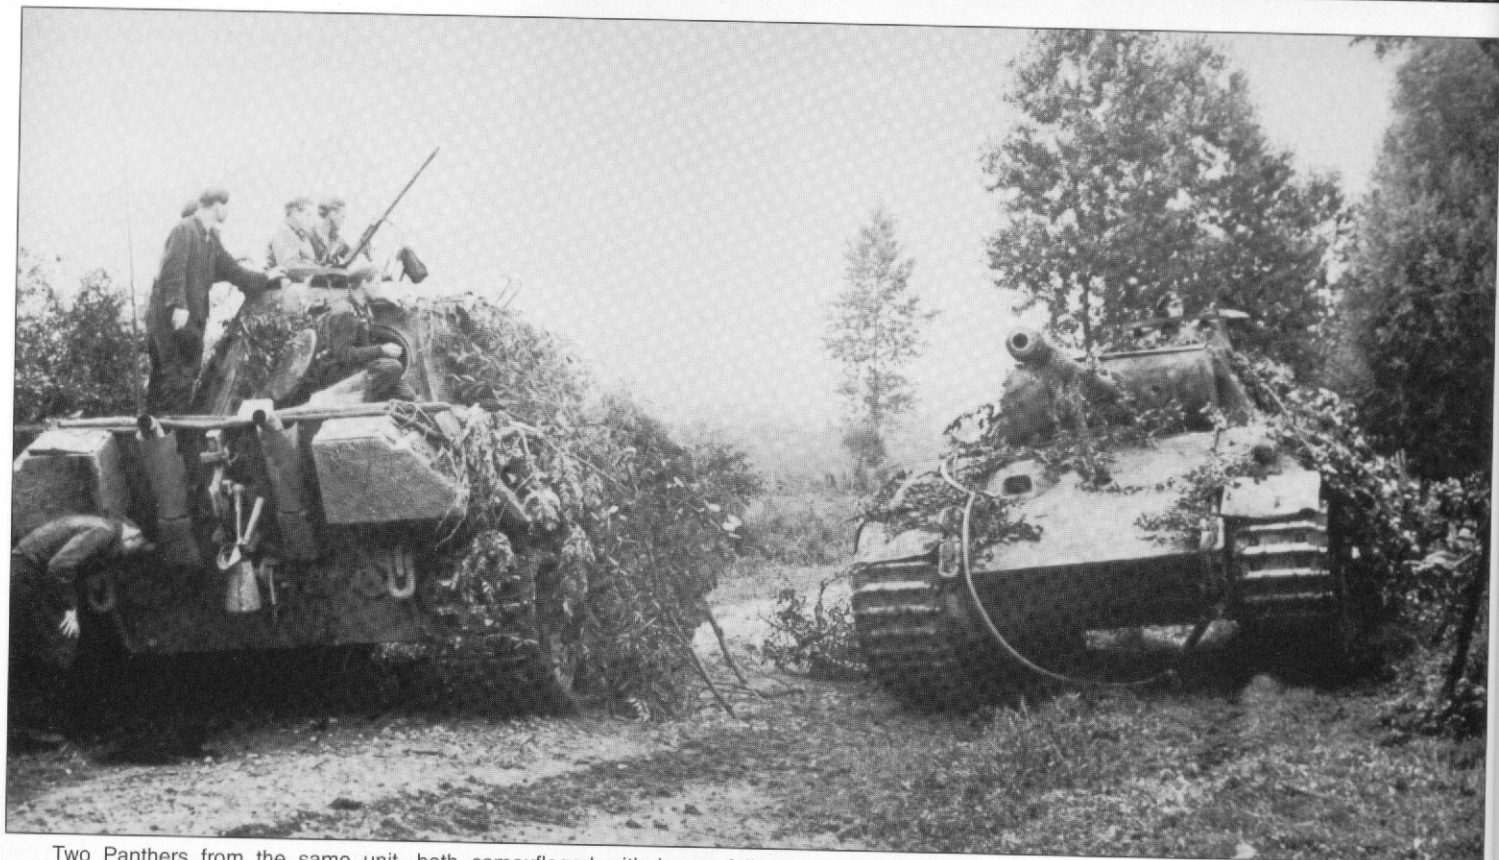
Two Panthers from the same unit, both camouflaged with heavy foliage, meet on a road. The Panther on the left carries an MG 34 in a *Fliegerbeschussgerät* (AA mount), but the ammunition drum is not fitted. The exhaust has been provided with protective covers, and the jack is mounted between the pipes. A towing rope (which would probably be lost soon) has been very slovenly attached to the Panther at right. (F. Schulz)

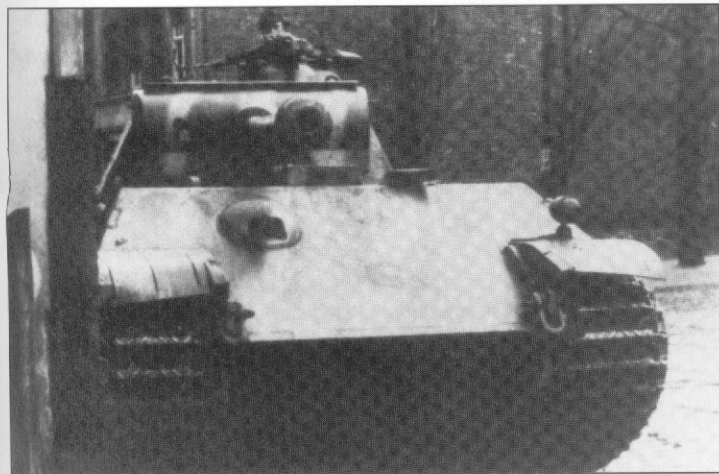
This Panther Ausf. G of Pz.Brig. 106 "Feldherrnhalle " carefully negotiates a corner in the German town of Bonn. The tank, which is of a late production, features the chin gun mantlet. The driver's periscope was provided with an enlarged cover that reduced glare. (BL)

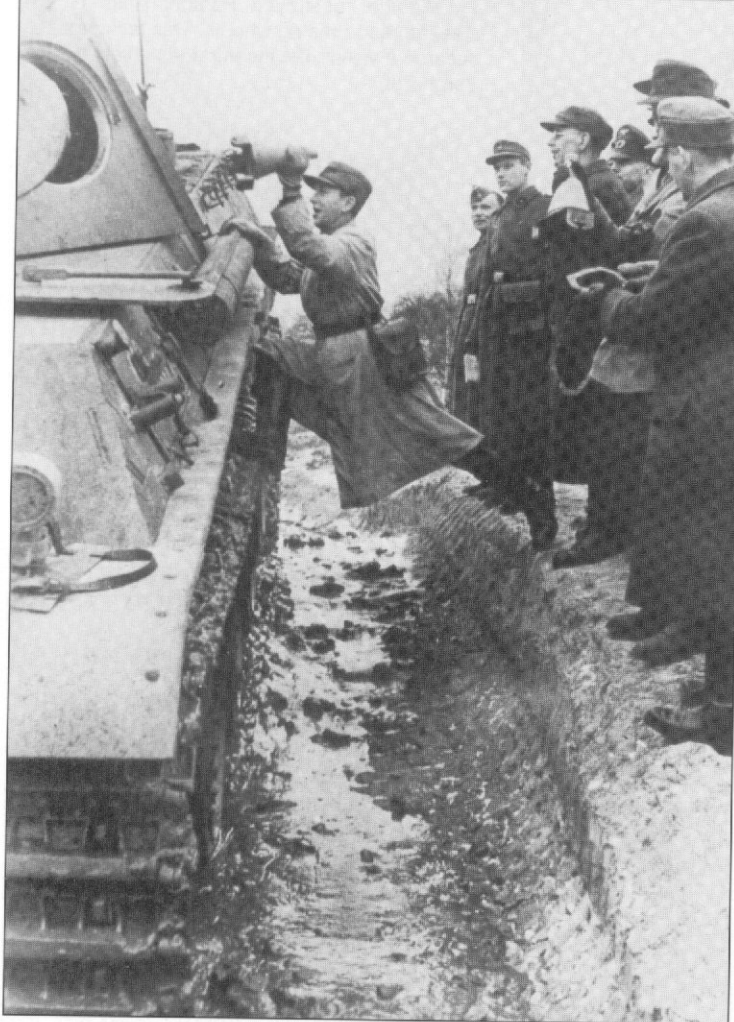
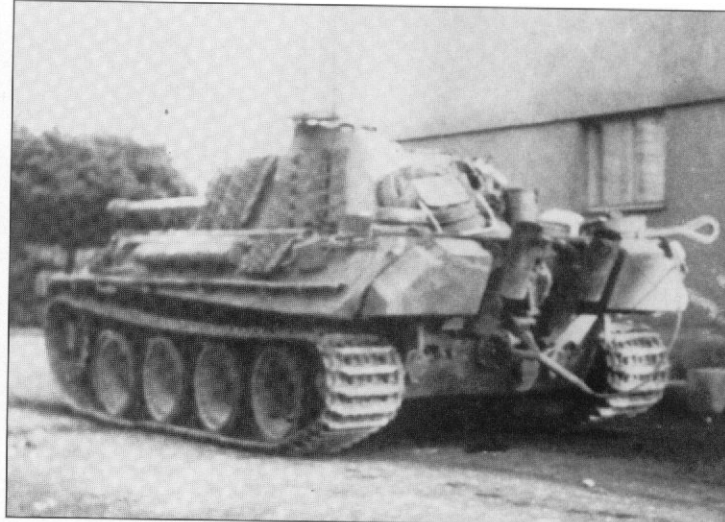
This undamaged Panther was abandoned at Tisnov, Czechoslovakia, at the end of April 1945. This is a very late Ausf. G fitted with a flame suppressor exhaust. A lot of extra equipment is carried on the engine deck and the turret. (S. Netrebenko)

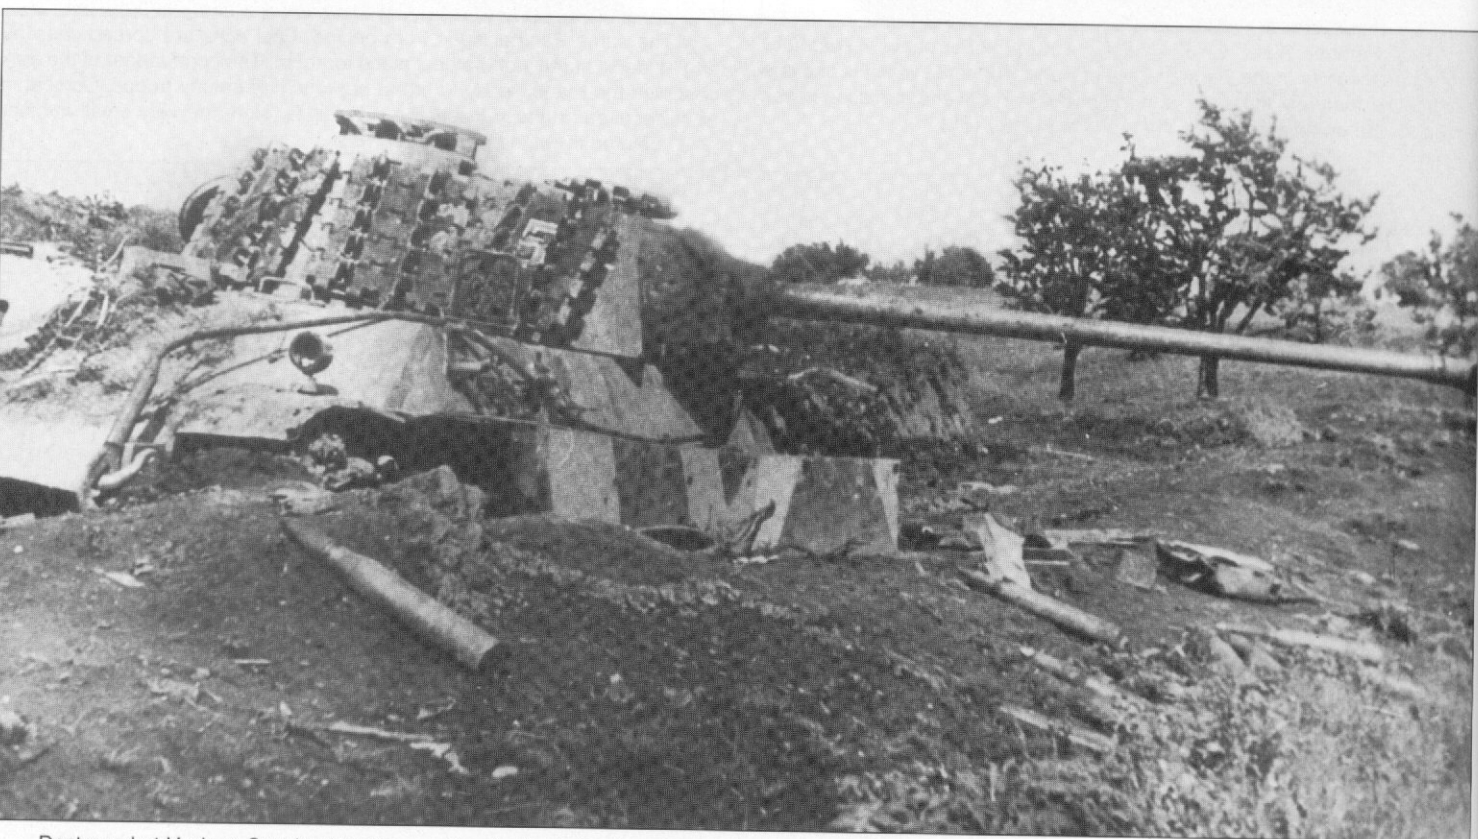
Destroyed at Vyskov, Czechoslovakia, another Ausf. G sits abandoned. The gun mantlet is of the late chin type. A lot of extra track links are stored on the turret. Its vehicle number, "215", is painted directly onto the track links. The camouflage scheme, diagonal green and brown stripes, was applied using stencils. (S. Netrebenko)

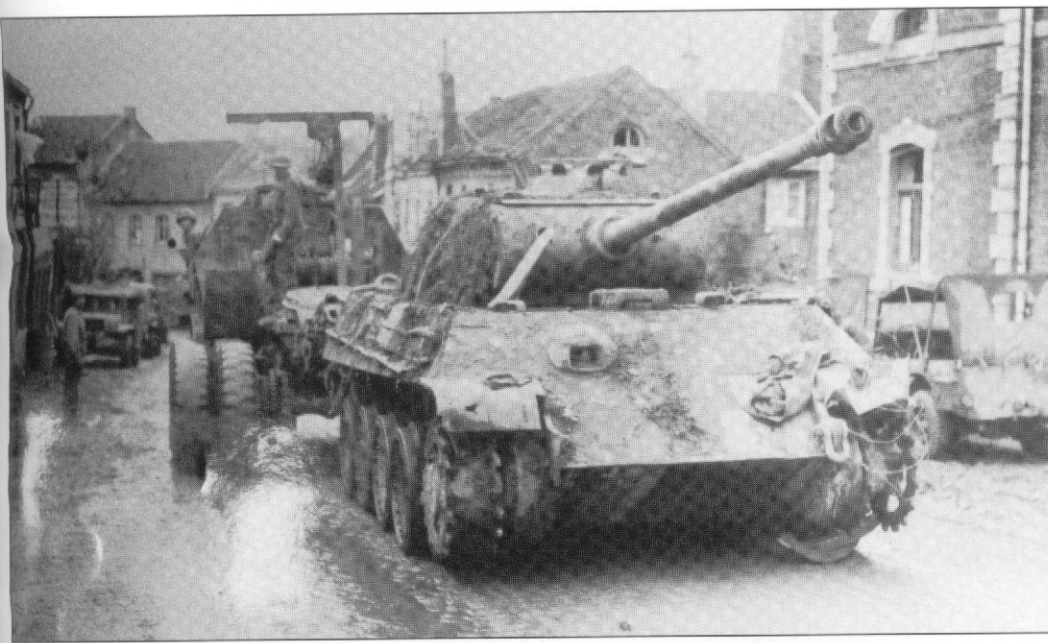
The chin-type gun mantlet prevented shells from being deflected to the thin roof, thus improving the level of ballistic protection. This late Ausf. G was provided with the raised engine cooler on the left side, and its exhaust pipes are fitted with protective covers. The German cross on the turret was non-standard. Overall, Panther "302" seems to be undamaged. (M. Green)

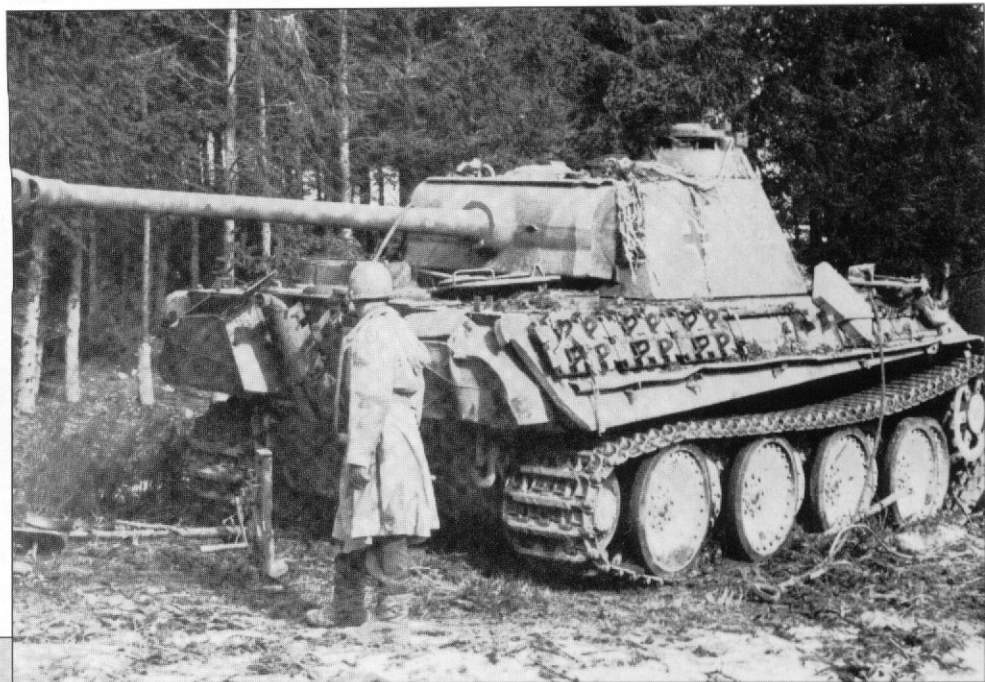
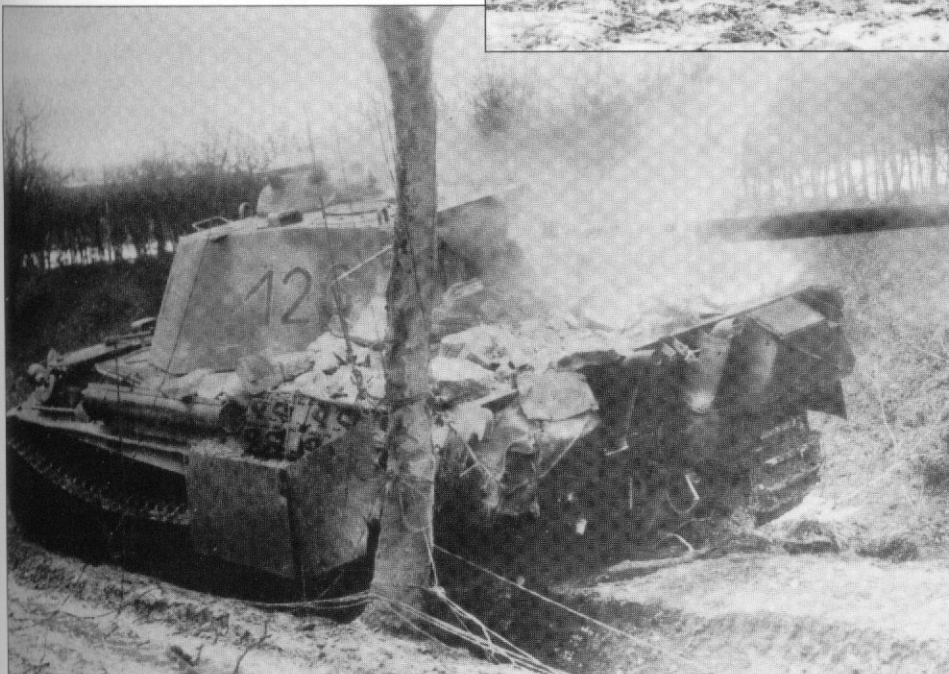
After being hit several times, a battered Panther "126" lies burning on the roadside. Scenes like this were common toward the end of the war when organized counterattacks were the exception to the rule. Hastily established battle groups tried their best to stop the enemy, but were swept away by the same *Blitzkrieg* -type tactics used by the German forces some five years earlier. (A. Geibel)

This brand new Ausf. G of the latest "G" production lot possibly suffered a mechanical breakdown after a short service life. The starter crank can be seen fitted into the rear opening. The camouflage scheme seems to consist of dark yellow and brown over a green base; the running gear is painted completely green. (A. Geibel)

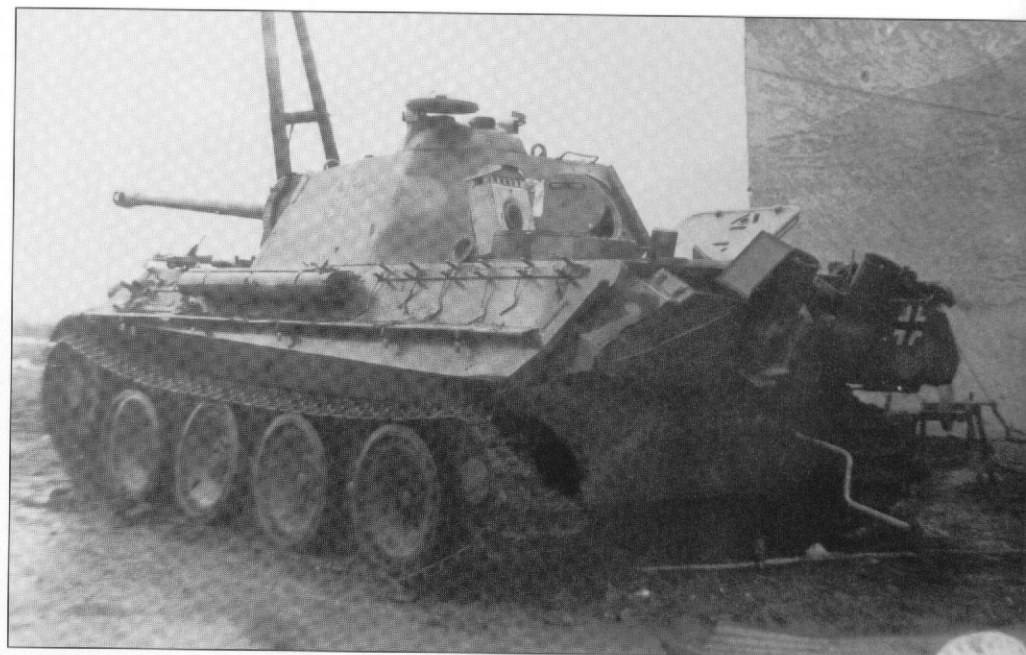
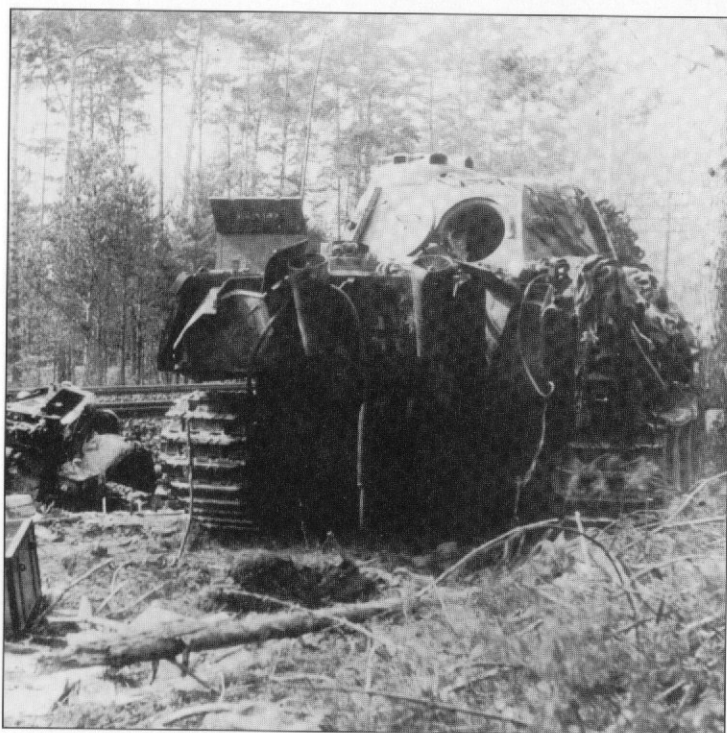
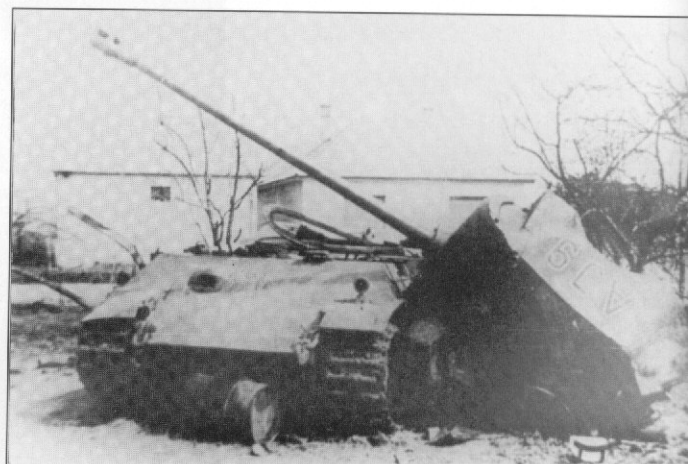
The blast of an internal explosion blew the turret off of this Panther Ausf. G. Of interest is the unusual turret number, "A J 9", the meaning of which is unknown. (S. Netrebenko)

A similar vehicle lies in a heap near a railroad track somewhere in eastern Germany. Note the late-style flame suppressor exhaust tube. Brackets were welded on both sides of the turret to carry extra road wheels. (S. Netrebenko)

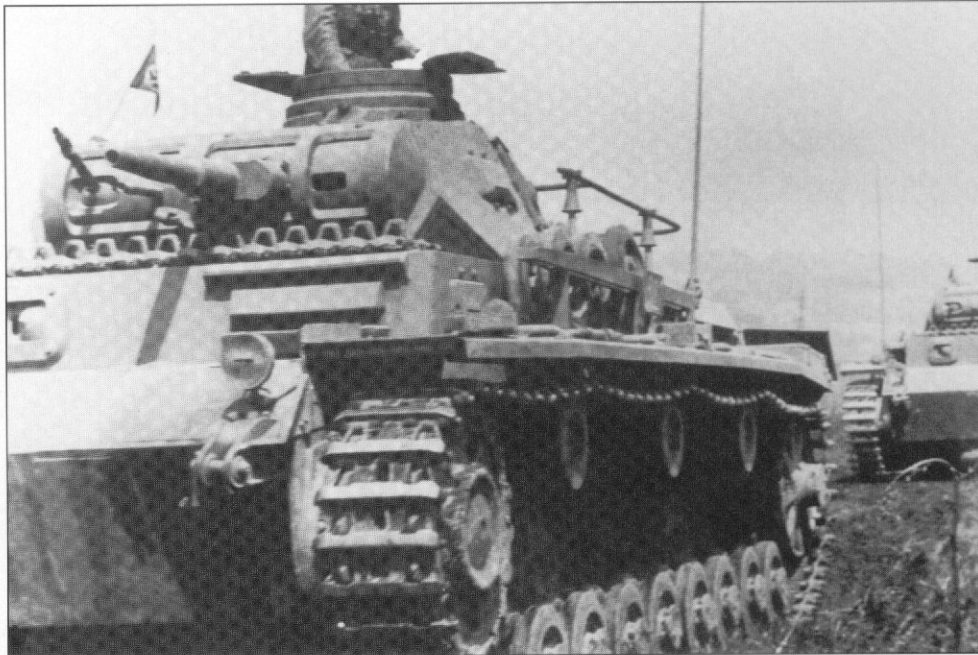
The high degree of communication was one reason for the success of German armored forces. Command tanks like this Pzbfswg III Ausf. B provided the troops with reliable long-distance radio systems. The early command tanks featured dummy guns and highly conspicuous frame antennas. (BL)

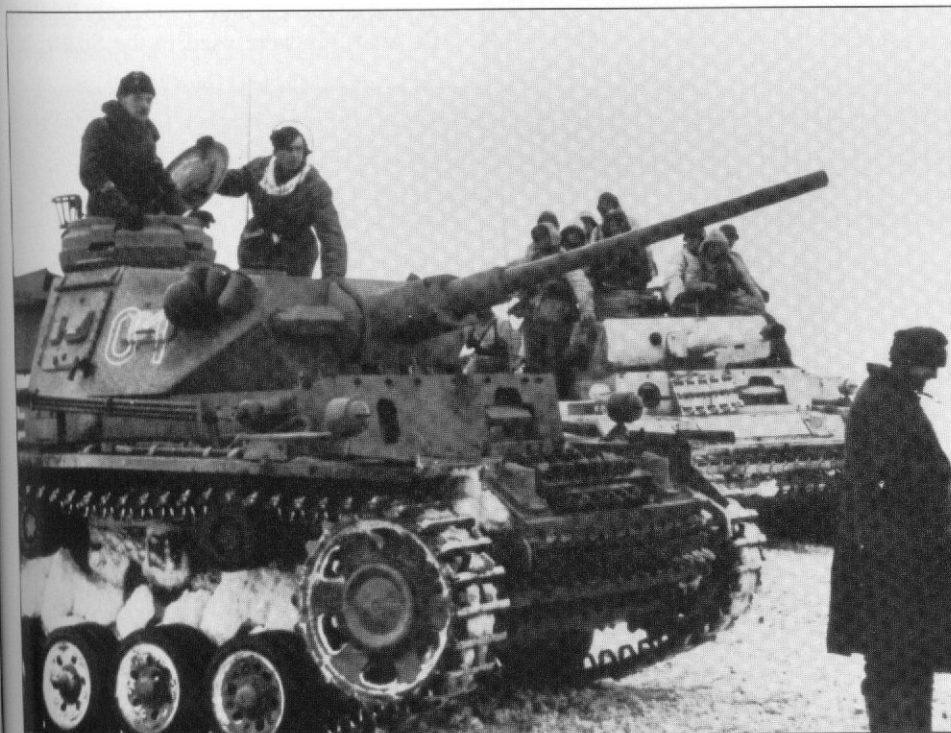
The Pzbfswg III Ausf. K was the first command tank to be provided with a standard tank gun. The 50 mm L/60 was shifted to the left, thus creating space for additional radio equipment in the turret. These vehicles carried a less conspicuous star antenna instead of the frame antenna. (F. Schulz)

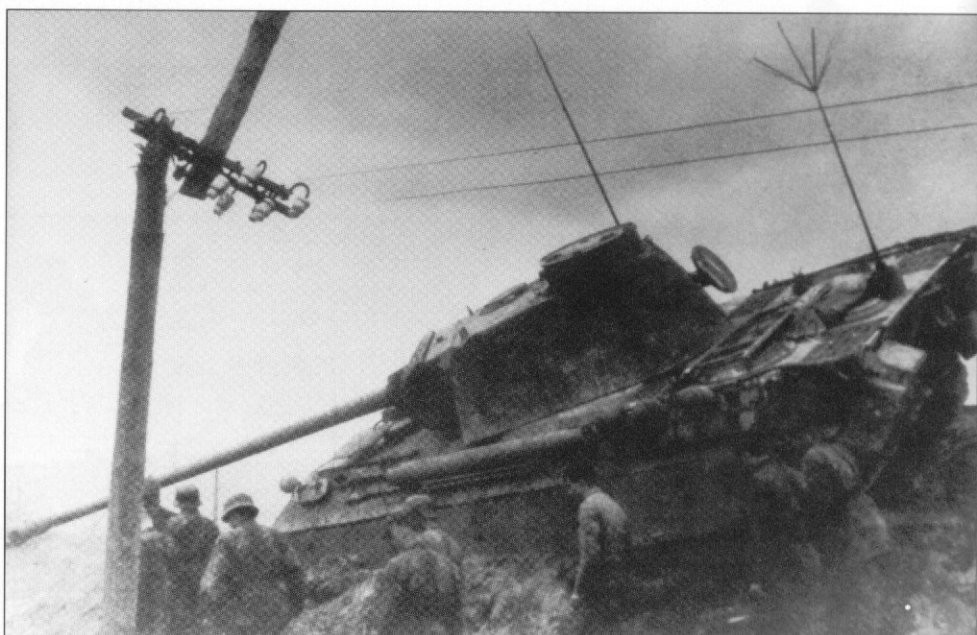
This abandoned Pzbfswg Panther Ausf. D, which has slipped off the rail line, features the standard equipment of a Sd.Kfz. 267: the 6-foot (2 m) antenna on top of the turret and the star antenna d in its armored pot located on the engine deck. The tank has also been provided with a ring for the AA MG. (P. Kammann)

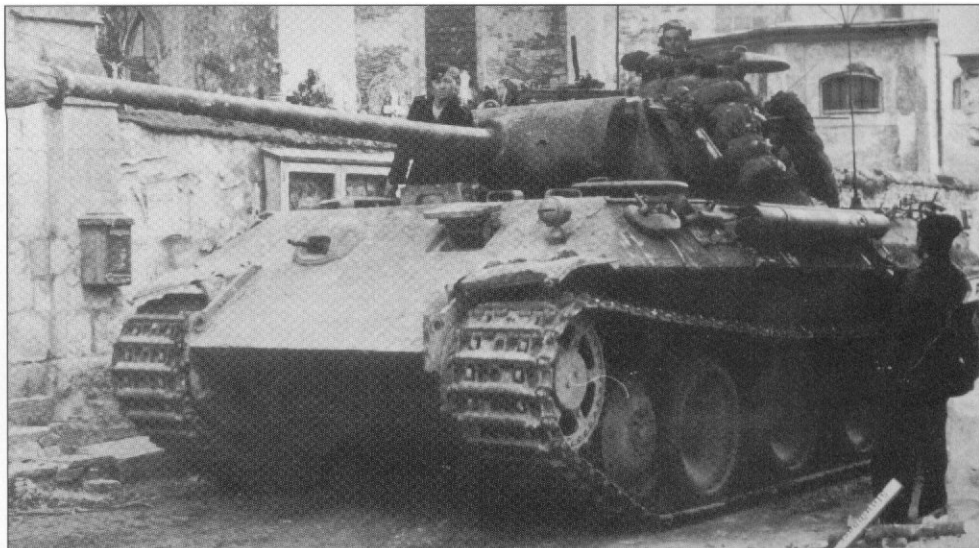
Another Pzbfswg Panther Ausf. A in a French town. Used as an Sd.Kfz. 267 (standard command vehicle for an armored unit) as well, it features the 6-foot (2 m) rod antenna fitted on the turret's roof, but the long-range star antenna is attached to the standard mount behind the turret. A possible reason for this unusual combination could be that the actual antenna mount was damaged. (F. Schulz)

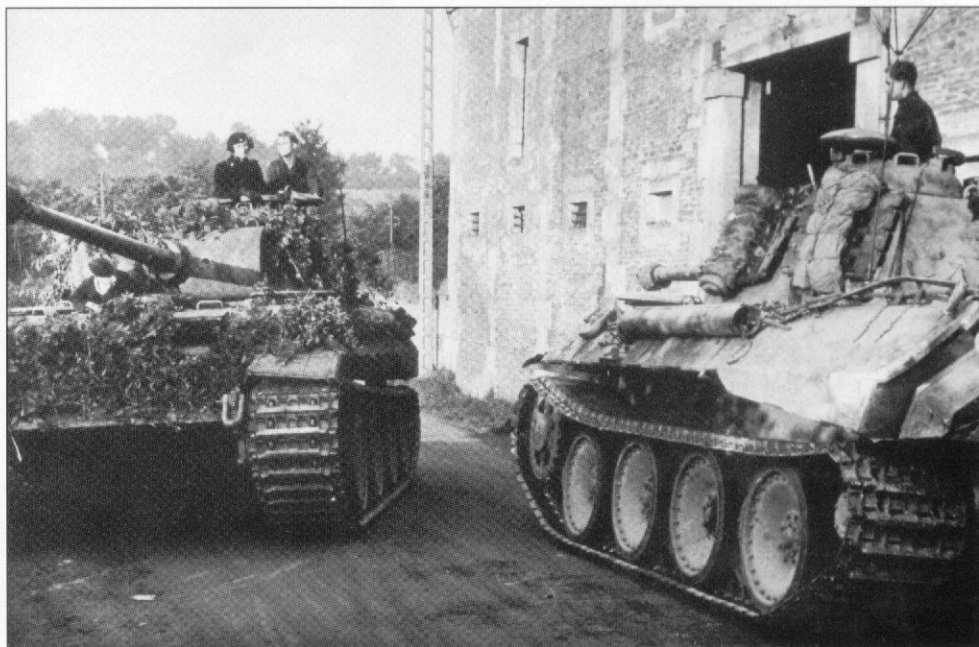
The same vehicle from behind. The "incorrect" position of the star antenna is evident here. The three elongation tubes for the star antenna, which are normally stored below the gun cleaning kit, are missing. (F.Schulz)

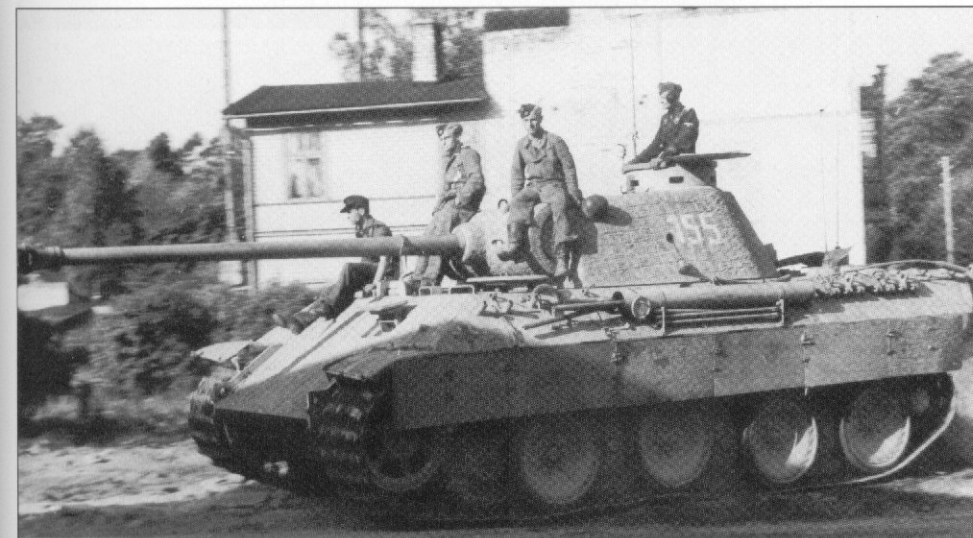
Panther "155", a Pzbfswg Ausf. D, shows off an unusual antenna arrangement, too. Beside the 6-foot (2 m) rod antenna on top of the turret, the star antenna is fitted onto the usual Panther mount. Since there were only two radio sets, the third antenna in the armored pot is actually superfluous. Below the gun cleaning kit may be seen the elongation tubes for the star antenna. (BA)

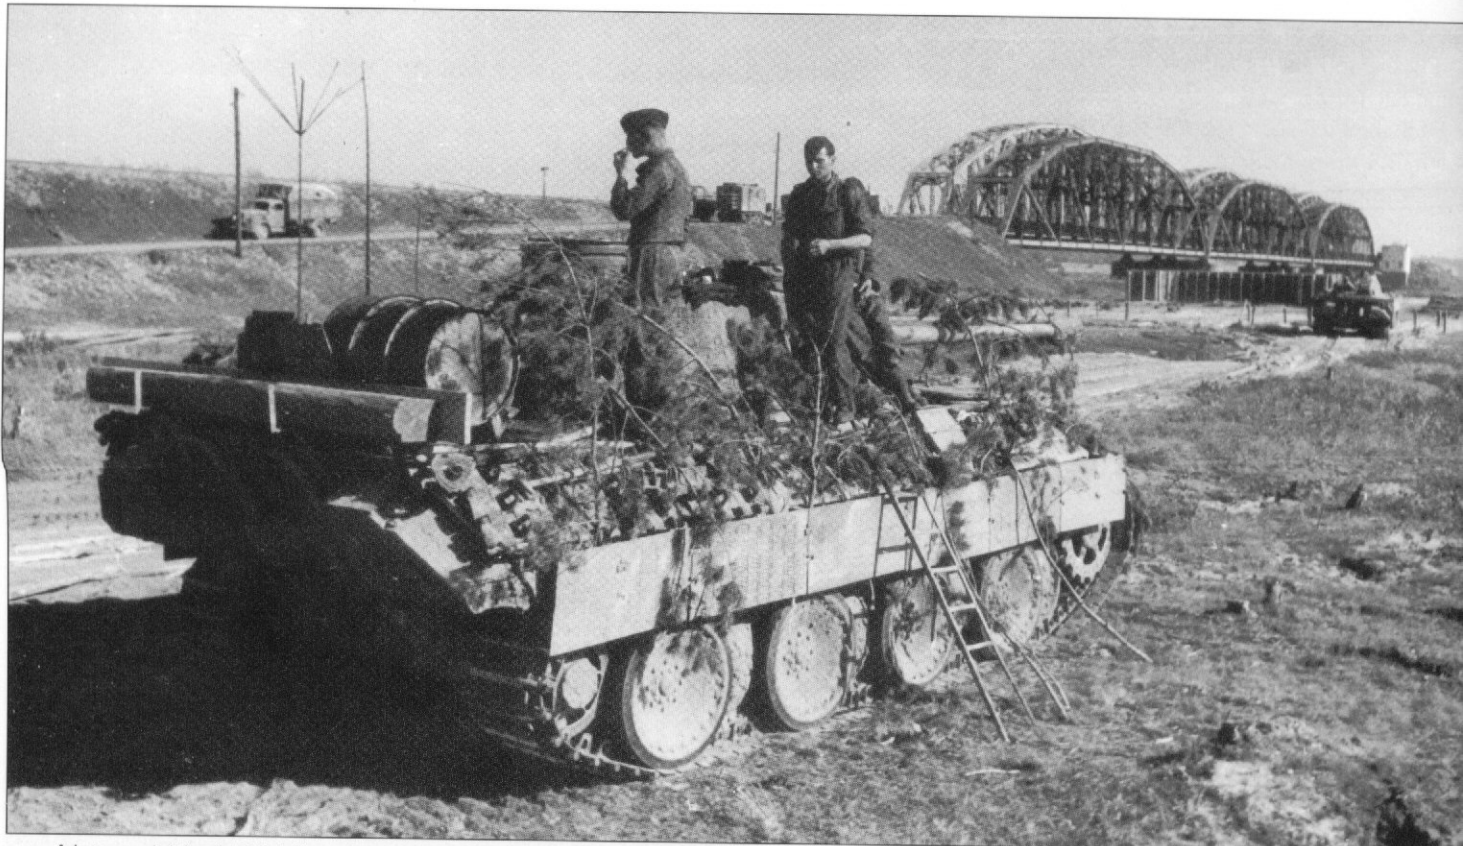
A late-model Ausf. D Pzbfswg Panther supervises a railway bridge. This particular tank is interesting because it shows the 6-ft (2-m) rod antenna fitted to the left mount on the hull rather than to the turret's antenna mount, making it clear that any configuration was possible. A lot of extra equipment was carried on the engine deck. (W. Schneider)

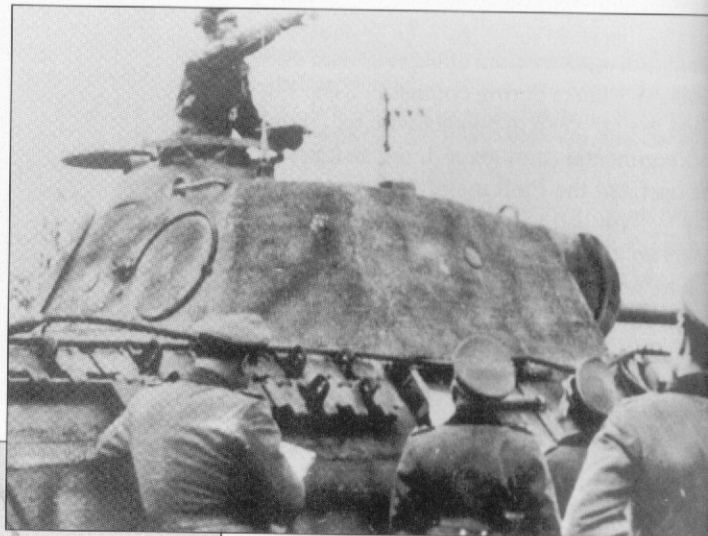
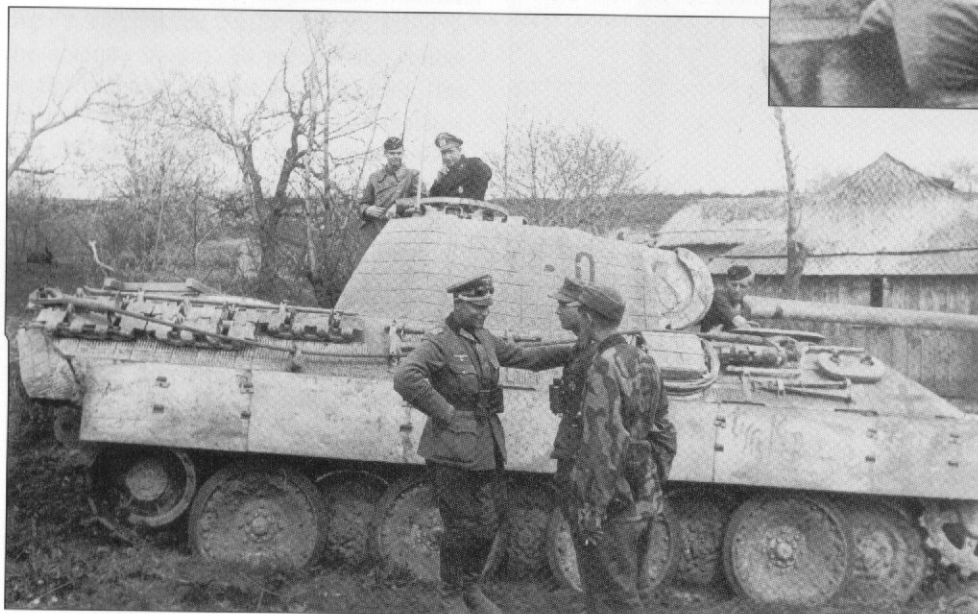
This obscure photo shows a late version of the Pzbfswg Panther Ausf. D belonging to 5.SS-Pz.Div. "Wiking". The commander is reporting the situation to some officers. This vehicle carries a 4.5-ft (1.4 m) rod antenna on the turret, a piece of equipment that is rare. It is possible that this vehicle was used as an SdKfz. 268, the Flivo command tank (ground-to-air communication vehicle). (P. Kammann)

Oberst Willi Langkeit of Pz.Gren.Rgt. "Grossdeutschland" is seen here in the cupola of his Pzbfswg Panther Ausf. A. In front of the vehicle was Oberst Karl Lorenz conferring with his staff officers. Showing the standard antenna equipment, this vehicle was used as a SdKfz. 267. The number "0" indicates its high rank. (BA)
