ARMOR AT WAR SERIES

Panther

Text by Thomas Anderson
Color plates by Vincent Wai

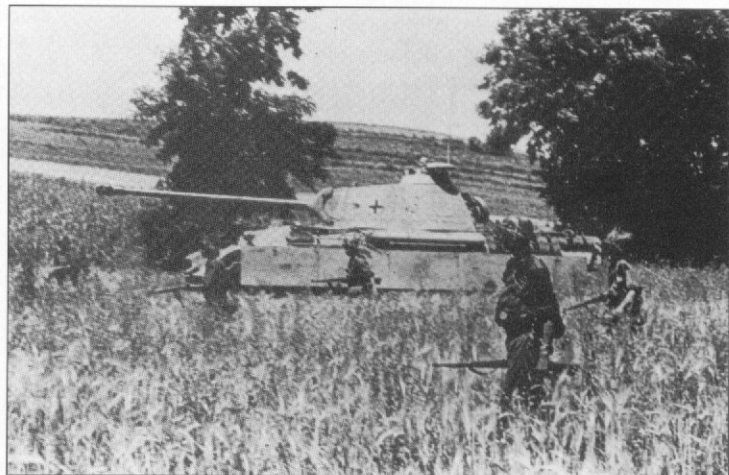
A Panther Ausf. G during an inspection. The antenna fitted on the turret of the vehicle indicates that it is probably a command tank. The turret number "I N 3" (meaning unknown) is barely visible; the German cross on the turret is an unusual one. (BL)

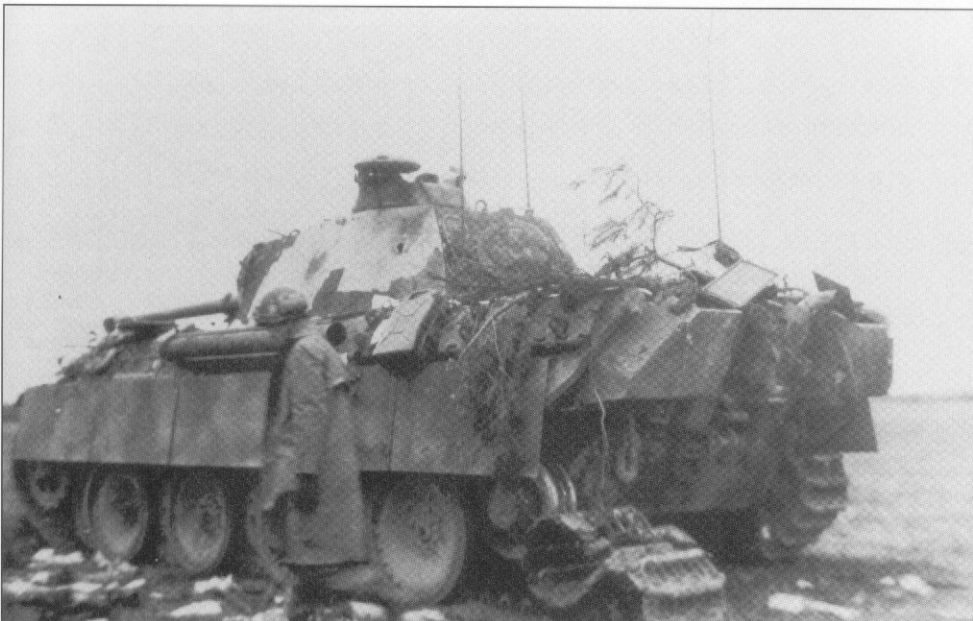
This Pzbfswg Panther Ausf. G was demolished at the Western Front. Yet another non-standard Panther, this command tank features three antennas. At least one shell penetrated the turret wall, causing the *Zimmerit* to fall off. The tank also lost one track. (A. Geibel)

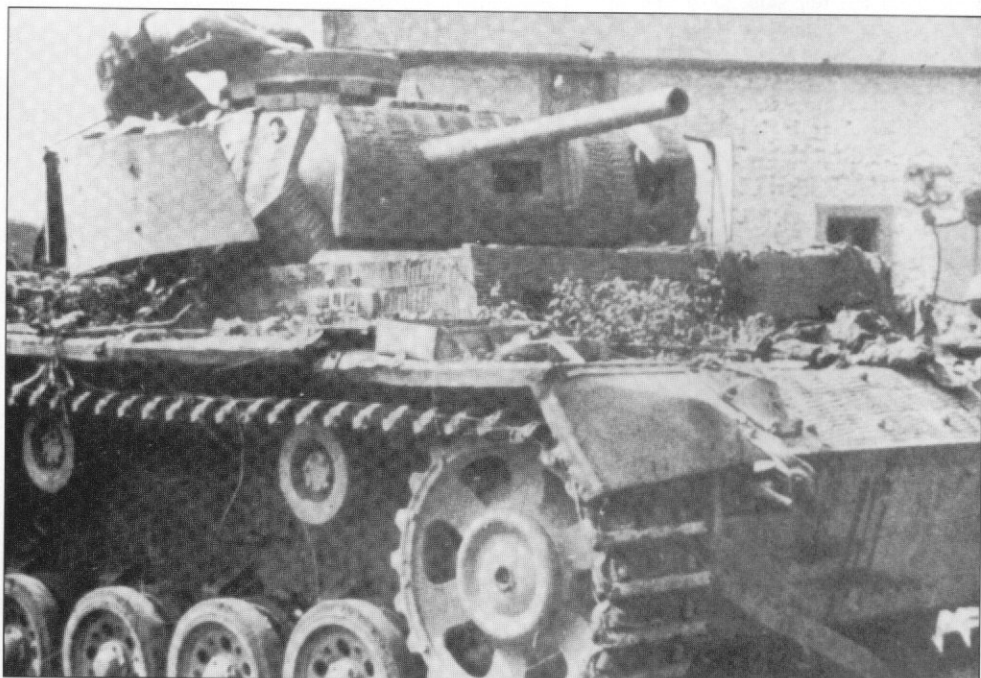
When the first German self-propelled artillery units were established, armored artillery observer's vehicles were developed using repaired Pzkw III MBTs. Extended radio equipment was added and the armament was deleted. This photo shows a derelict Pzbeobwg III Ausf. H. The dummy gun, which resembles a 50 mm gun, and the MG ball mount are visible. The *Zimmerit* was added by field workshops. (J. Mueller)

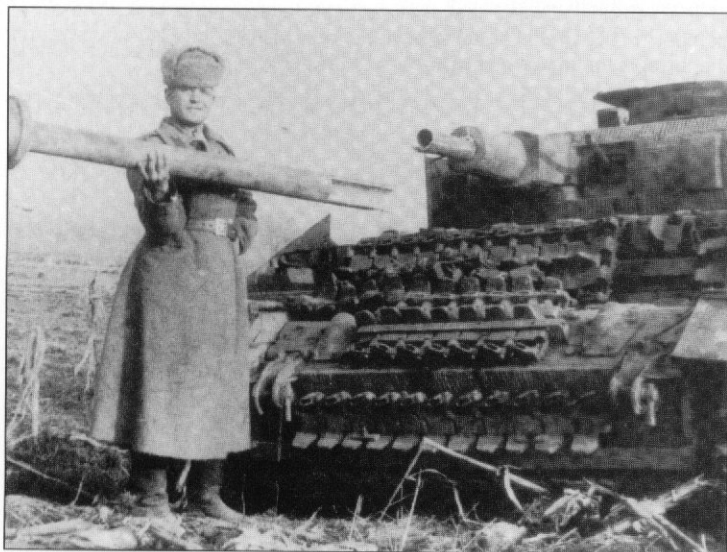
This Pzbeobwg III Ausf. H was heavily converted to be integrated in Pzkw IV units. The original dummy gun was converted with a longer wooden beam and a muzzle brake so the tank would resemble the 75 mm KWK-armed Pzkw IV. *Zimmerit* and a full set of side skirts were added in a field workshop. This photo was taken in Kursk in the summer 1943. (S. Netrobenko)

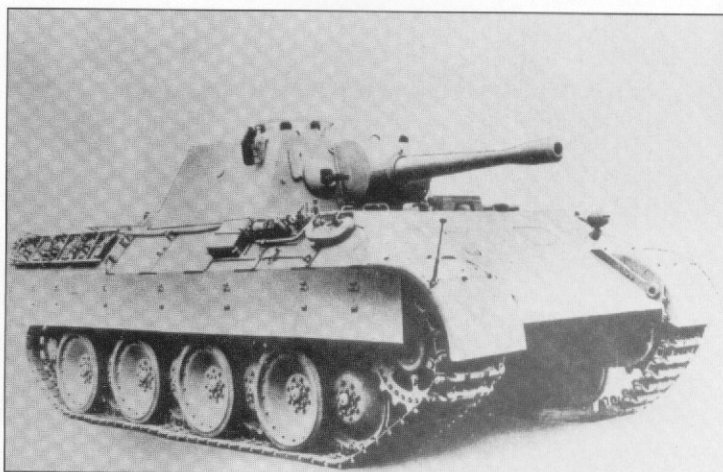
This is the only photo known to the author that shows the Pzbeobwg Panther. Based on a late-model Ausf. D, the tank's turret was heavily modified. A short dummy gun replaced the L/70 gun. The right flap of the rangefinder that was integrated into the turret front plate is visible beside the machine gun's ball mount. (A. Geibel)

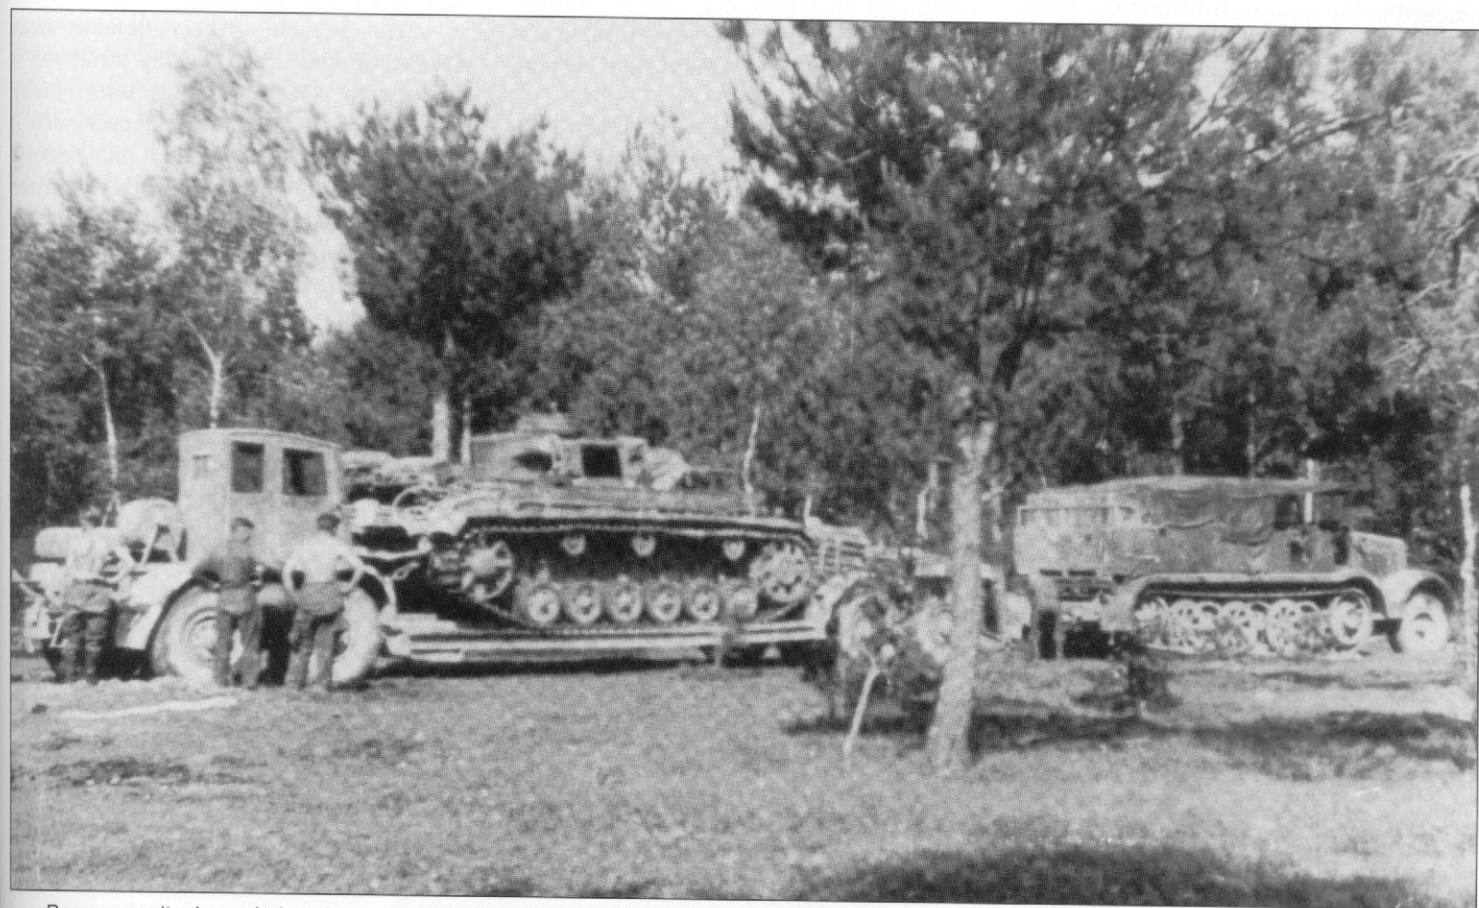
Recovery units depended on the proven Sd. Kfz. 9 heavy half-track and the Sd.Anh. 116 trailer. This combination was sufficient when dealing with Pzkw IIIs or IVs that weighed up to 20 tons. This particular flatbed trailer, which is being towed by a 12-ton half-track, is interesting since it shows a fully closed rear steering cabin. (W. Schneider)

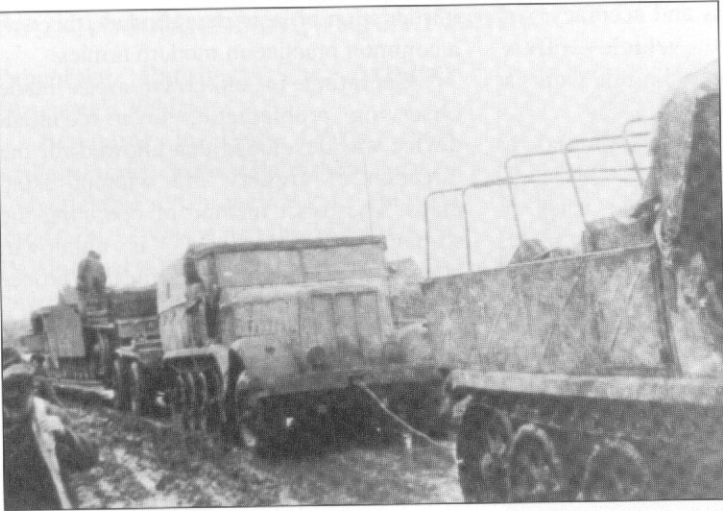
The situation on the Eastern Front proved to be vastly different from pre-war plans. Here a disabled Stug III Ausf. G is being recovered from muddy terrain. Two 18-ton Famo half-tracks were needed to tow the overloaded Sd. Anh. 116. (H. Hoppe)

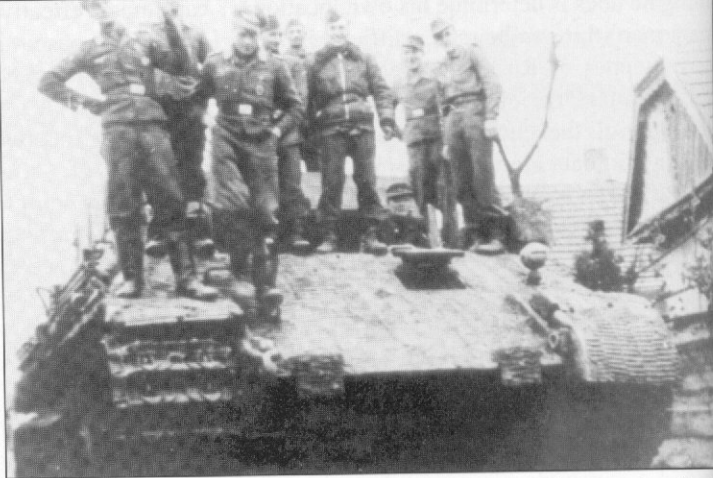
Lacking planes, these Luftwaffe troops pose atop a Bergepanther Ausf. D. This versatile recovery vehicle was probably the most important conversion of the Panther. The square steel plates attached to the bow are clearly shown. The crane is dismounted and stored on the right side of the hull. This Panther has received a complete coating of *Zimmerit*. (H. Hoppe)

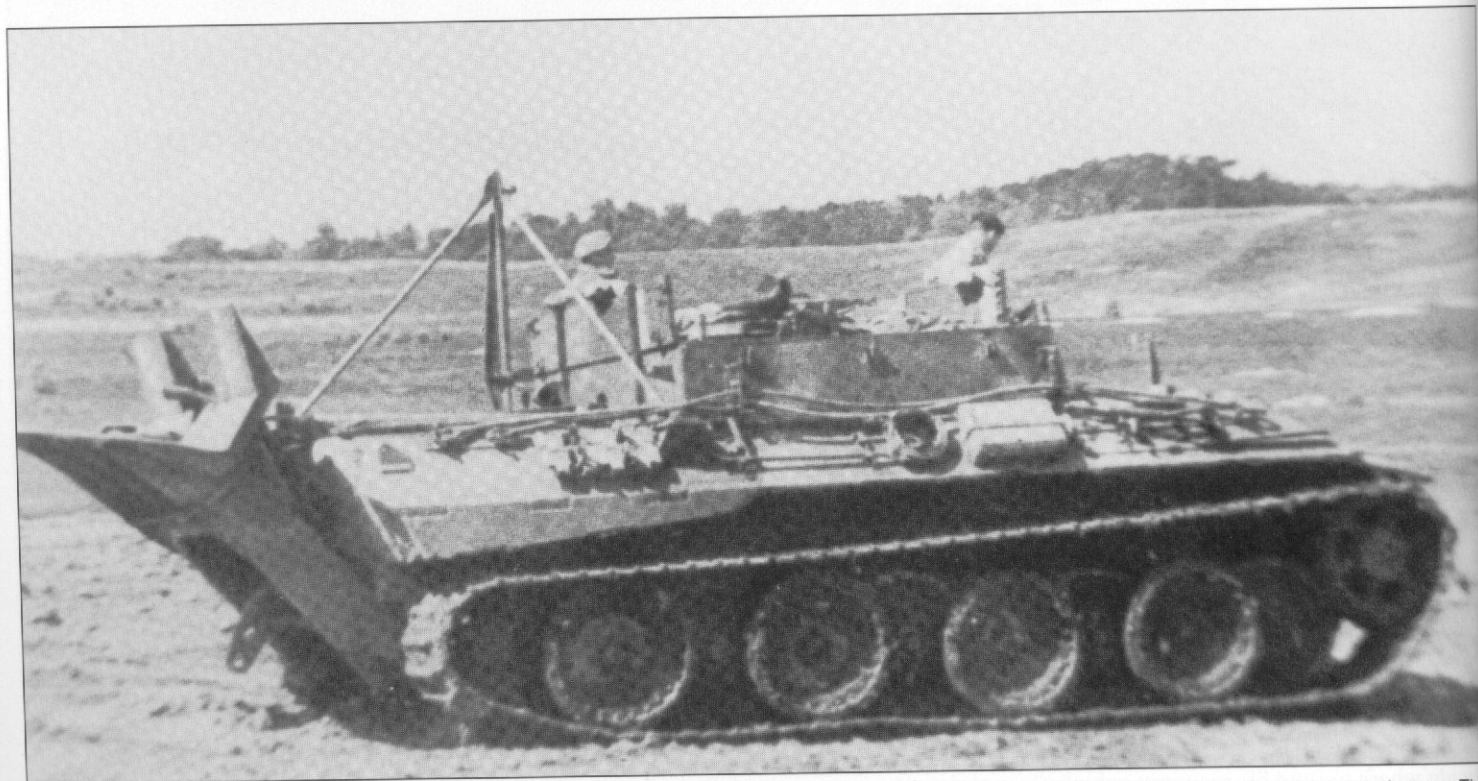
The British soldiers seen here can't help but be impressed as they evaluate this Bergepanther, which shows off its rear spade and erected crane. The latter could be mounted on either side of the engine deck. A lot of recovery equipment is visible in this photo. (A. Geibel)

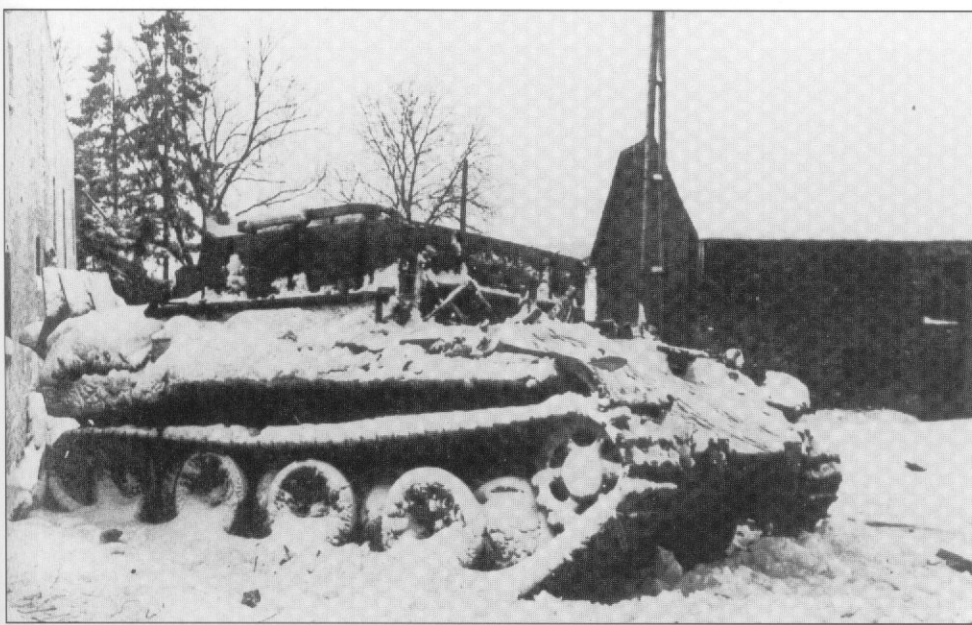
A Bergepanther Ausf. D lies abandoned in a French town. The wooden body was large enough to carry replacement engines or transmissions, which could be fitted using the crane. (J. Mueller)

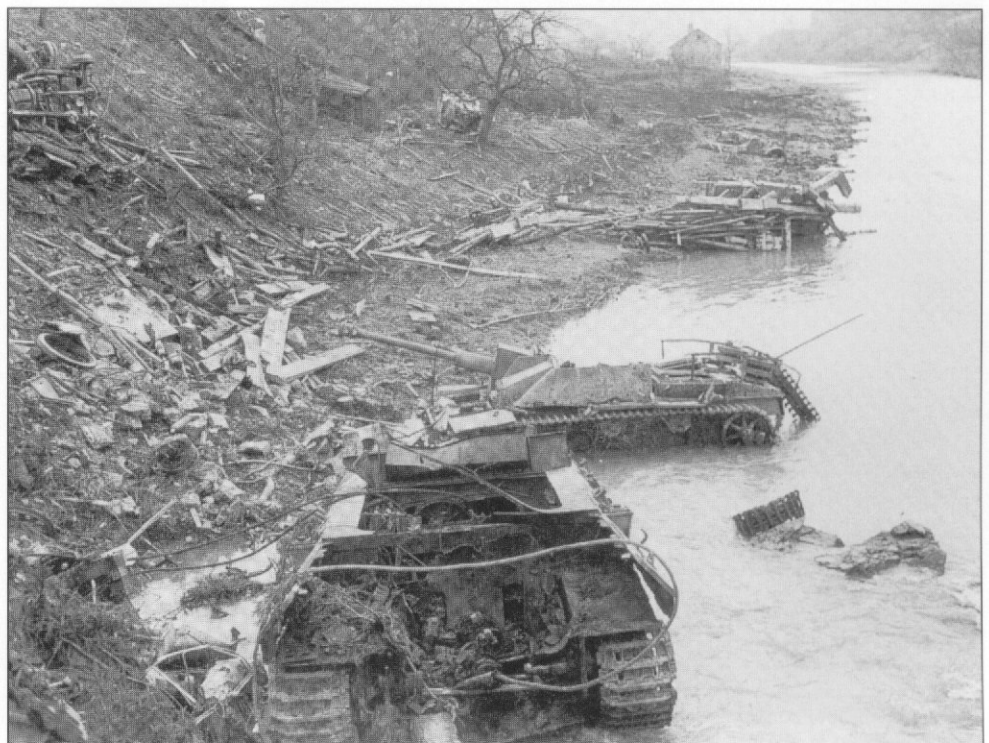
This photo shows the result of an Allied air strike that surprised a unit while it was crossing a bridge. The Bergepanther is totally destroyed, providing us a view into the engine and winch compartment. (J. Mueller)

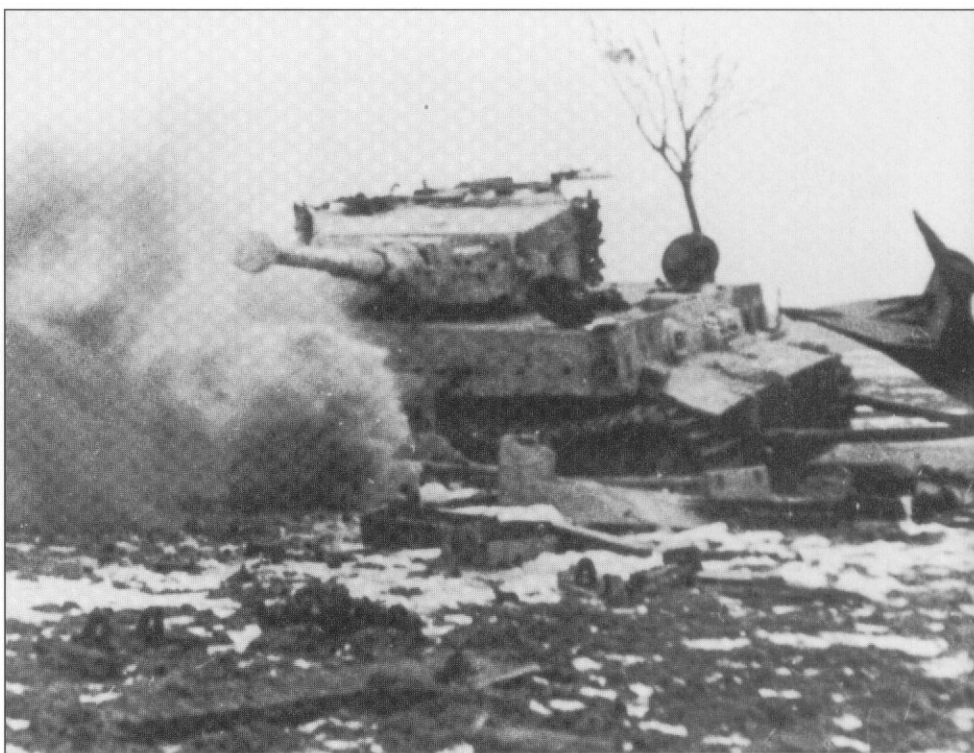
This dramatic shot shows a failed attempt to recover a disabled Tiger Ausf. E. The armored *Bergepanther* was able to move up to the Tiger and connect its towing device. Apparently, though, before it could start the recovery, it also took a hit. (S. Netrebenko)

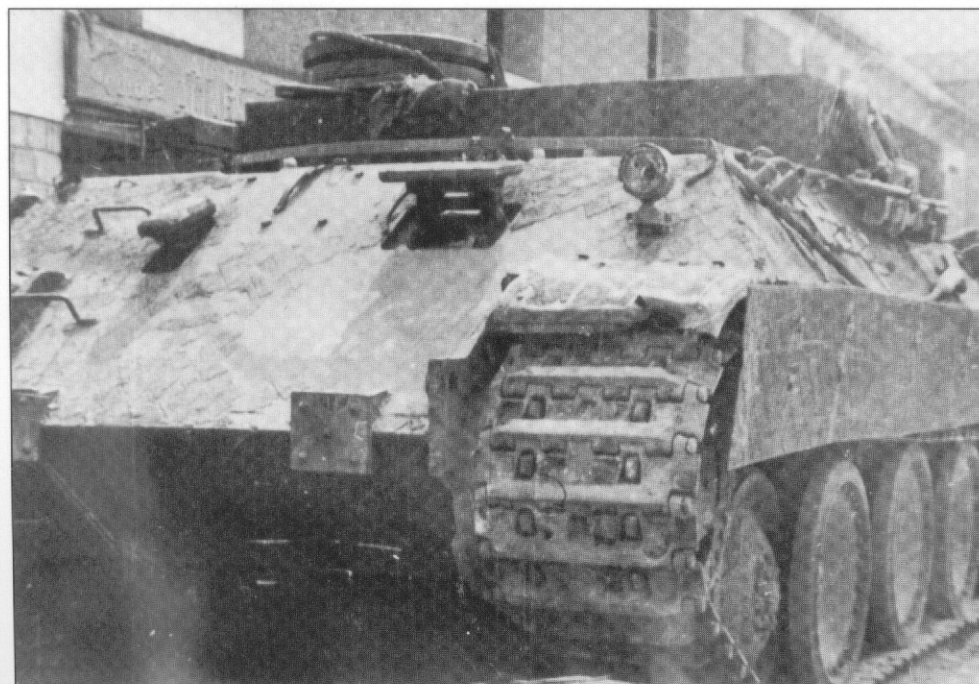
Another abandoned *Bergepanther* somewhere in France. Like most of these vehicles that we've seen, this is an Ausf. D. Both the driver's sight flap and the MG port are opened. Large portions of the *Zimmerit* coating have fallen off, possibly due to small arms fire. The wooden body is missing, and some extra roadwheels are visible on the metal superstructure. The 2 cm KWK mount was not fitted. (K. Münch)

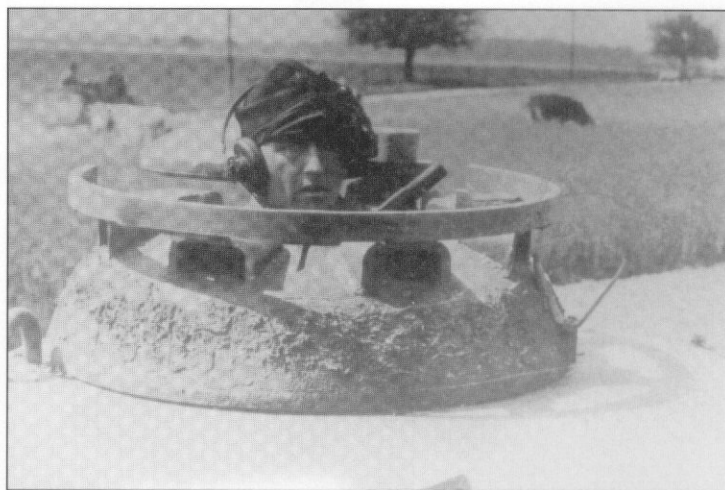
Carefully looking out of his cupola, this Panther commander wears a *Schiffchen* field cap with headphones. He holds a signal pistol in his hand, possibly indicating that combat would start soon. This Panther even wears a coating of *Zimmerit* around the cupola. The bent metal strip in the cupola is where the platform for the IR set would be located. (P. Kammann)

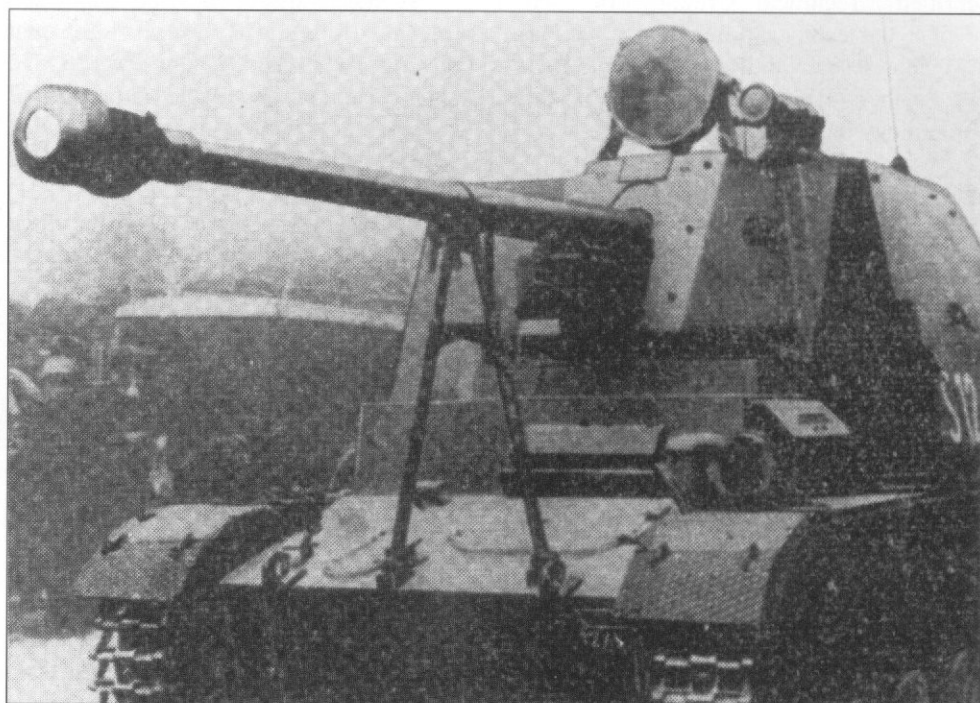
IR night-vision equipment was tested on many different vehicles. This Marder II, wearing the number “S 12”, shows an IR search light/image converter combination on top of the Pak 40. Another image converter was added to the left of the driver's side visor. (F. Schmidt)

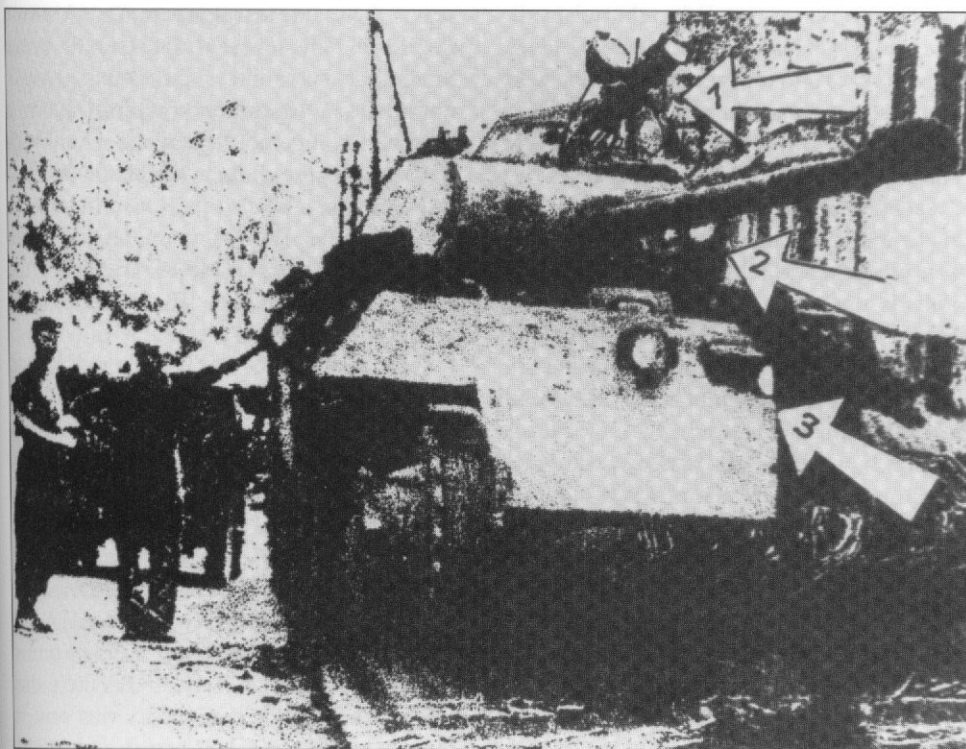
This obscure photo shows a Panther Ausf. D fitted with a triple IR search light/image converter set.

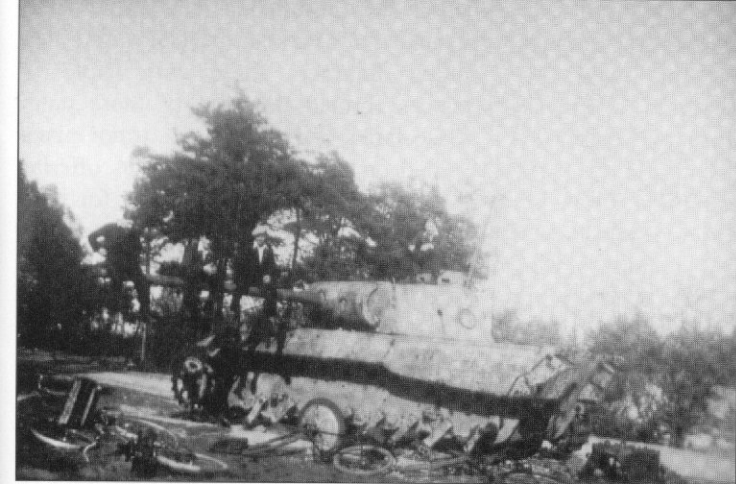
This crippled Panther lay near the town of Uelzen for a long time before it was fully scrapped. This early Ausf. D still shows two welding marks on the mantlet below the gun sight. It is possible that this vehicle was provided with a triple IR set of Solution B. (F. Schulz)

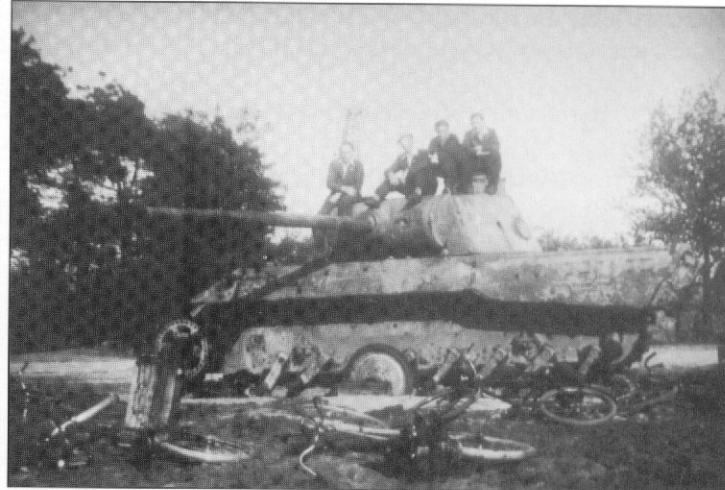
Another photo of the same tank taken in 1946. The Panther has been totally stripped, probably by local farmers and scrap dealers. Note the welding marks below the gun sight. (F. Schulz)

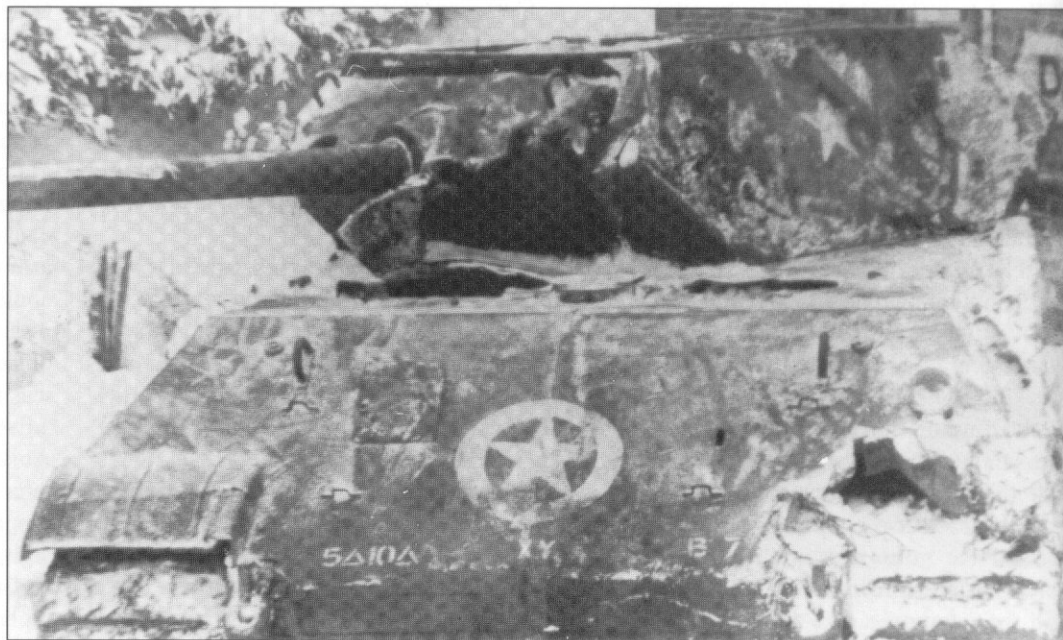
The same vehicle from the rear. Even the rear plate has been thoroughly concealed, making it almost impossible to recognize the shape of the Panther. Note that even small details like loops and cat's eyes were reproduced. (S. Zaloga)

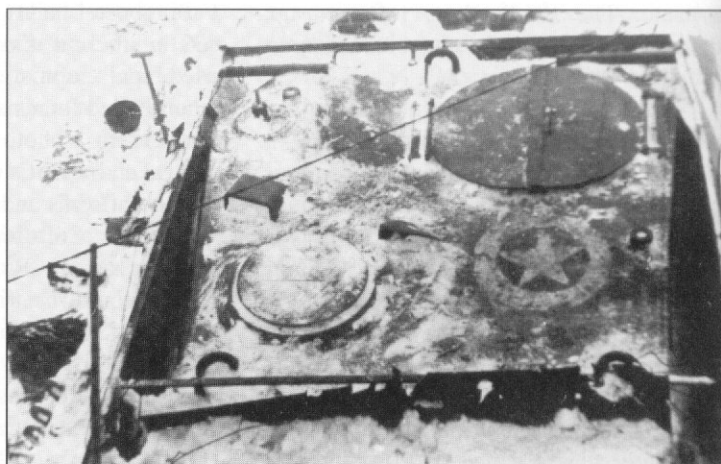
The top view shows that even the commander's hatch of the Panther was removed for this modification. This particular Panther was a late-model Ausf. G command tank, as is evident by the mounts for the auxiliary crane and the antenna mount on the left of the split hatch. Note how the false side plates were attached. (S. Zaloga)

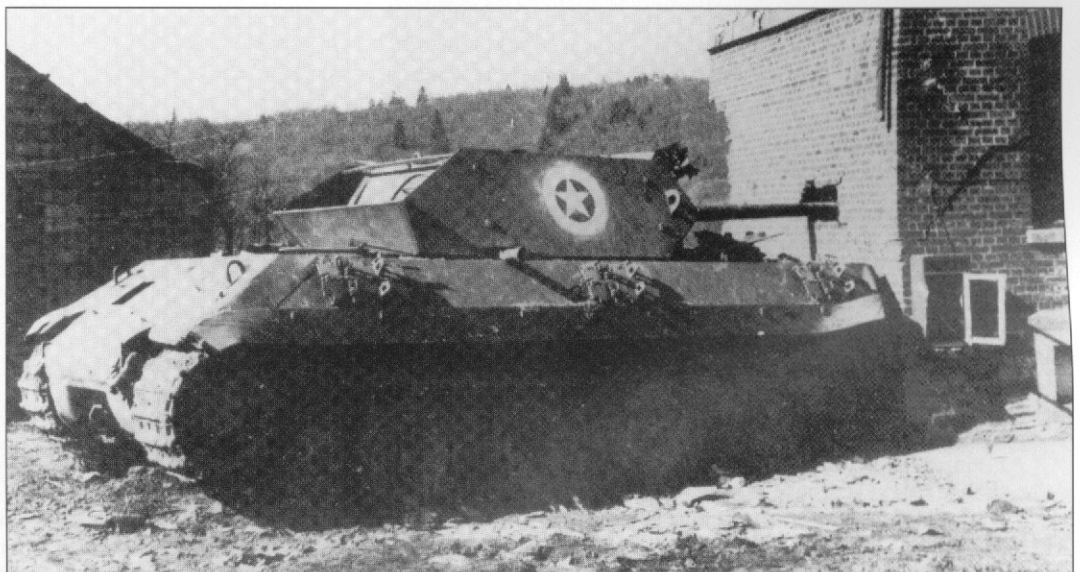
This Ersatz M10 was hit several times. The thin sheet metal has been partially ripped off by the impact of fire. (J. Mueller)

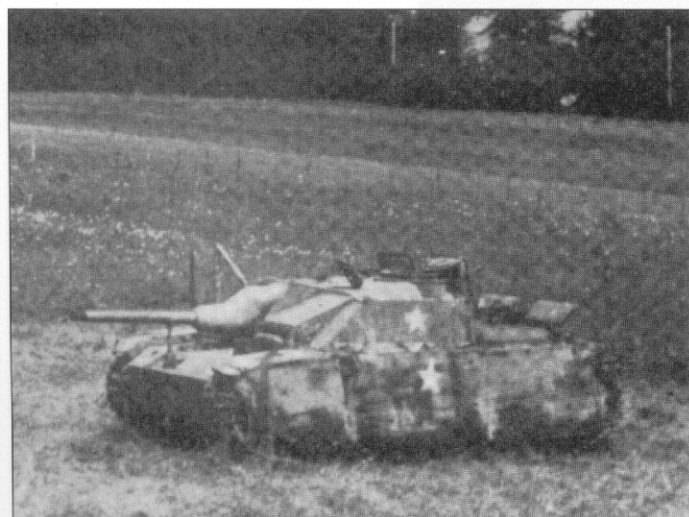
Pz.Brig. 150 used ten Ersatz M10s, a number of Sd.Kfz. 251s and some strange Stug IIIs. These were converted as well, with new side skirts being added to cover the entire running gear. The disguised tank was sprayed olive green and received US-style markings. This destroyed vehicle even lacks the muzzle brake. (J. Mueller)

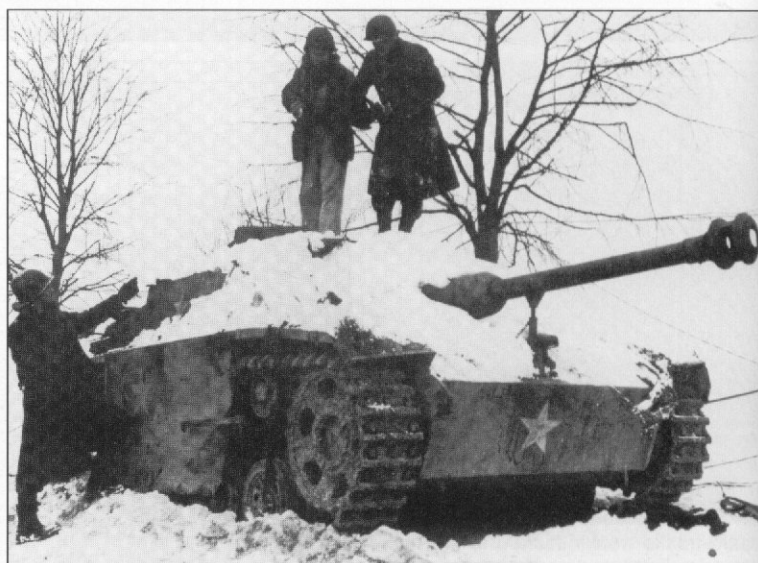
G.I.s inspect another concealed Stug III. This was a late-production vehicle, as the cast mantlet and the return rollers indicate. Pz.Brig. 150 conducted a number of unsuccessful assaults due to incorrect combat tactics. (J. Mueller)

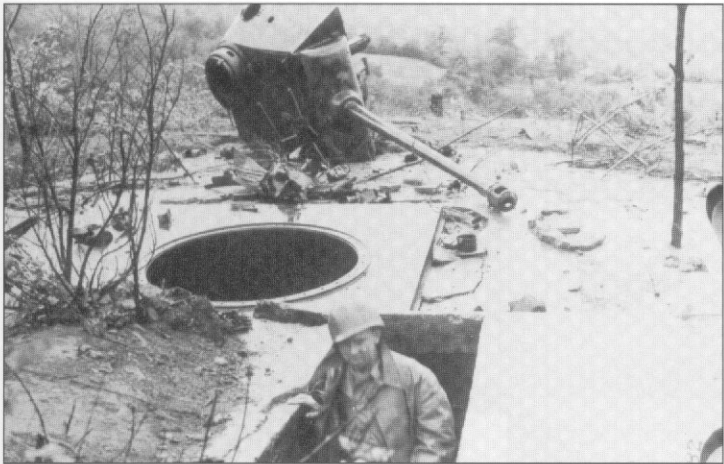
During the fighting in Italy, the Germans prepared a defensive line south of Rome. Since the Allied advance could be slowed down, there was enough time to establish fortifications and pillboxes. The *Goten-Linie* was reinforced by Panther turrets, which would supervise crucial positions with their effective guns. This particular pillbox was totally destroyed, the Ausf. D turret having been blown off its mount. (A. Geibel)

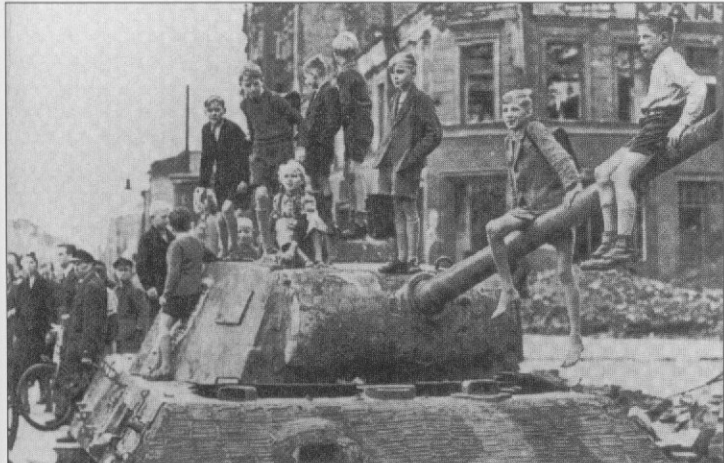
Berlin children play on a dug-in Panther. This Ausf. G was probably destroyed on the Eastern Front and then sent back to Germany where it was used to defend the capital. Note that the turret shows a point of penetration, which was welded shut with a rectangular plate. (H. Hoppe)

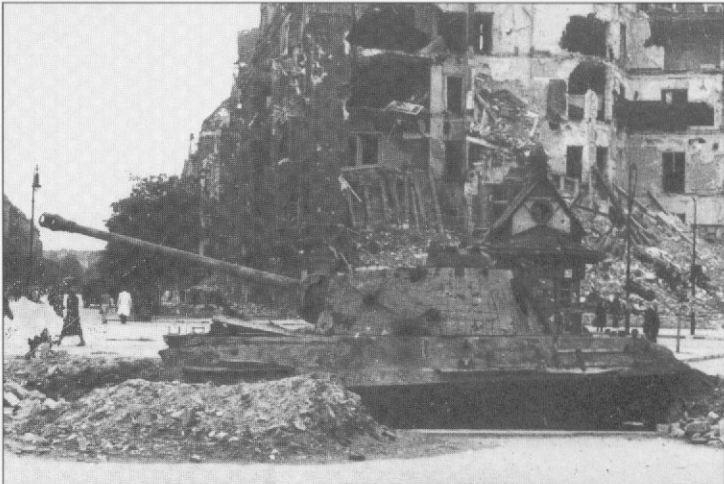
Another Panther that has dug-in at an unknown German city. This Ausf. G lacks complete running gear. Its turret has been penetrated by at least four shells. (S. Netrebenko)

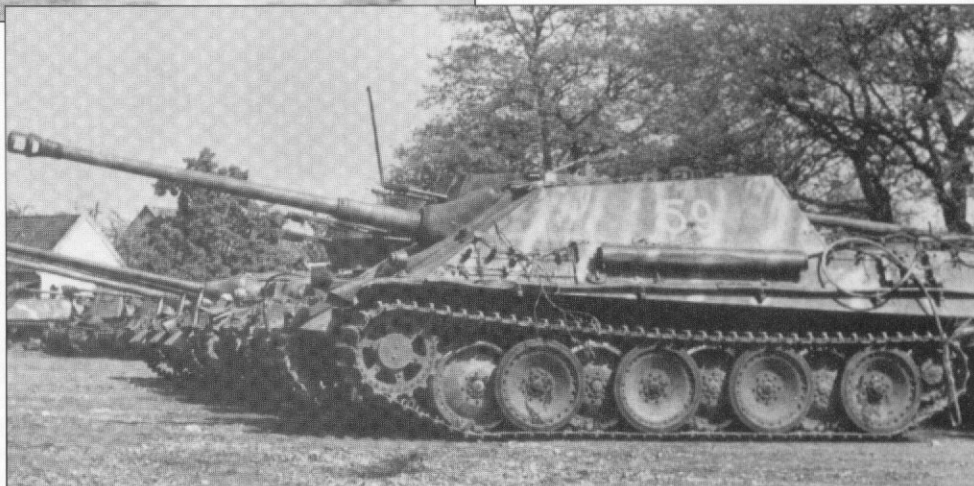
Beside the Bergepanther recovery tank, the Jagdpanther was the most important derivative of the Panther MBT. This early version (so identified by the narrow bulge around the gun assembly), which is part of 3./s.PzJg.Abt. 654 at Bourgtheroulde, is towing another disabled tank destroyer. The crew apparently confiscated some umbrellas for their personal use. Compare the hull's shape with that of the Panther Ausf.G and A. (K. Münch)

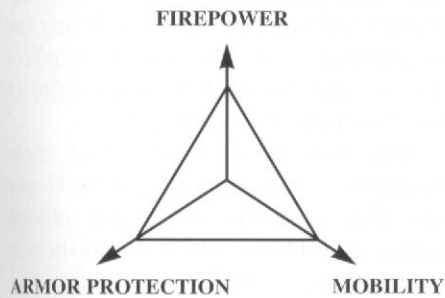
- 1) Firepower (maximum)
- 2) Armor protection (maximum)
- 3) Mobility (maximum)

These three criteria form a triangle, which we will call the **tank triangle**.
