PANZERWAFFE AT WAR

(2) MOSCOW TO BERLIN

Robert Michulec & Thomas Anderson

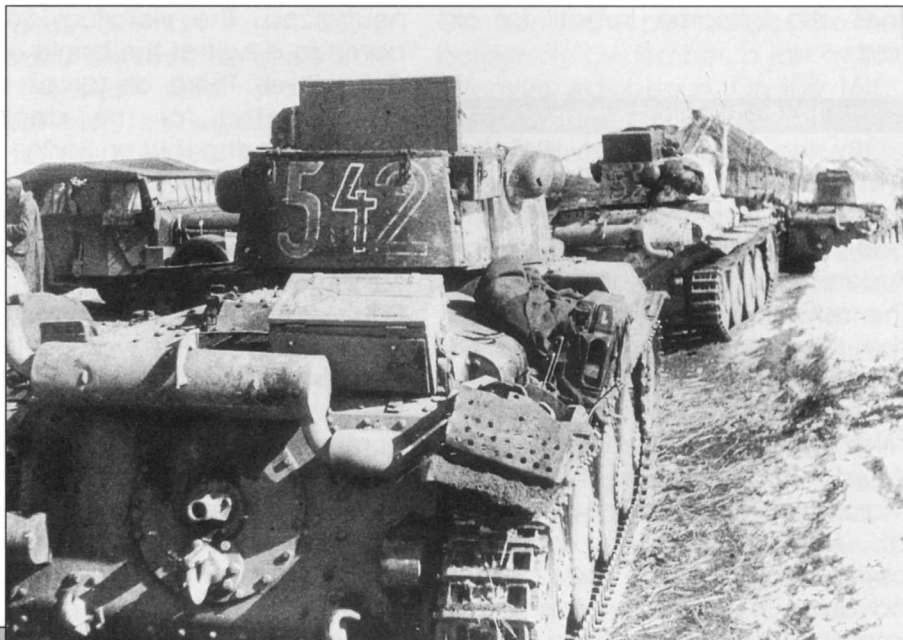
Although obsolete, more than 500 Pz.Kpfw. 38(t) tanks were in service at the beginning of 1942. With their thin armor and 3.7cm gun, their combat value was very limited. So, from mid-1942 they were used primarily for reconnaissance and anti-partisan purposes. These Ausf. Gs are shown advancing in the northern sector of the Eastern Front near Leningrad.

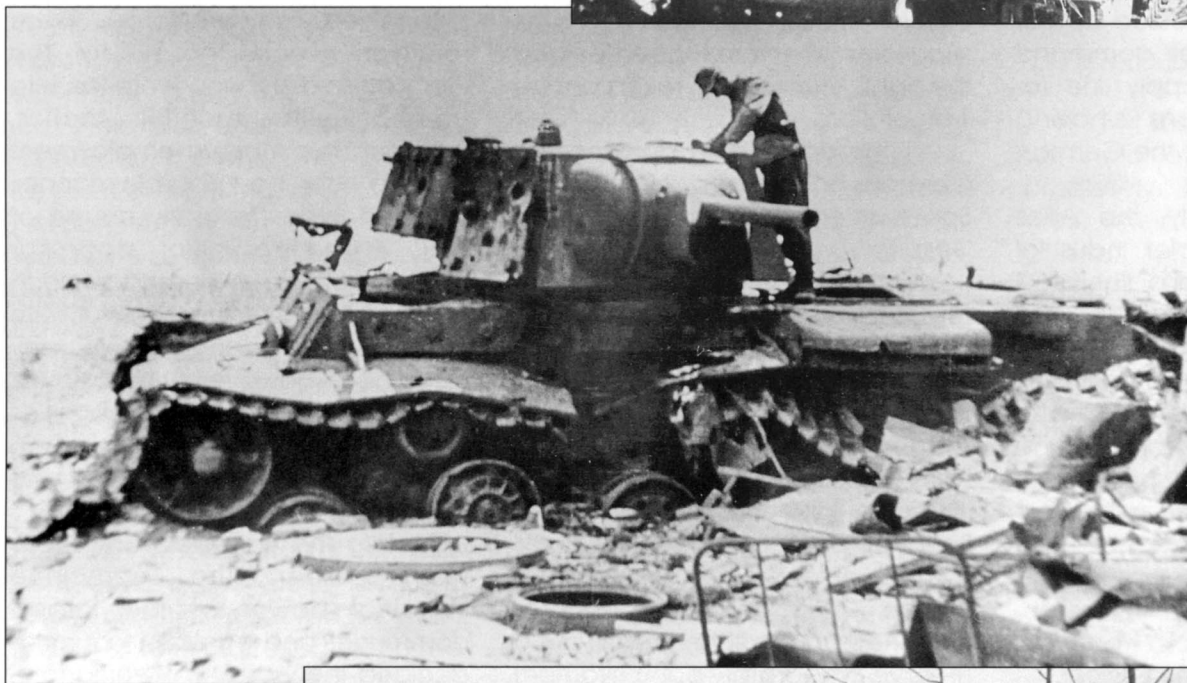
Compared to most German tanks, the massive Russian KV-1 was an invincible foe. In many cases, only the *Heeresflak* with its 8.8cm Flak gun was able to handle this threat. This uparmored KV-1 Model 1941 was destroyed by *Heeresgruppe Mitte* in early 1942.

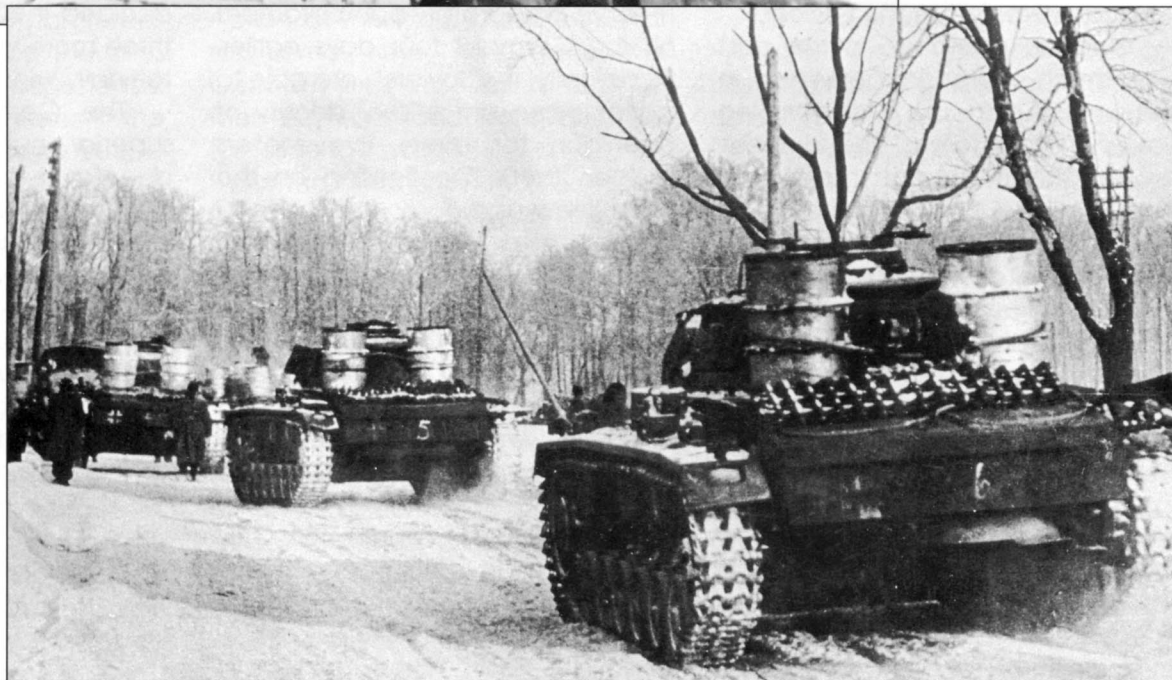
This column of Pz.Kpfw. III Ausf. Js (armed with the 5cm KwK L/42) is advancing to the Kharkov area in March 1942. Extra fuel drums are stowed on the engine deck, a common practice in the early stages of Operation "Barbarossa". The second battle for Kharkov was one of the finest examples of German armored warfare.

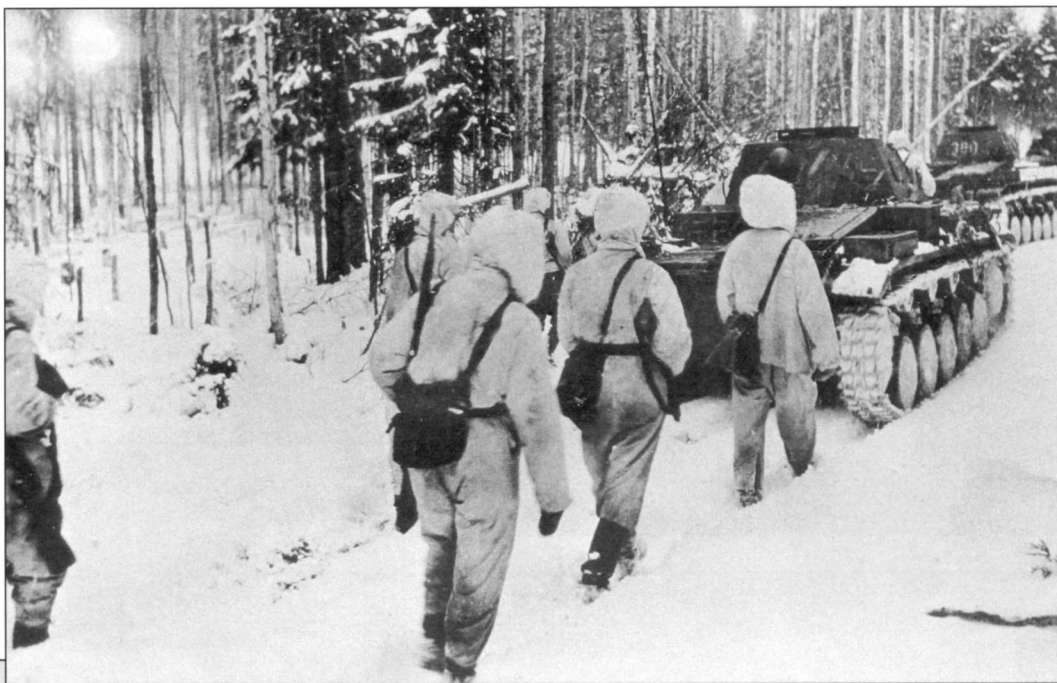
In the northern region, Finnish troops fought alongside the German tank force. Here Finnish infantrymen follow a Pz.Kpfw. II Ausf. C in the vast woods of Karelia. Here, where the rapid advance quickly turned into positional warfare, the light tanks performed better than in the large-scale tank battles of the middle or southern districts.

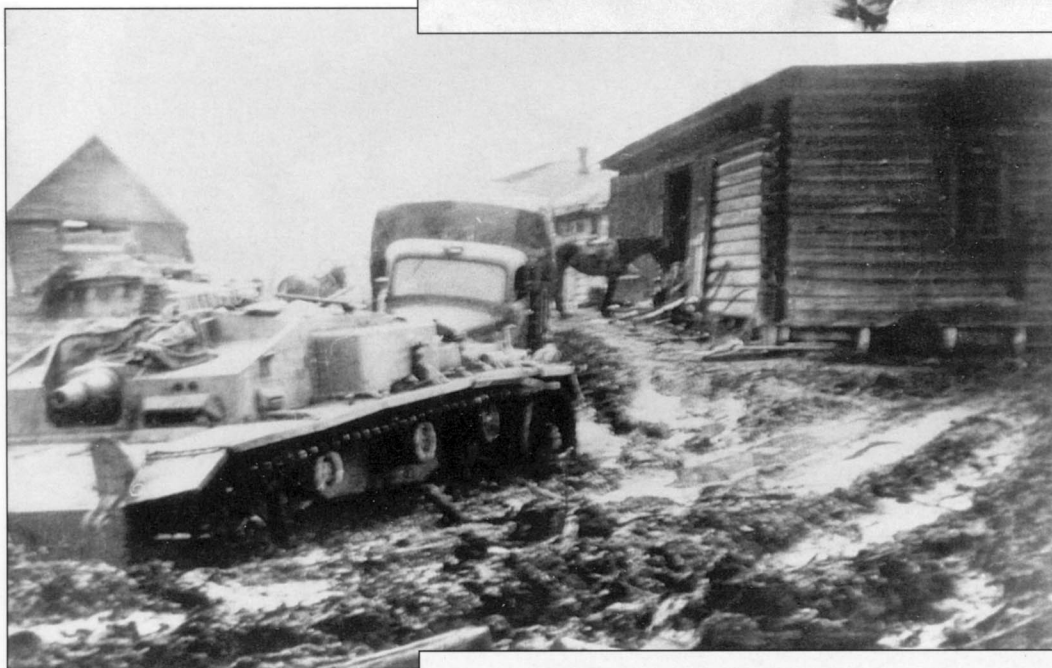
Autumn and spring in Russia brought new, unexpected troubles for the German troops. Mud — very deep and a problem even for tracked vehicles — stopped all movement. Here a Sturmgeschütz (StuG) III Ausf. E of StuG.Abt.226 tows a lorry (truck) through a mud hole. Veterans say that many tanks were ordered for the specific purpose of making supply possible.

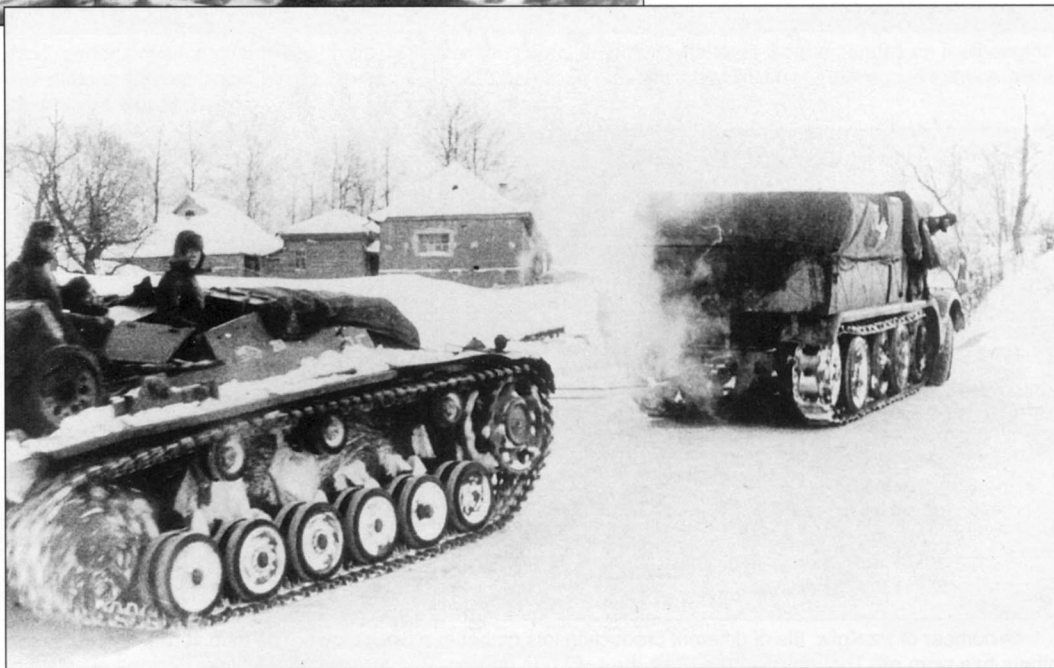
This Pz.Kpfw. III Ausf. J (5cm KwK L/42) monitors a snowy road in Russia. In the background, a typical supply scene takes place. Lacking lorries, the *Wehrmacht* had to rely on horse-drawn wagons. The tank wears an interesting winter camouflage consisting of thin, irregular white stripes over a gray base. The turret number '634' is barely visible.

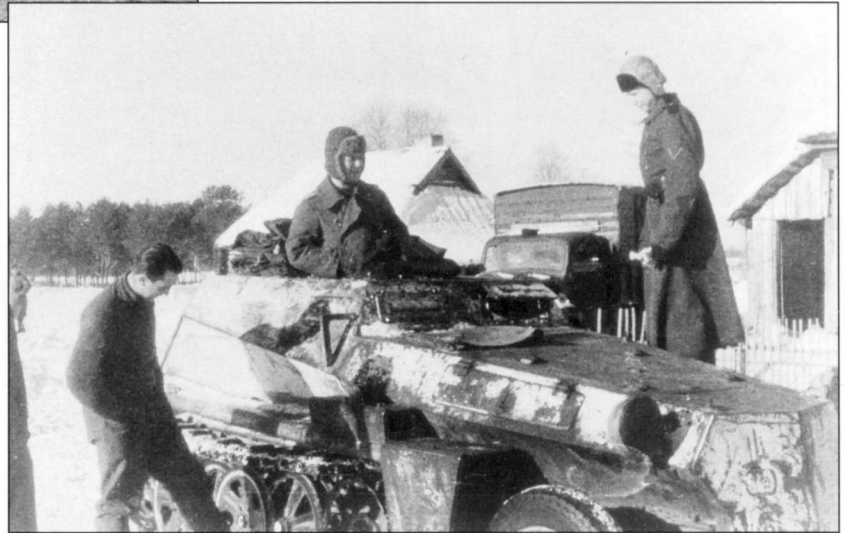
A Sd.Kfz. 252 ammunition carrier of StuG.Abt.226 waits for action. This highly specialized version of the versatile light armored personnel carriers (APC) performed quite well. Their armor protection allowed them to supply StuGs near the front lines.

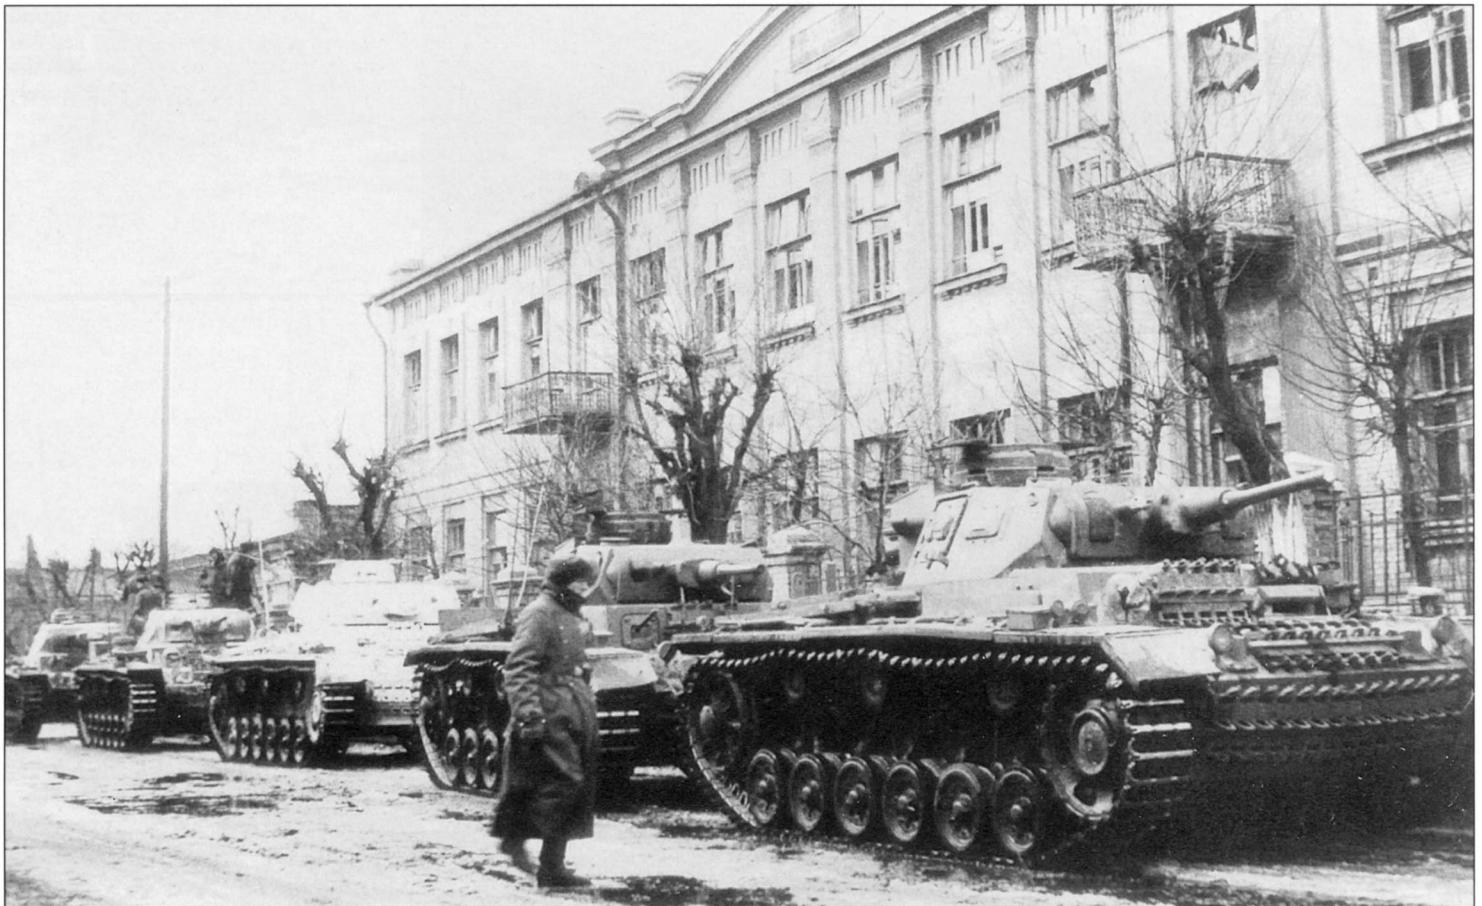
A number of Pz.Kpfw. IIIs of different production lots gather in a Soviet town. The third vehicle appears to be brand-new since the camouflage on all the others has worn off. Though upgunned with the L/42 gun prior to "Barbarossa", these tanks became obsolete on the battlefields of 1942.

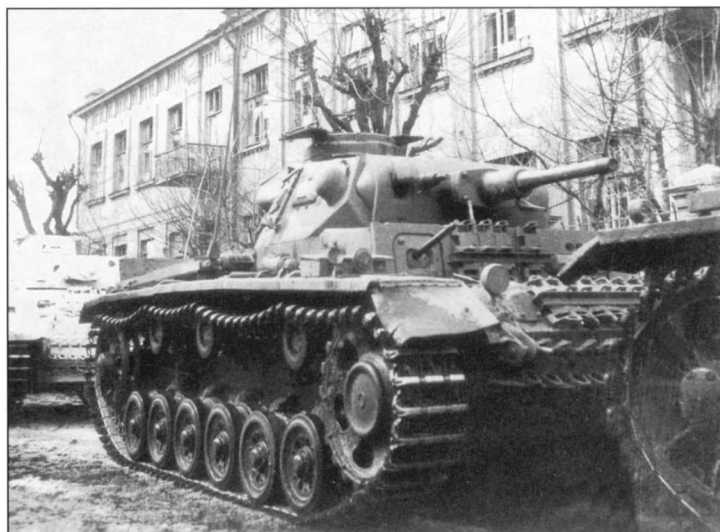
Judging by the production numbers, the Pz.Kpfw. III was the most important German tank of 1942/43. This Ausf. H was photographed as it waited in a column. The basic frontal armor of 30mm was reinforced to 50mm with welded steel plates. Additional protection was achieved by the attachment of large sections of spare tracks.

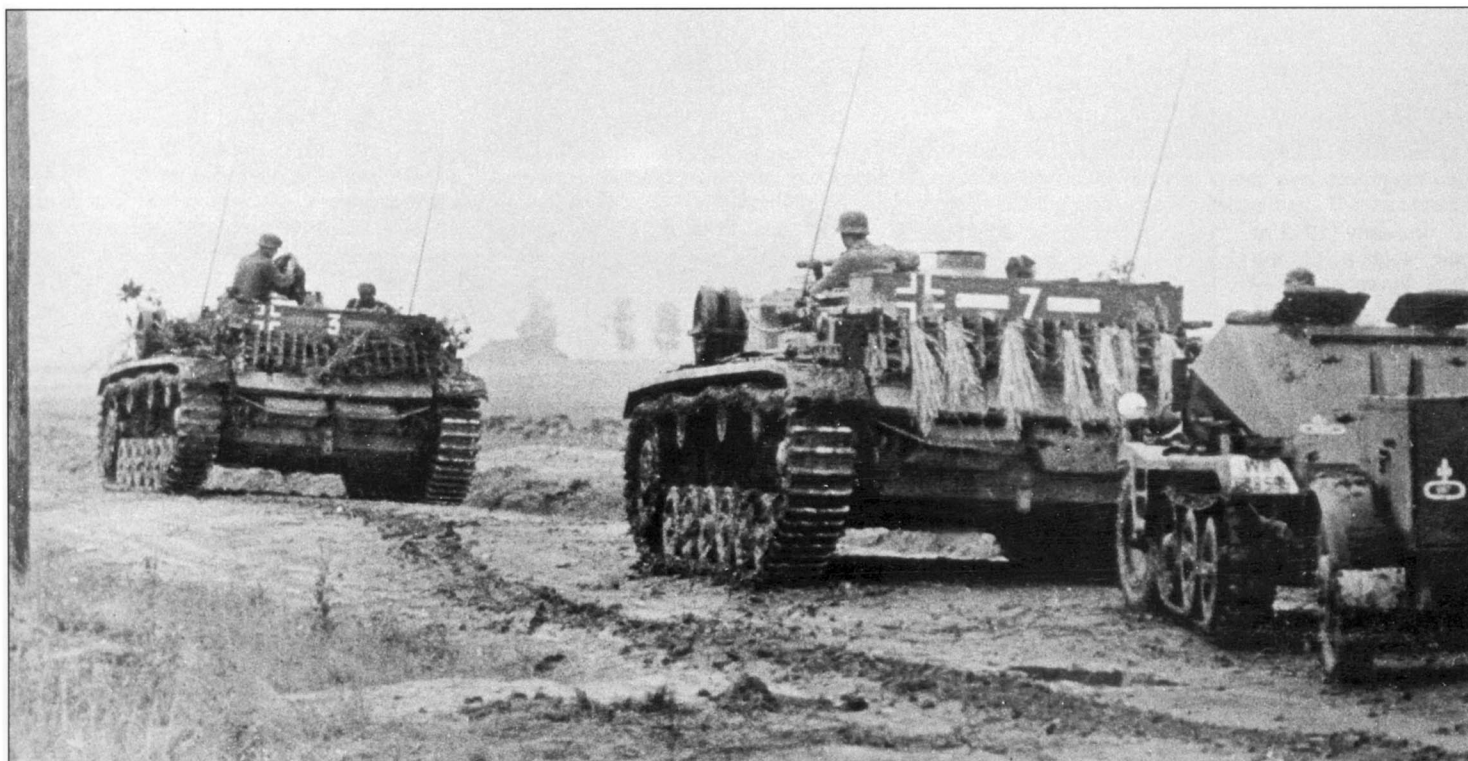
Two StuG III Ausf. Fs, followed by an ammo carrier, advance over muddy ground. The assault guns are fitted with large wooden crates on their engine decks. Their non-standard markings denote the platoon (recognizable by the bars' color) and the vehicle number. Identification markings like these were often seen in assault gun units, which very often fought independently.

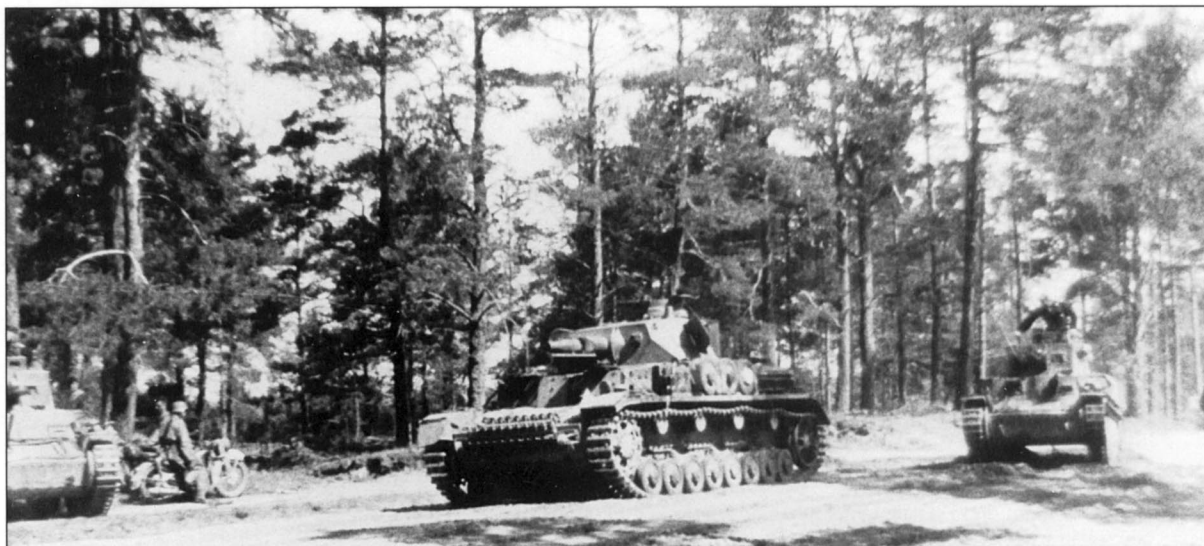
A Pz.Kpfw. IV Ausf. D is being passed by a Pz.Kpfw 38(t). Many divisions still had a lot of these former Czech tanks in their light platoons. Uparmed with a long-barreled 7.5cm gun, the Pz.Kpfw. IV would serve as Germany's main battle tank until the war's end. This older version of the 7.5cm L/24 soon proved to be obsolete for dealing with the T-34 and KV-1.

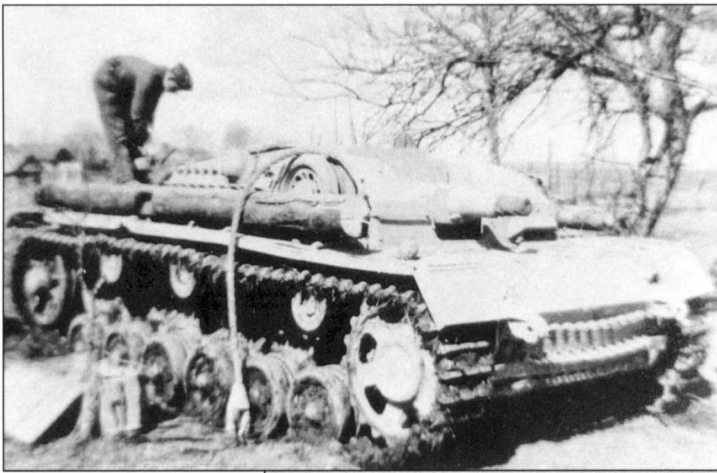
This battle-proven StuG III Ausf. D carries a lot of extra equipment. This practice was necessary because the assault guns were so cramped inside. Two wooden beams were stowed on the fenders for recovery purposes. Spare tracks, additional running wheels and Soviet towing ropes complete the load of equipment.

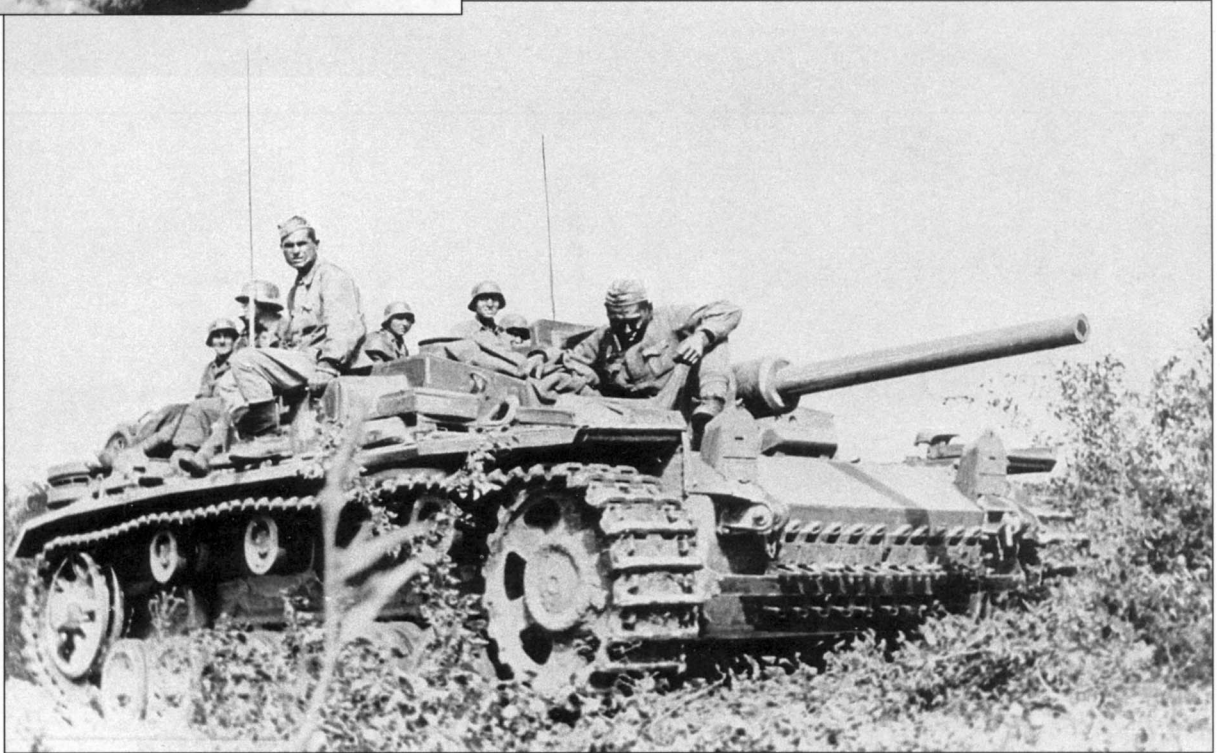
In early 1942 a new version of the StuG III appeared — the Ausf. F. This assault gun was provided with the 7.5cm StuK 40, a long-barrelled gun with high velocity. It was able to deal with any enemy tank. This interesting photo of an Ausf. F was retouched by the censors, who deleted the muzzle brake so that enemy intelligence would be misinformed.

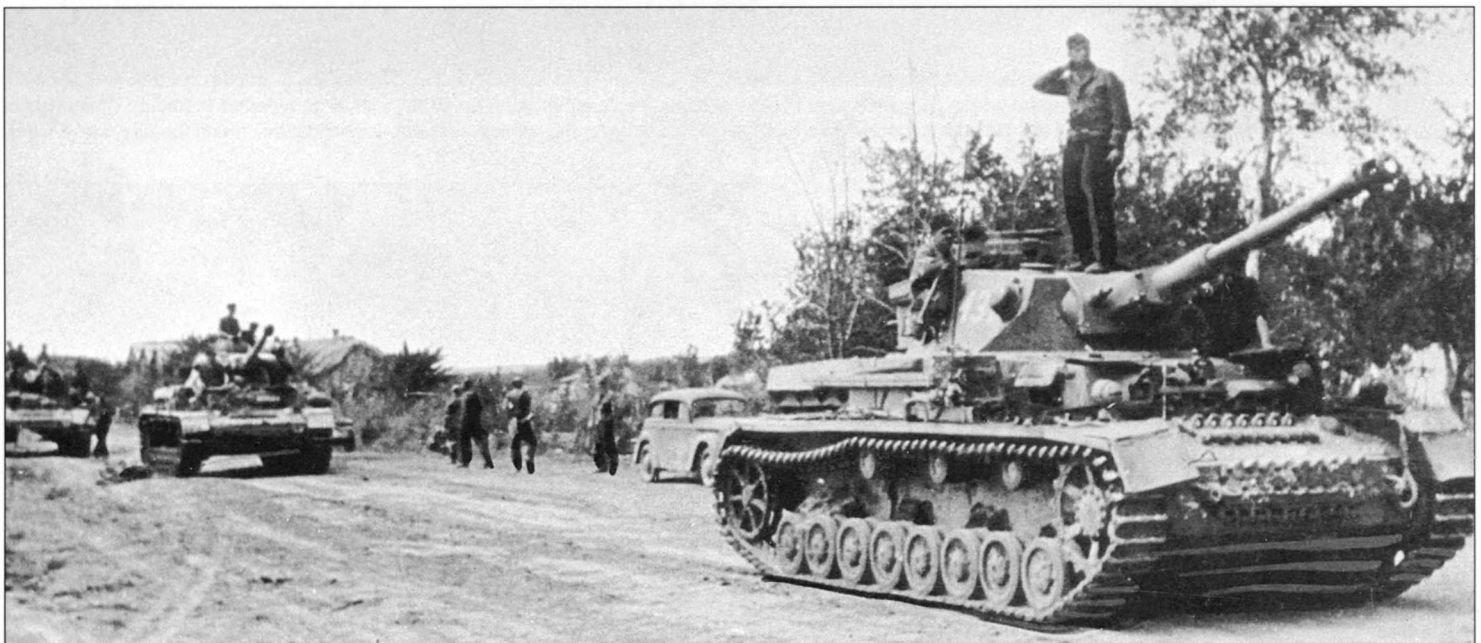
In the late spring of 1942, the first Pz.Kpfw. IVs fitted with the high velocity gun seen here were delivered to the front-line units. This Ausf. G was able to deal with all Soviet and English tanks at distances up to 700 m (765 yards). The tank at right is finished in plain dark gray, with the turret number '431' being painted in white.

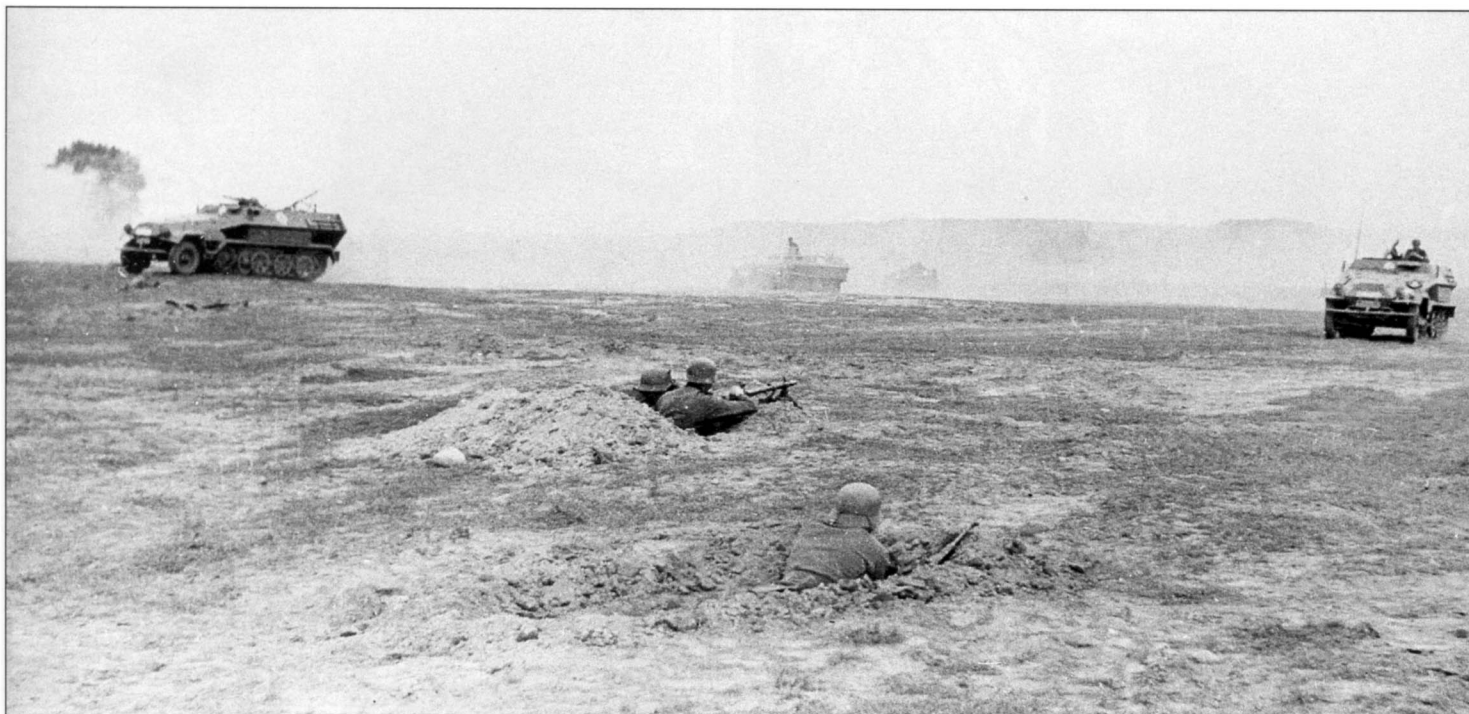
Suffering from the heavy fighting in Russia, many armored formations were transferred to occupied France for refitting. There, new equipment was supplied and fresh troops were integrated and trained. In this photo, APCs perform an assault on dug-in infantry who were expecting them. The half-tracks in the foreground are older Sd.Kfz. 251 Ausf. Bs, while the other is a more recent Ausf. C.

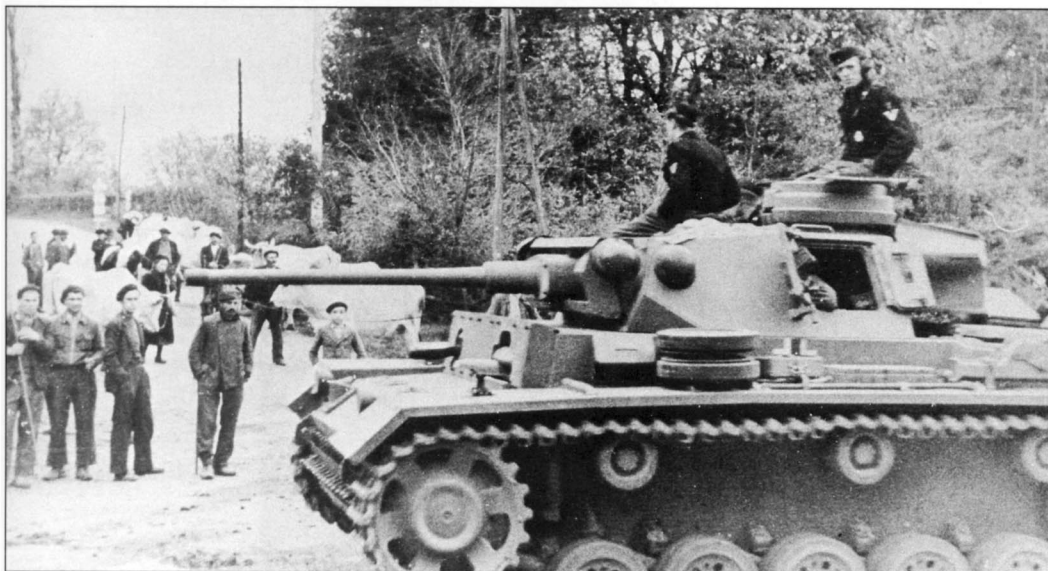
Somewhere in France a Pz.Kpfw. III Ausf. L passes a group of curious civilians. The tank's 5cm L/60 was a long-expected improvement, but it was still not the gun the *Panzertruppe* had waited for. Compared to Soviet tank guns and armor, it was clearly inferior.

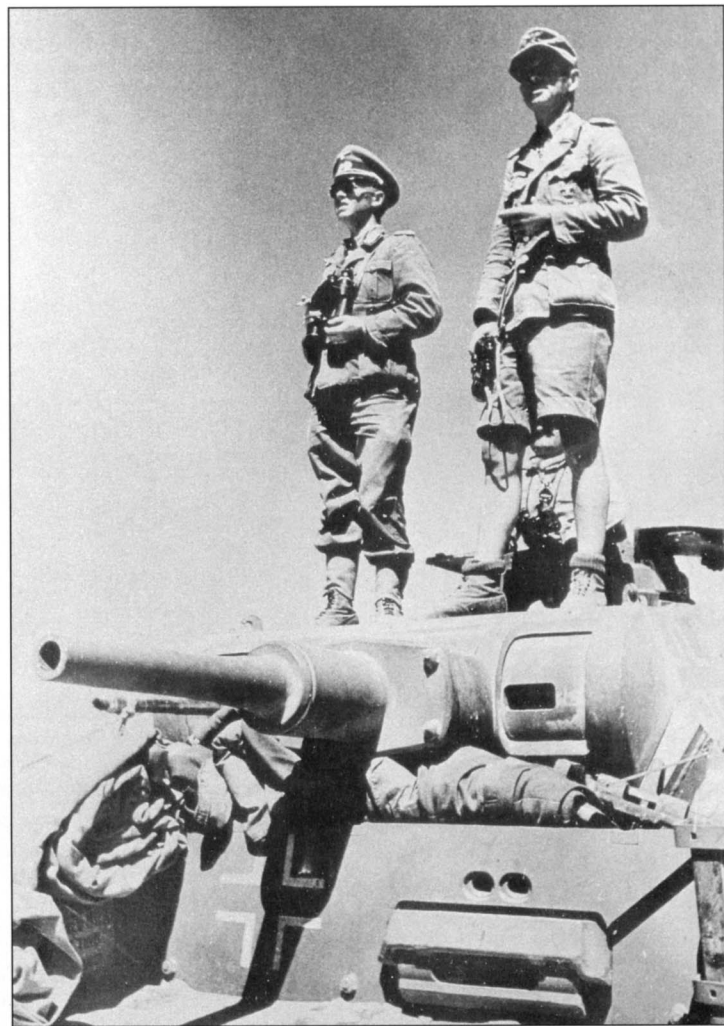
The situation in North Africa was different than in Russia. Highly motivated troops were led by very capable officers. Although poorly equipped, the Germans were able to invade large areas. Here Major-General von Bismark stands on the turret of his Pz.Bef.Wg. III Ausf. H command tank. The gun was a dummy, thus saving space for the extended radio equipment.

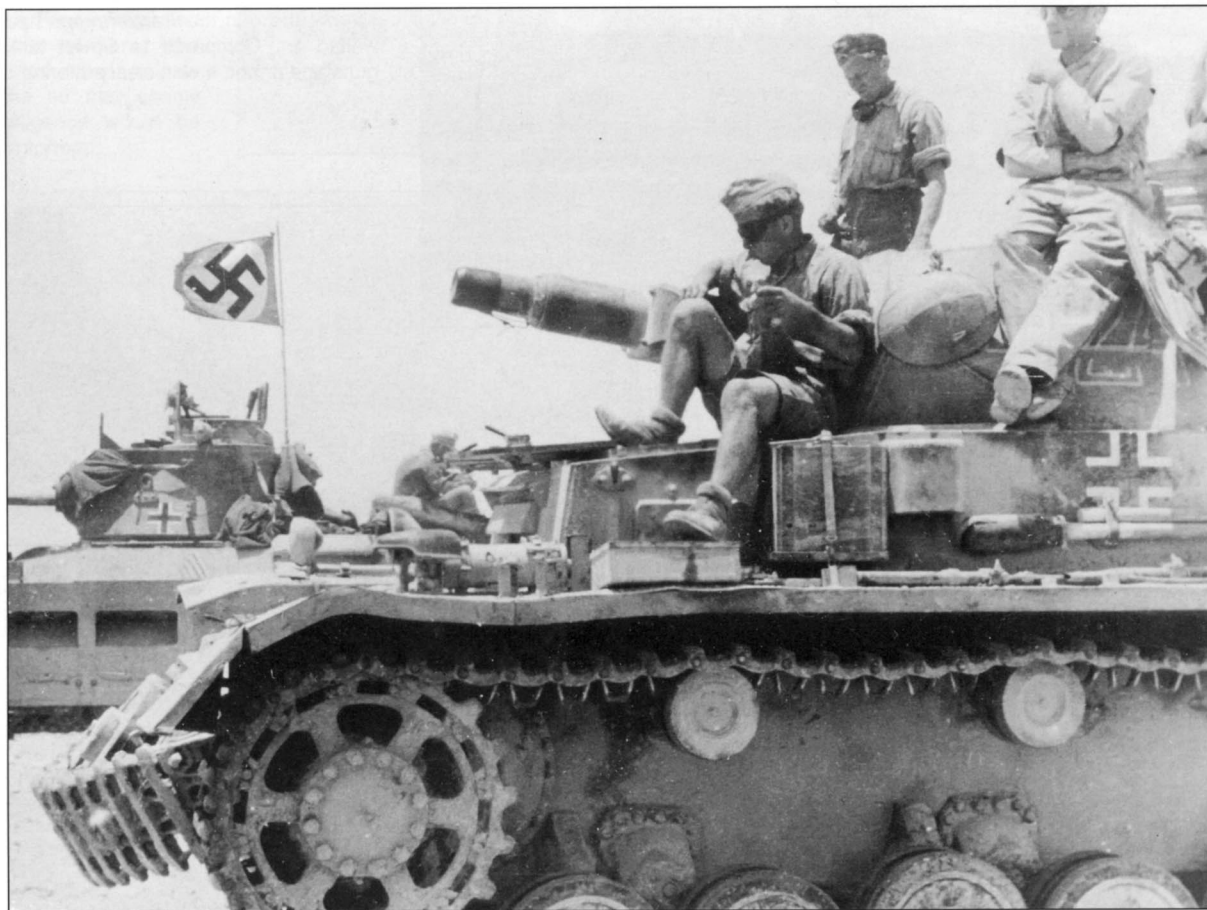
Unusual brothers-in-arms. Here a Pz.Kpfw. IV Ausf. D stands beside a captured Matilda Mk.2. While the Matilda lacked firepower—it was equipped with a 2 pdr. gun (40mm), its German opponent's flaw was its poor armor protection (30mm at the nose).

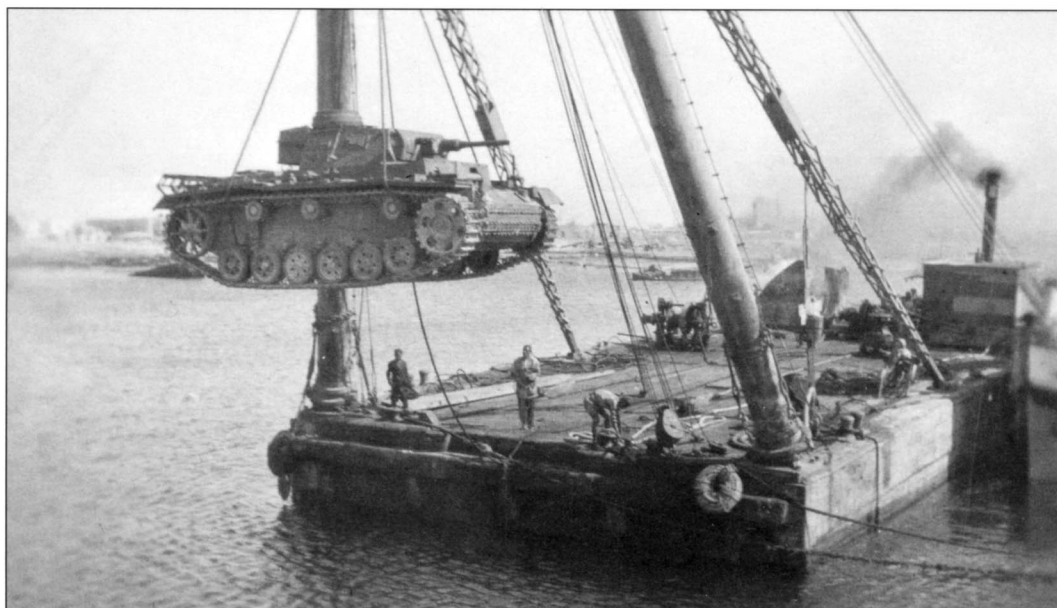
Seen here in August 1942, a Pz.Kpfw. III Ausf. H is being unloaded in Benghazi. The vehicle is fitted with the short-barreled L/42 gun and an interesting basket at its rear, which was designed for carrying fuel cans over the vast terrain of North Africa. (Photo: Hasler)

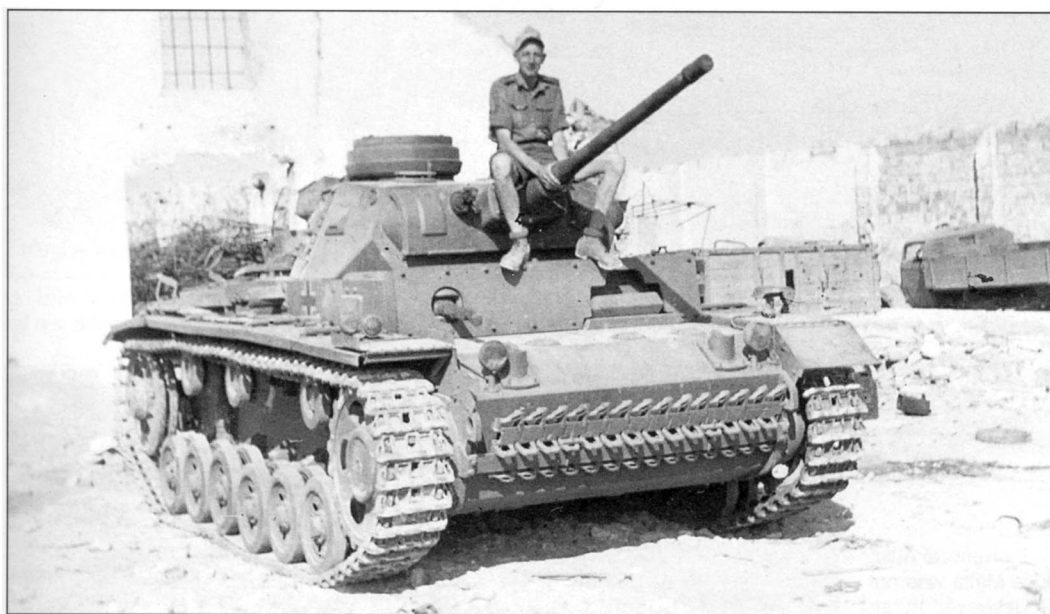
An Ausf. L belonging to the same unit waits near the harbor of Benghazi for further orders. The vehicle seems to be finished in a desert sand paint scheme rather than in dark gray. Note that the Pz.Kpfw. III appears to be brand-new and shows no sign of damage. (Photo: Hasler)

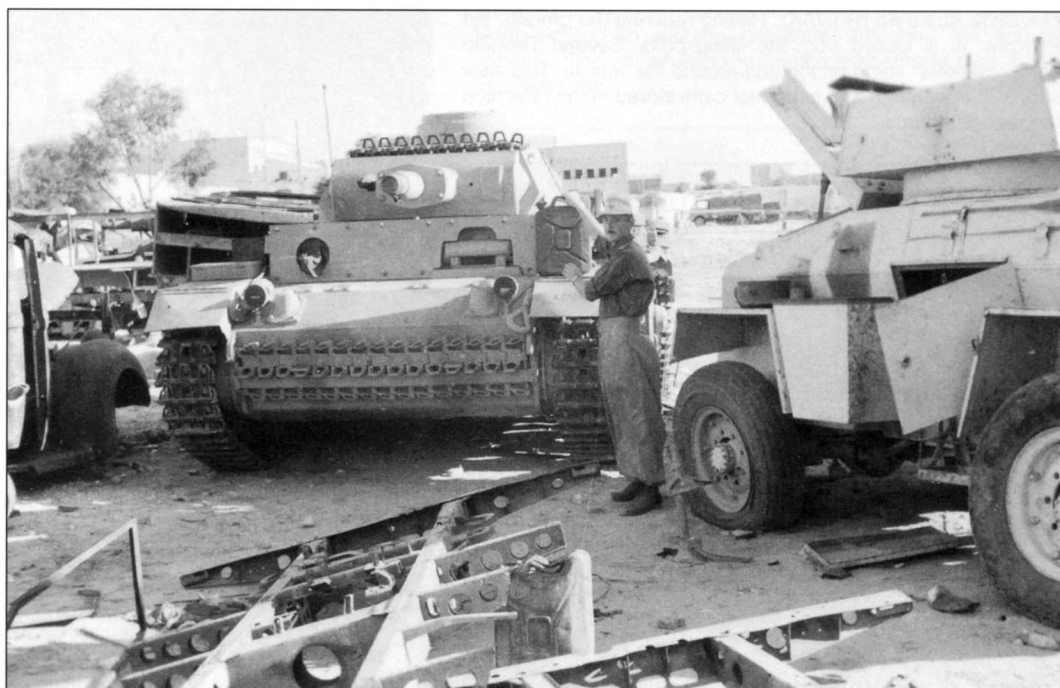
Yet another version of the Pz.Kpfw. III, this one an Ausf. N armed with a 7.5cm L/24 gun, stands near a captured Humber armored car. The Afrika Korps used as much enemy materiel as possible. There were even situations when the inventory consisted more of captured tanks than German ones. (Photo: Hasler)

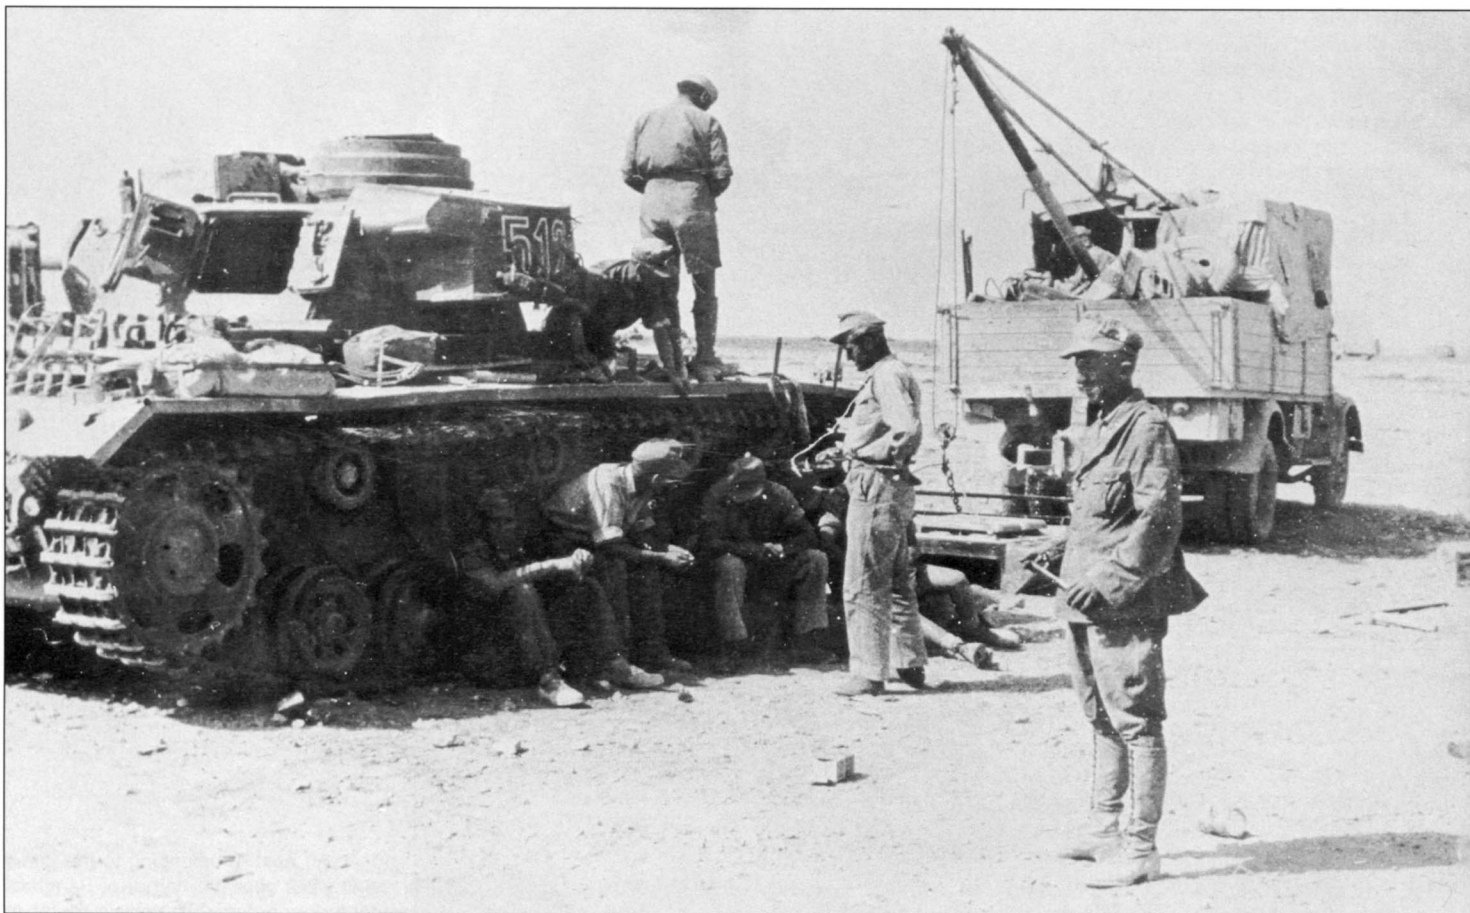
In this photo a 3-ton truck, which has been converted to a workshop, is employed to remove the engine cover of a damaged Pz.Kpfw. III Ausf. J. Apparently, the engine broke down, which was quite a frequent problem in the heat of North Africa. Note how the tank crew members escape the sun by sitting in the shade created by their vehicle.

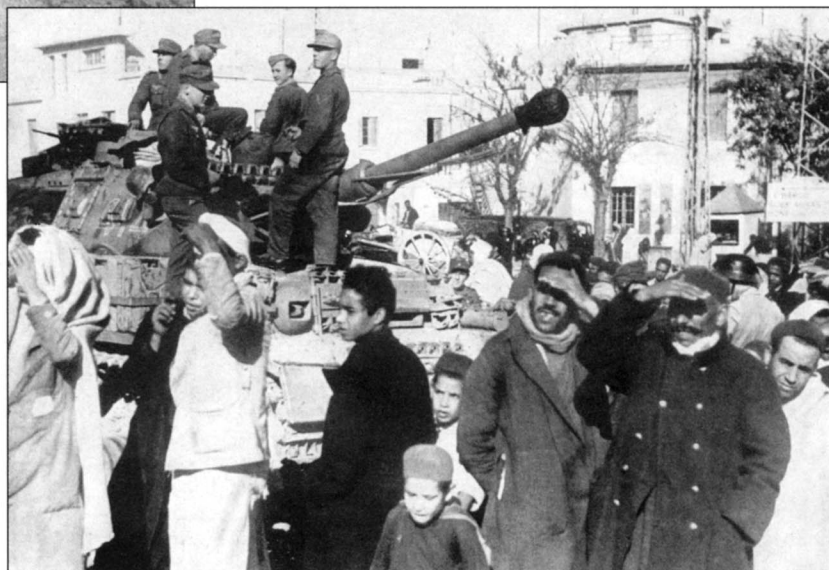
Photographed in Tunis in December 1942, this Pz.Kpfw. IV Ausf. F2 is encircled by civilians. Armed with the powerful 7.5cm KwK L/42, this version was quickly called 'Mk. IV special' by the British. It was able to defeat any enemy tank at ranges of more than 1,000 m (1,093 yards). The tank is finished in sand yellow, and the turret number is probably red with white outlines. Extra equipment is carried on the fenders and turret. Of interest is the large antenna deflector fitted below the barrel.

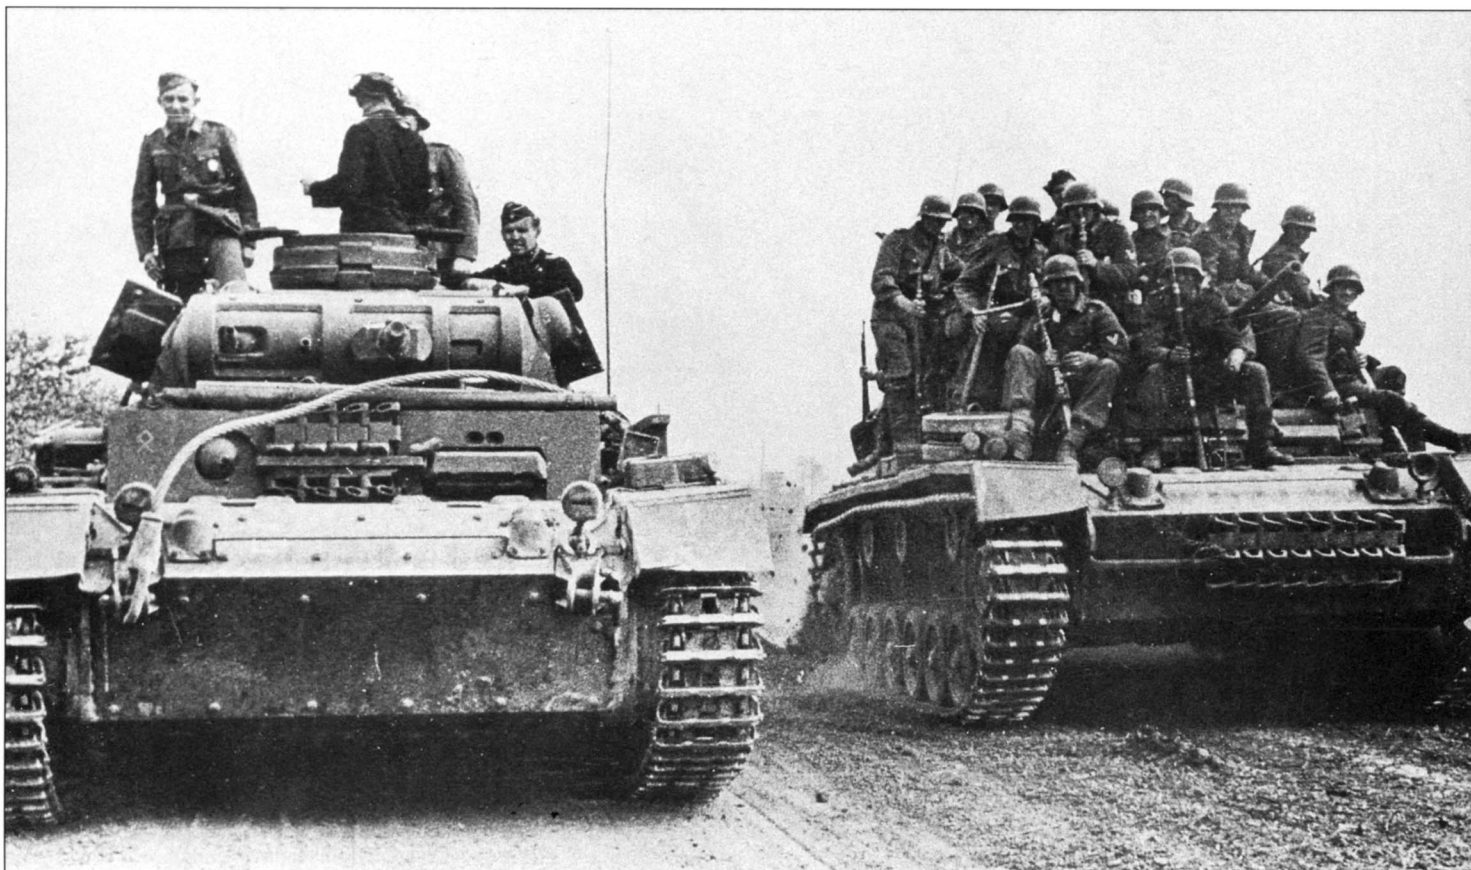
On patrol in Russia, this Pz.Kpfw. III Ausf. J (L/42), which is loaded down with infantry, passes a Panzerbefehlswagen III Ausf. G command vehicle that is probably from the battalion staff section. The command tank was fitted with a dummy gun, its only armament consisting of an MG34 in a ball mount to the right of the dummy gun. Once again, a Soviet-style towing rope was pressed into service.

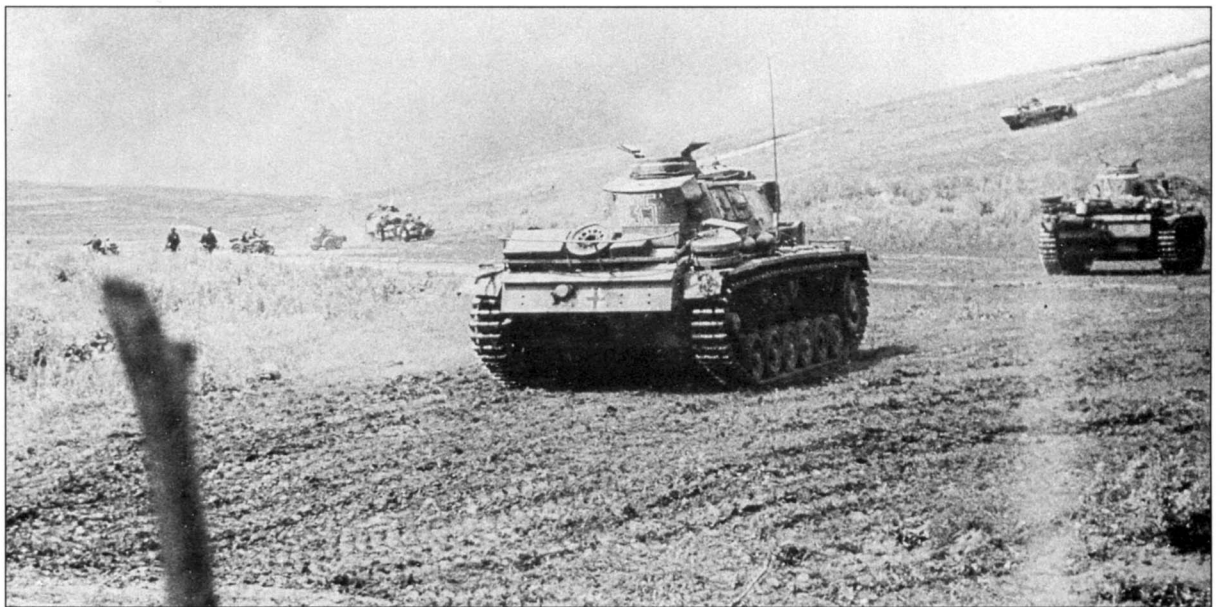
Some more Pz.Kpfw. III (Ausf. L and M) tanks deploy across the vast Russian plains. Armored infantry in half-tracks can be seen supporting the advance. Again, a rack filled with extra equipment is visible on the engine deck of the tank at center. Its turret number is no doubt painted in red with a white outline.

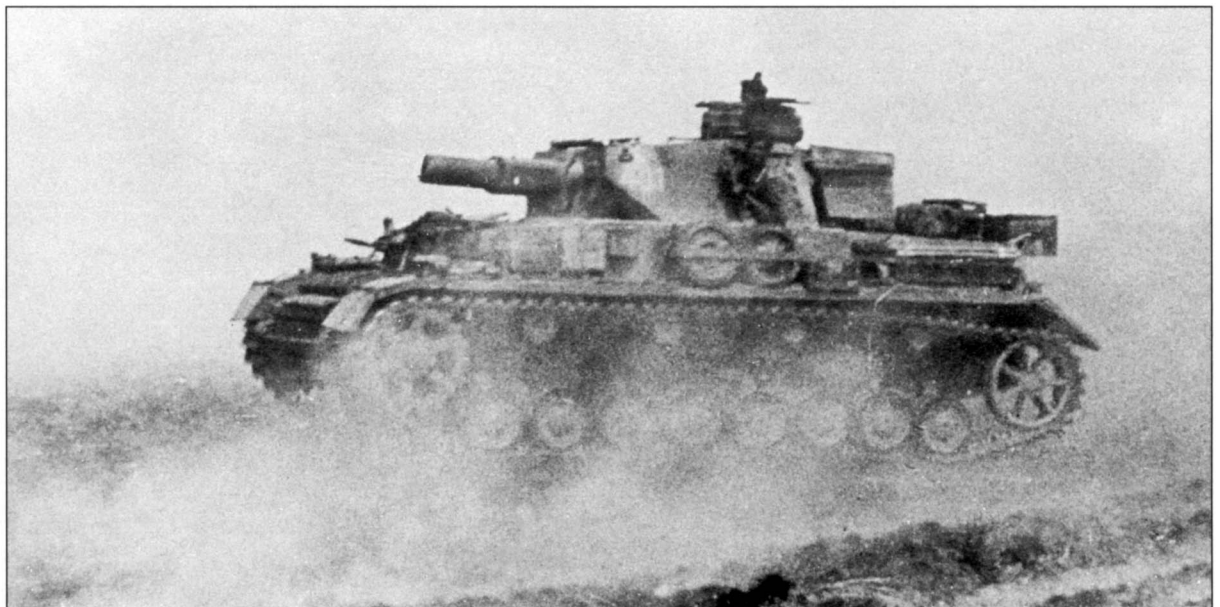
Slowly moving along the Russian steppes, this Pz.Kpfw. IV seems to be an 7.5cm-armed version. The photo was retouched by German censors, who almost completely deleted the new L/43 gun barrel of this Ausf. F2. These vehicles were able to deal with all of the Soviet tanks under normal conditions. A white number '401' was applied to the sides of the turret.
