PANZERWAFFE AT WAR

(2) MOSCOW TO BERLIN

Robert Michulec & Thomas Anderson

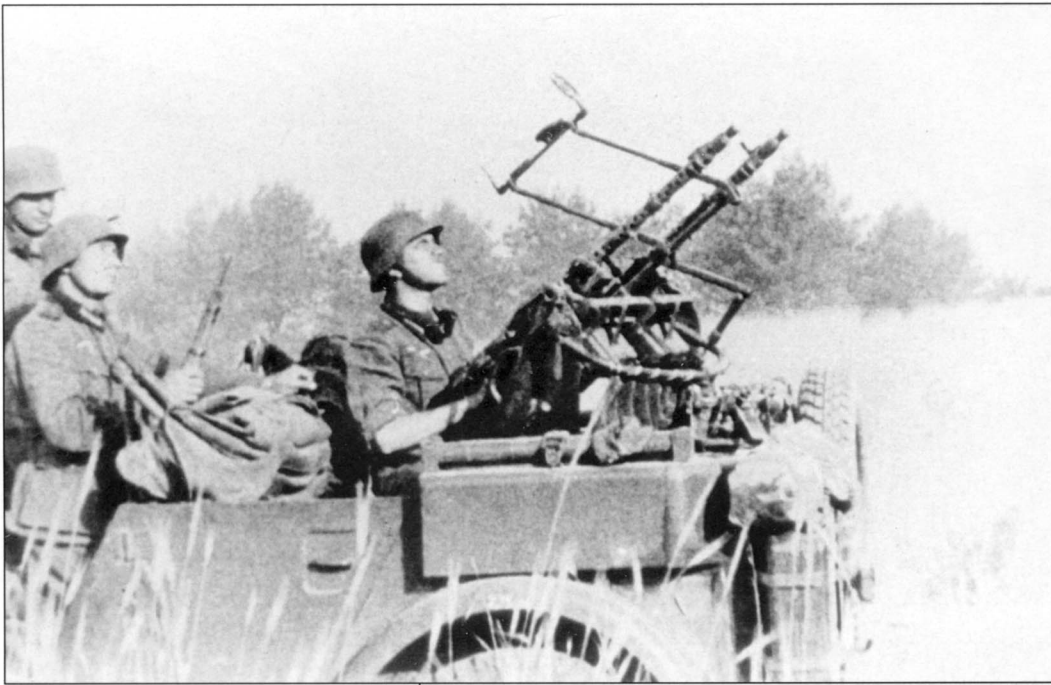
A fine shot of a *Truppenluftschutzwagen*, a Kfz. 4 wheeled vehicle armed with twin MG34 machine guns. Note how the gunner zeroes in on the enemy planes through the anti-aircraft gun sight extending above the gun barrels.

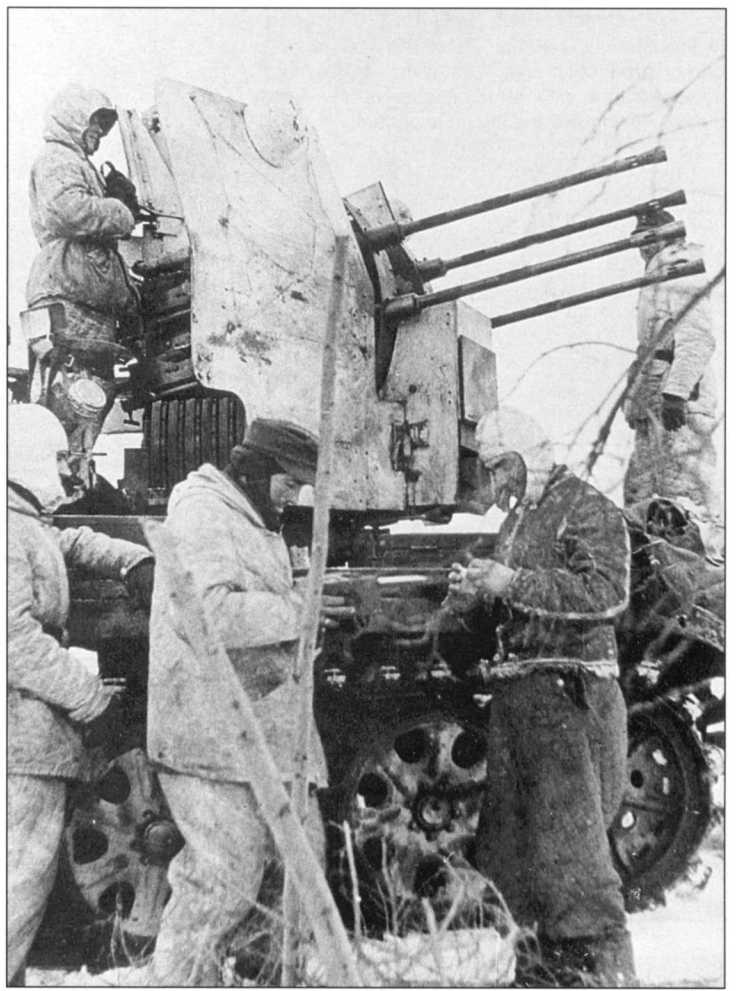
The 2cm quadruple anti-aircraft gun was one of the most feared weapons on the Eastern Front. Intended for action against low-flying dive bombers, it was often used to engage ground targets. The warmly dressed crew of this Sd.Kfz. 7/1 is seen on a cold November day as they prepare for the next action.

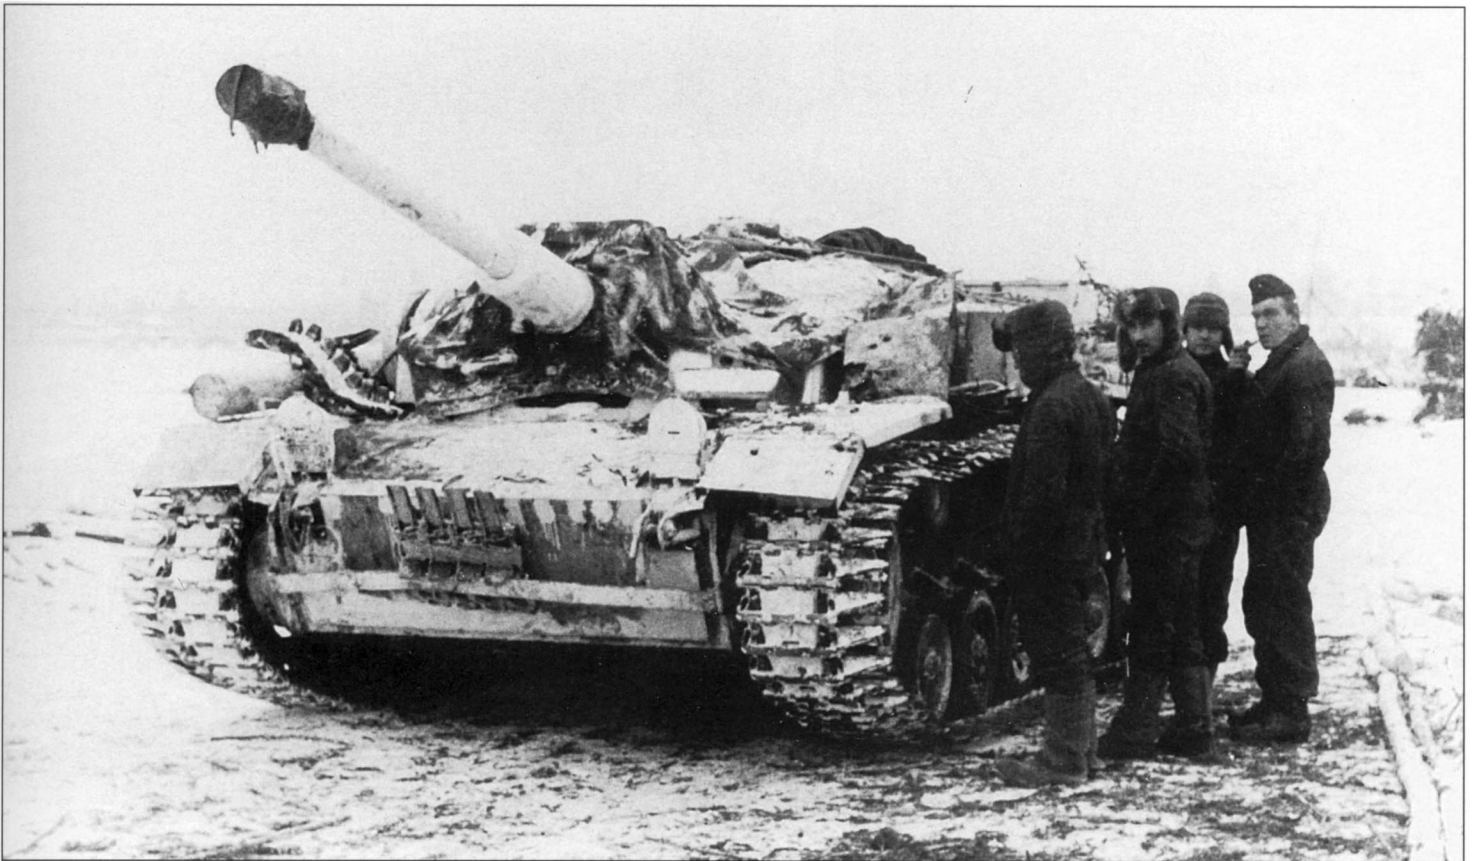
This StuG III Ausf. F of StuG.Abt.226 displays a perfect winter camouflage. A tarpaulin is used to cover the superstructure, which had many openings. The assault gun has been provided with winter tracks. Note that parts of the fenders are missing; battle damage like this was quite common. This early Ausf. F shows no additional armor at the bow.

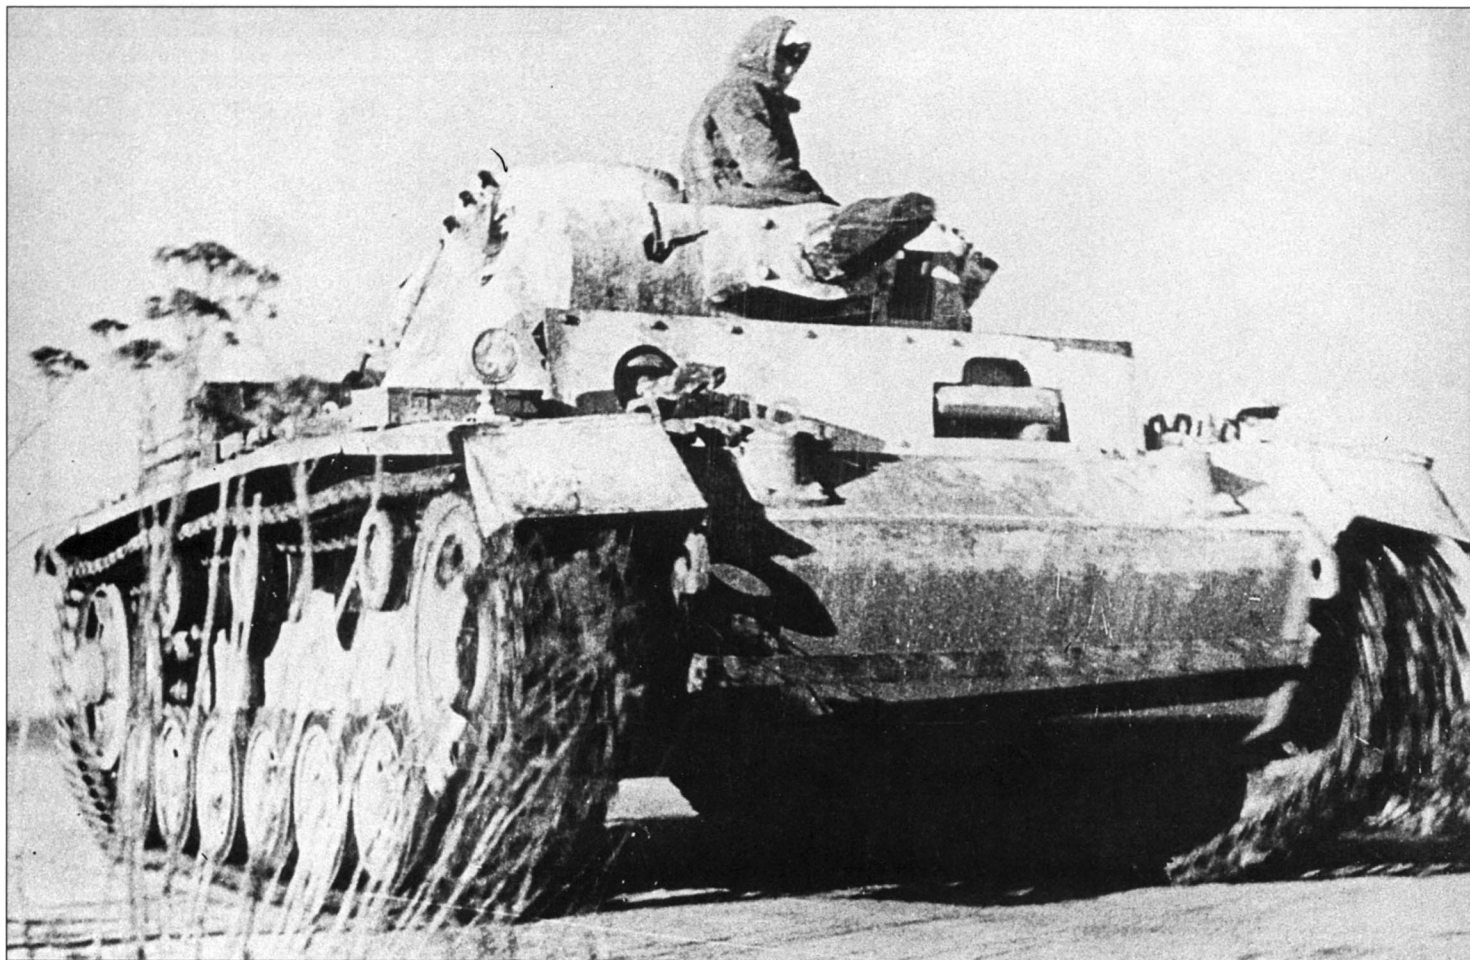
In late 1942 a number of Pz.Kpfw. IIIs were reworked to receive the 7.5cm L/24 gun. New ammunition provided this gun with better penetration data than the 5cm KwK. Most of these vehicles were despatched to Tiger units as direct support weapons. This vehicle was reworked from an Ausf. N.

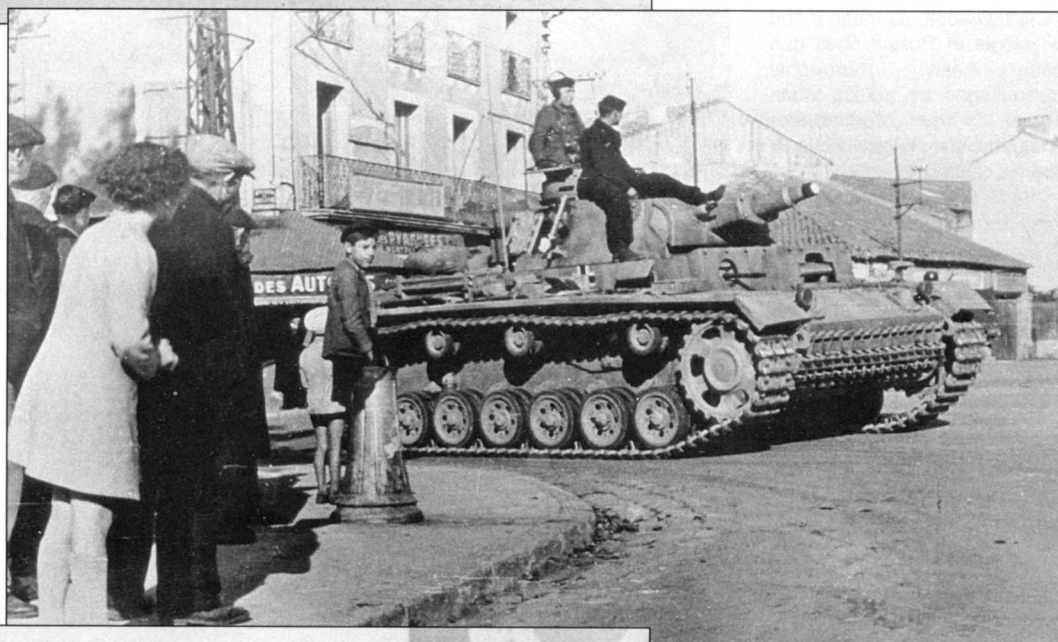
This Pz.Kpfw. III Ausf. N (reworked from Ausf. L), which is shown passing through a French city, is camouflaged in desert sand with brown blotches. The tanks belonging to this unit were soon transferred to North Africa. The Ausf. N was the final variant of the Panzer III.

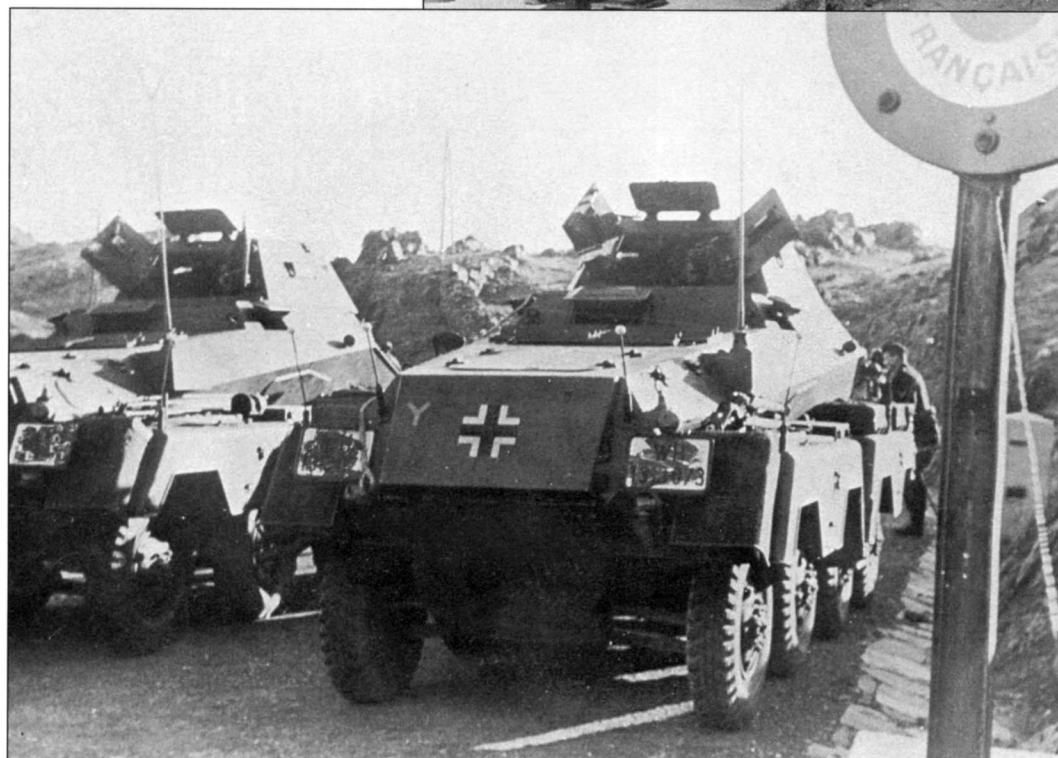
Many armored units were sent to France for refitting. These armored cars of 7.Panzer-Division are late production Sd.Kfz. 232s sporting the 1.3m star antenna instead of the prominent frame antennas. The vehicles are still finished in plain dark gray.

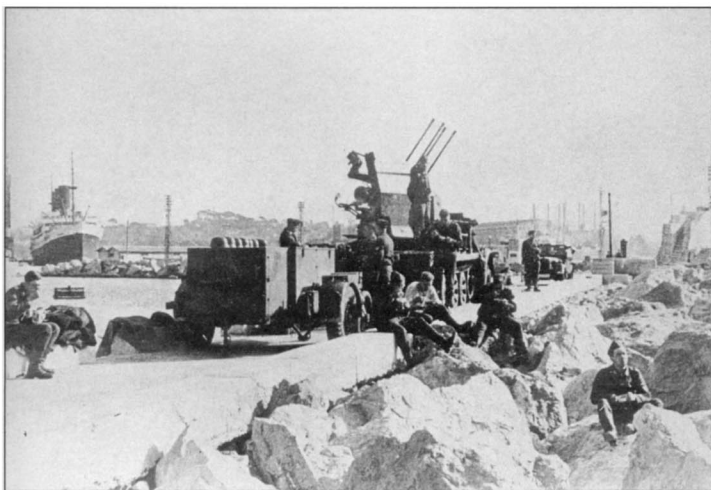
Taking a brief break from protecting a French harbor with an imposing quadruple-barellled anti-aircraft gun, the crew of this Sd.Kfz. 7/1 enjoys their lunch in the Mediterranean sun. The dark gray half-track is towing an ammunition trailer.

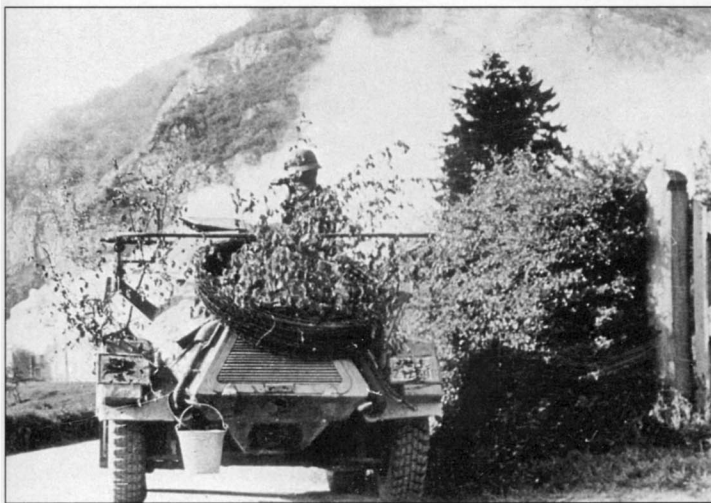
Somewhere in Italy the commander of a Sd.Kfz. 223 communication/recece armored car carefully watches the street fighting taking place in an Italian city. These old vehicles performed much better in the dry climate of southern Europe than under the rough conditions of the Eastern Front.

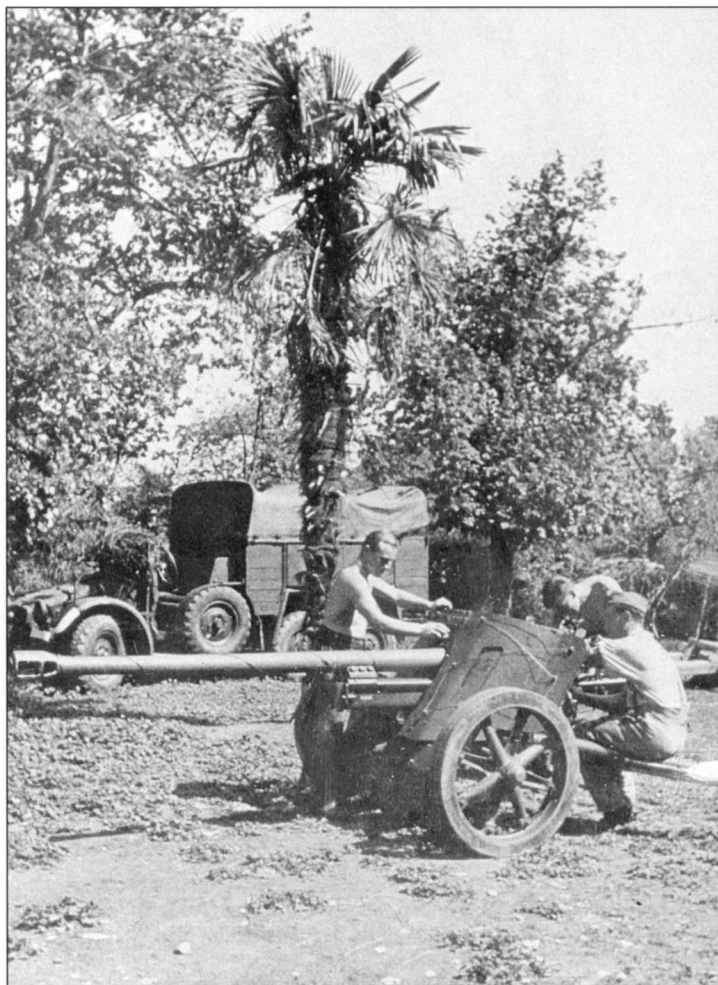
This photo, taken sometime around the turn of the year 1942/43, shows the crew of a 5cm Pak 38 cleaning up their gun. The wires wrapped around the gun shield allow for the application of foliage. In the background is parked the towing vehicle, a brand-new Krupp Protze.

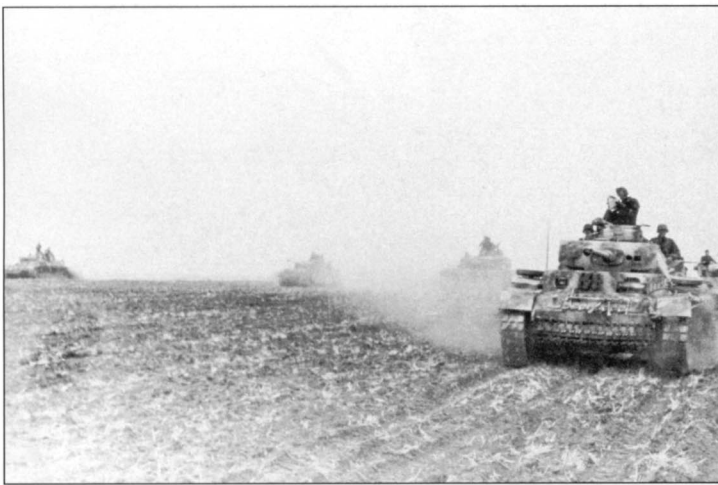
Shown during Operation "Zitadelle", a mixed tank column of 3.SS-Panzer-Division moves up to the front. The Pz.Kpfw. III to the right is an Ausf. L with interesting camouflage consisting of green blotches on a dark yellow base. In the background, Pz.Kpfw. IV Ausf. Gs or Hs are visible.

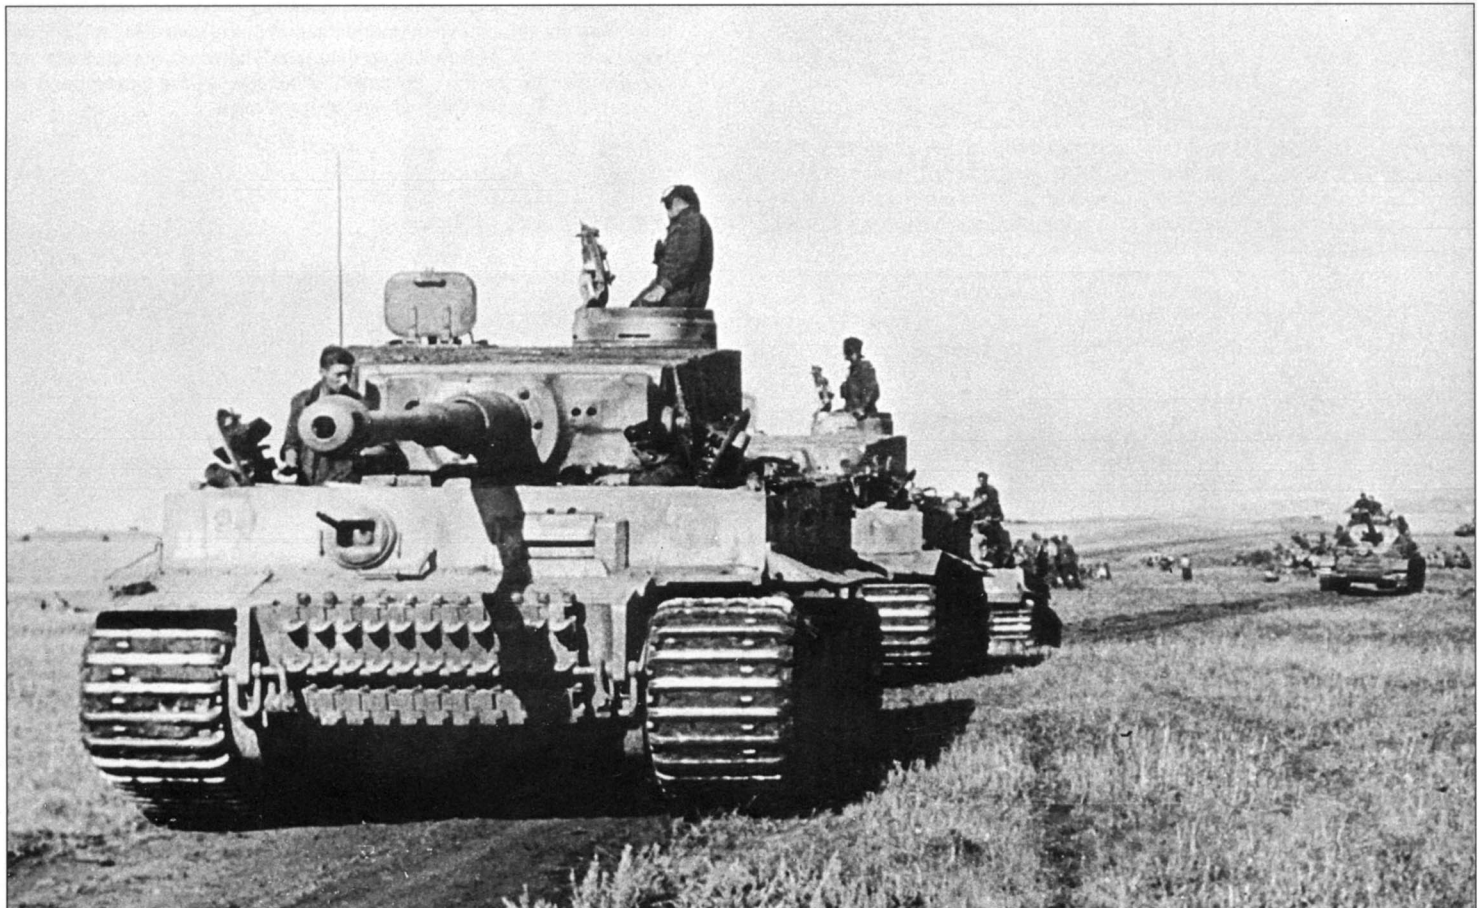
Tigers of 2.SS-Panzer-Division move up to the front during Operation "Zitadelle". With Tigers available in greater numbers, new tactics were introduced. The *Panzerkeil* (wedge) proved to be very successful, especially southwest of Kursk where the Soviet lines were penetrated and heavy losses inflicted on the defenders. The vehicles show dark green stripes painted over a dark yellow base, a camouflage scheme typical of mid-1943.

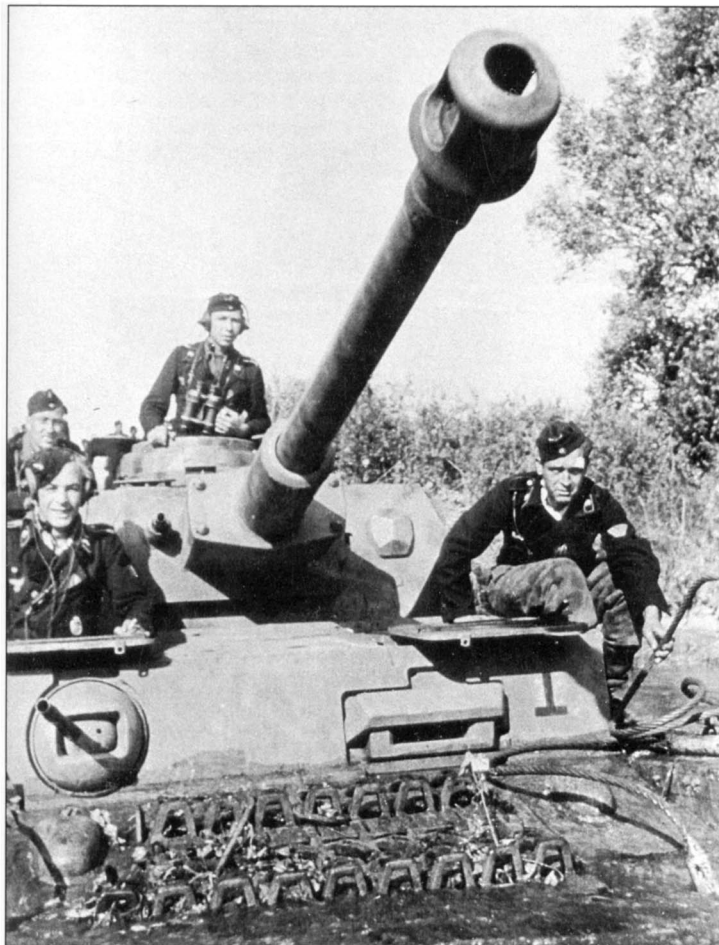
The crew members of this Pz.Kpfw. IV Ausf. G look rather worried as they cross a river. The front armor was reinforced to 80mm by welded-on plates, a change that was made on many reworked vehicles. The marking (a vertical bar over a horizontal bar) identifies the tank as part of 1.SS-Panzer-Division 'Leibstandarte Adolf Hitler'. Again, this was a temporary marking applied during the Battle of Kursk.

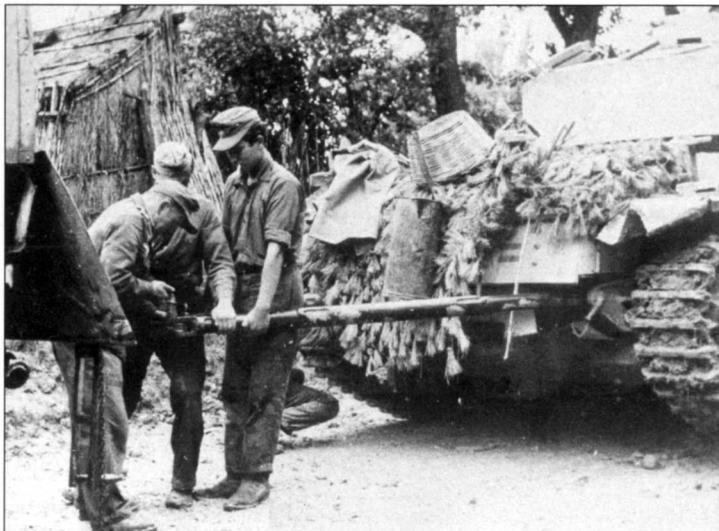
A late production Pz.Kpfw. III Ausf. L fitted with side skirts is being recovered by a Famo 18-ton half-track. The meaning of the black bars visible on the rear plate of the tank is unknown. It is probably a temporary unit marking used during Operation "Zitadelle".

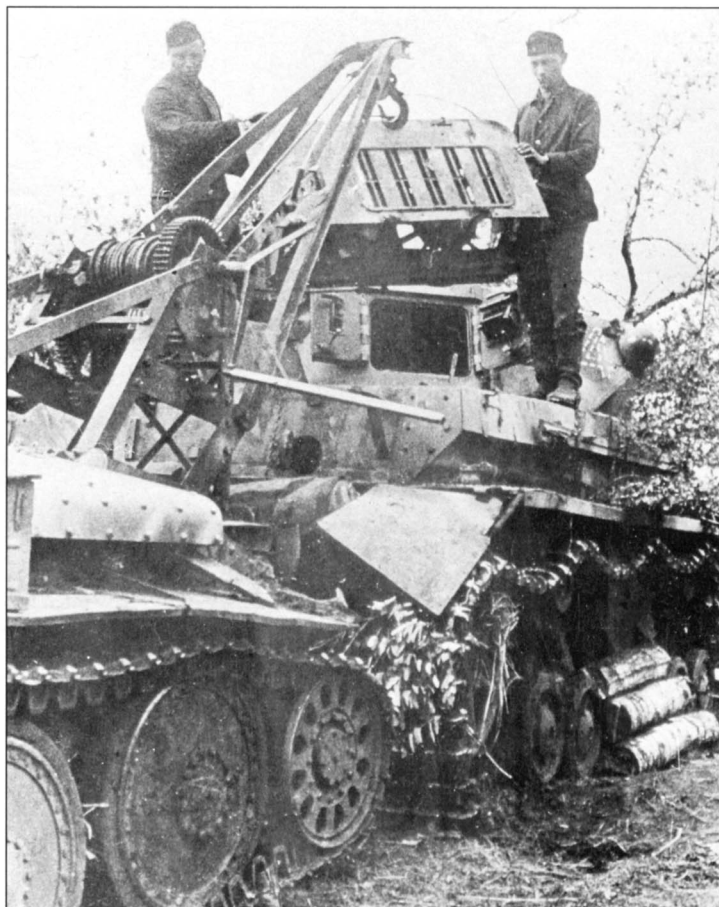
Many obsolete tanks were used by workshop units. The turret of this Pz.Kpfw. 38(t) was removed, then a crane was mounted on the engine cover. Note how the hull sinks while removing the engine cover of a damaged Pz.Kpfw. IV.

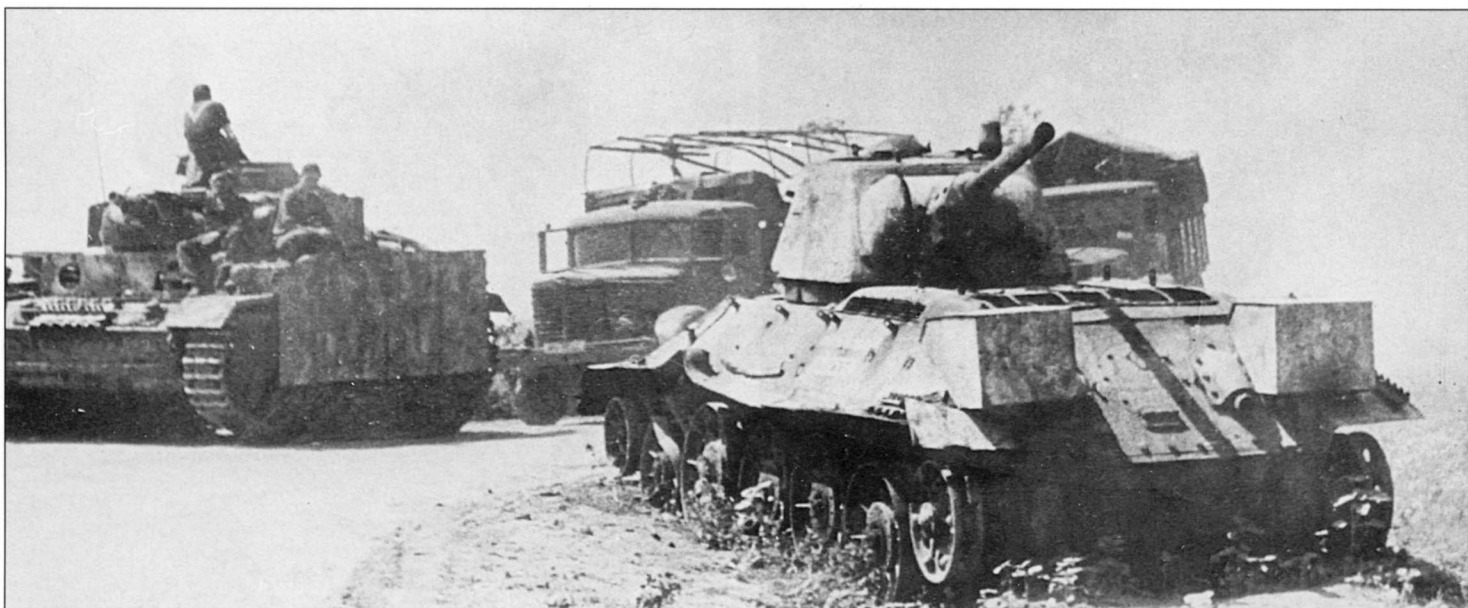
Guarding some supply lorries, a Pz.Kpfw. III Ausf. N passes by a destroyed T-34 Model 1943. With its side skirts and fenders still intact, the tank appears to be brand-new. The ubiquitous three-tone camouflage was applied to this tank, too.

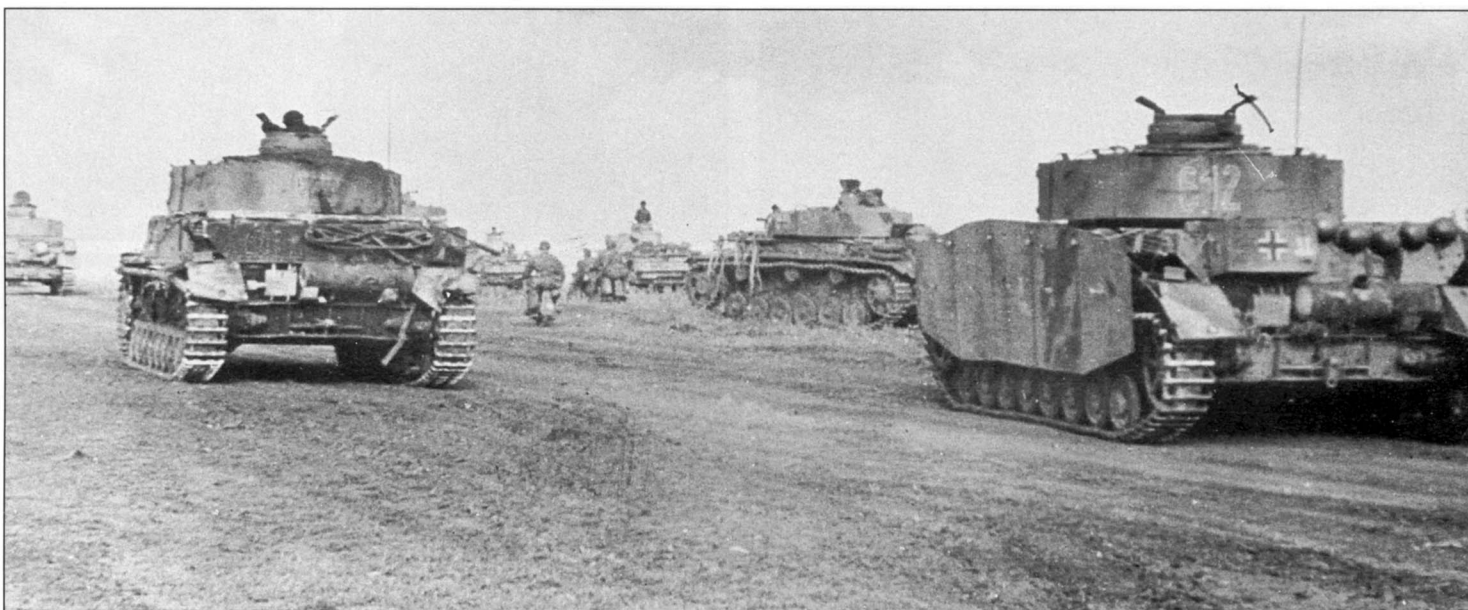
Here a formation of late production or reworked Pz.Kpfw. IV Ausf. Gs of 2.SS-Panzer-Division is accompanied by a *Panzerbeobachtungswagen* (Pz.Beob.Wg.) III artillery observation vehicle. These specialized tanks were very similar to the command tanks, being fitted with extra radio and observation equipment. Note that tactical markings and the national insignia have been painted on the wooden box added on at the rear.

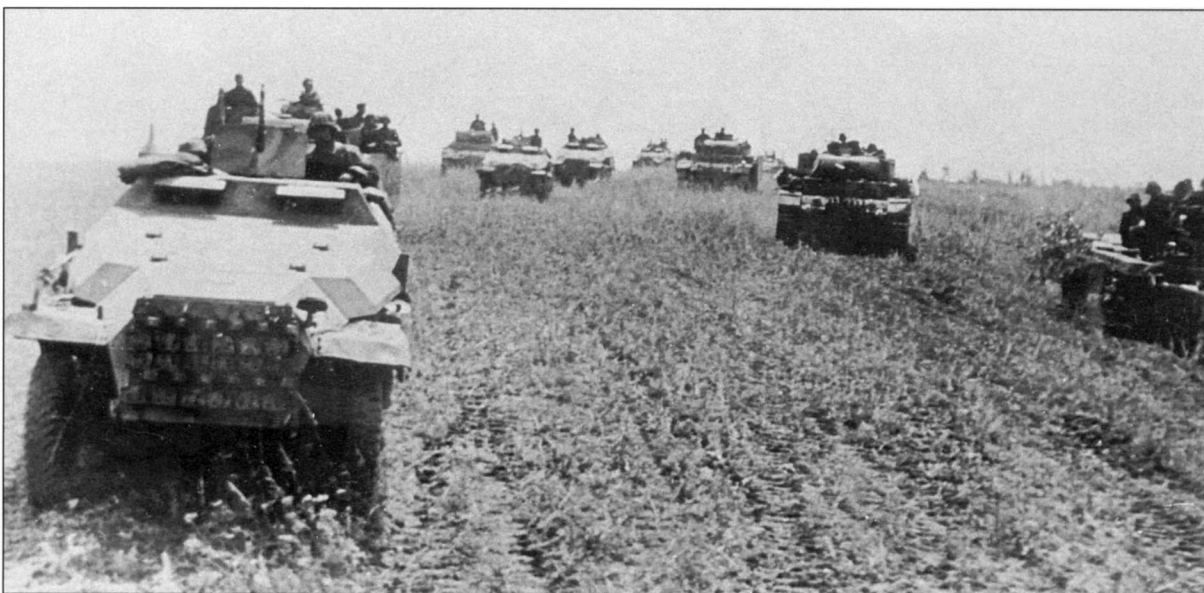
Here various elements of the German *Panzerwaffe* are represented as a section of armored personnel carriers accompanies the advance of Pz.Kpfw. III Ausf. L or M tanks. At the extreme right is visible a *Sturmflak*, a 2cm Flak 38 gun mounted on a 1-ton half-track.

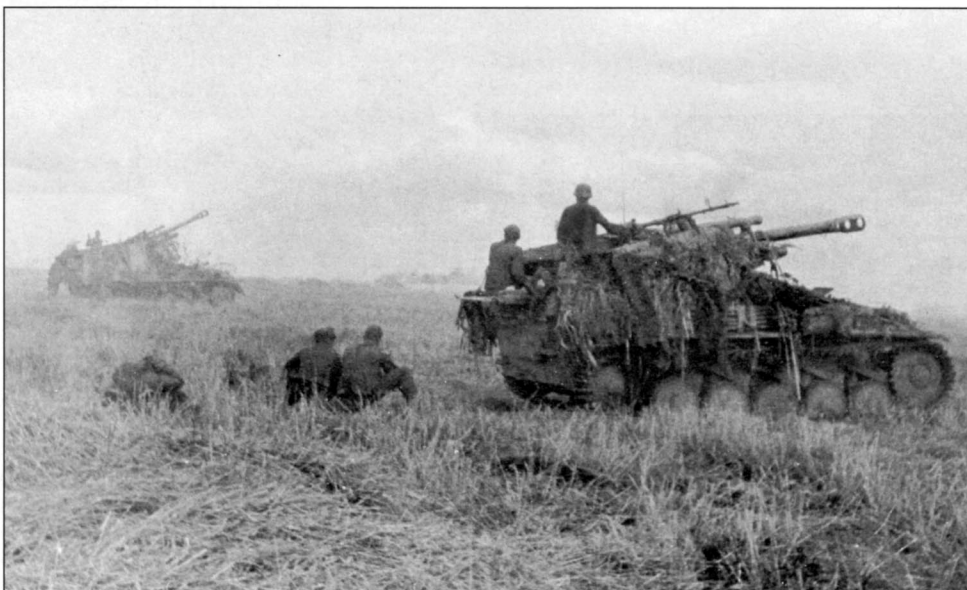
From mid-1943 onward, tank artillery units were sent to the front lines in greater numbers. This battery of 10.5cm le.FH 18/2 guns mounted on Gw. II Wespe vehicles prepares to support an attack with indirect fire. The obsolete Pz.Kpfw. IIs were used in a very sensible way, like their big brother the Hummel, and the Wespe performed well up to the end of the war.

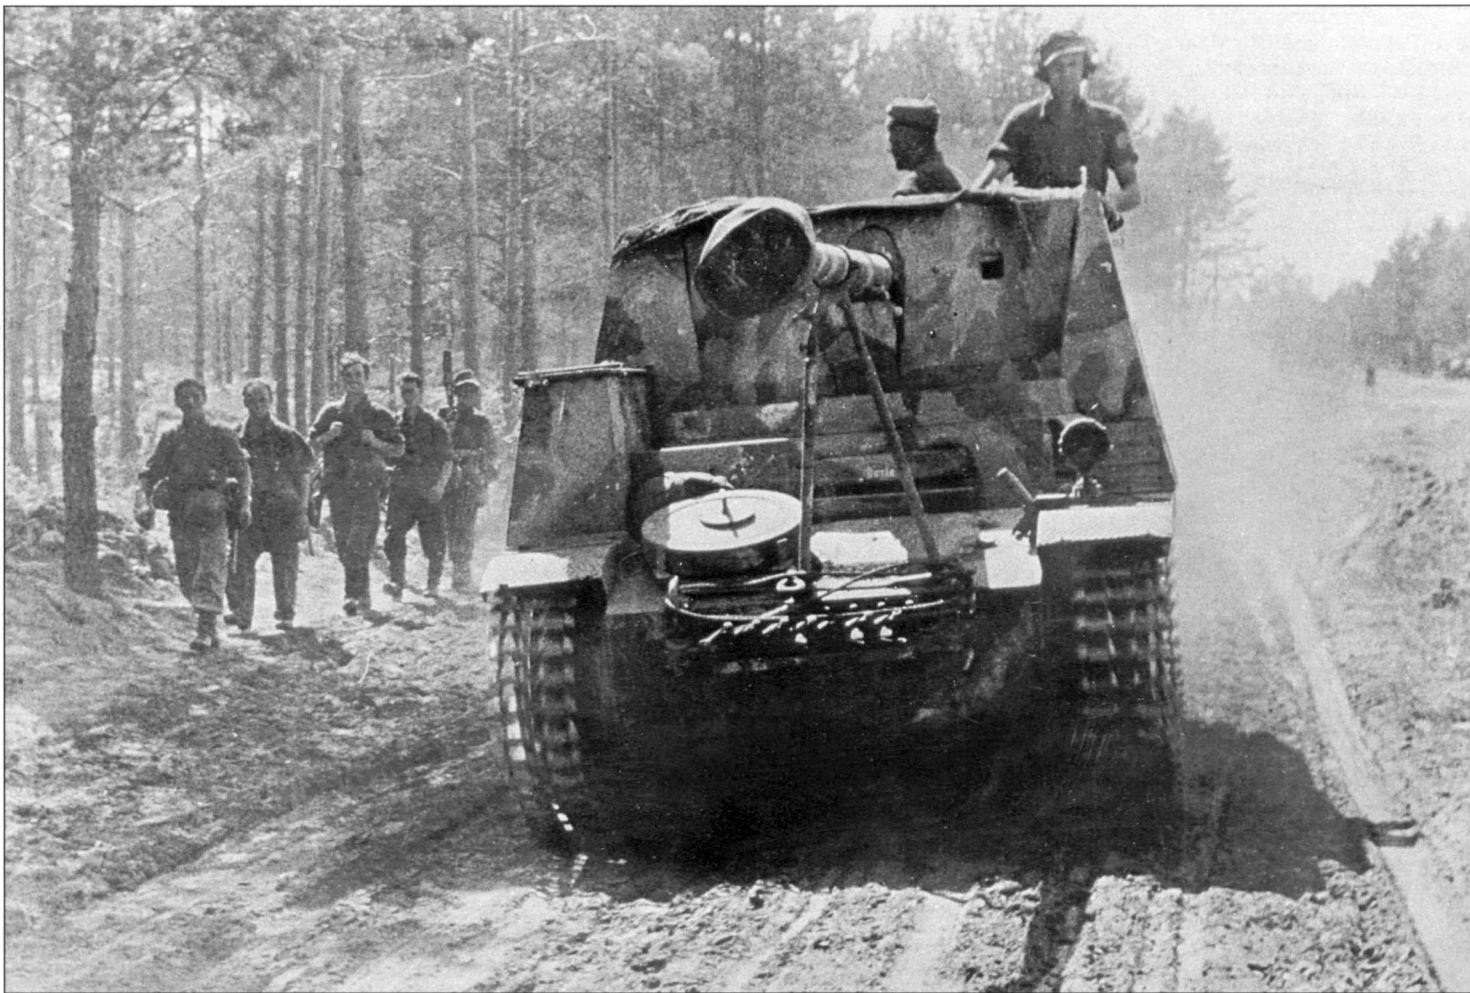
Another stop-gap solution was the Marder II. The German 7.5cm Pak 40 was fitted onto the hull of the Pz.Kpfw. II, thus creating yet another tank hunter. This vehicle features a three-tone camouflage scheme applied with a brush. Close scrutiny of the photo will reveal the name of the driver's wife, Dorle, painted on the visor.

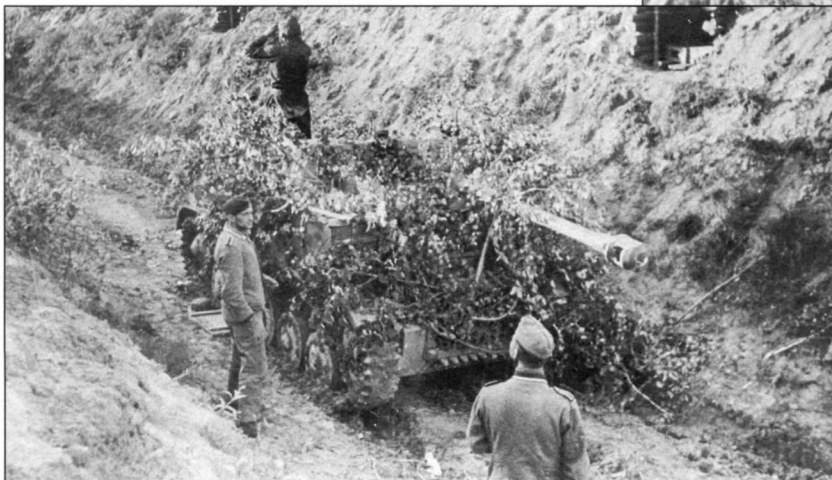
Ready to unleash the deadly force of its 7.5cm Pak 40 gun, a perfectly camouflaged Marder II seeks cover in a ravine. Before the tank destroyer goes back into combat, some of the foliage used to hide it will be removed to give the gunner a clear view through his telescope.

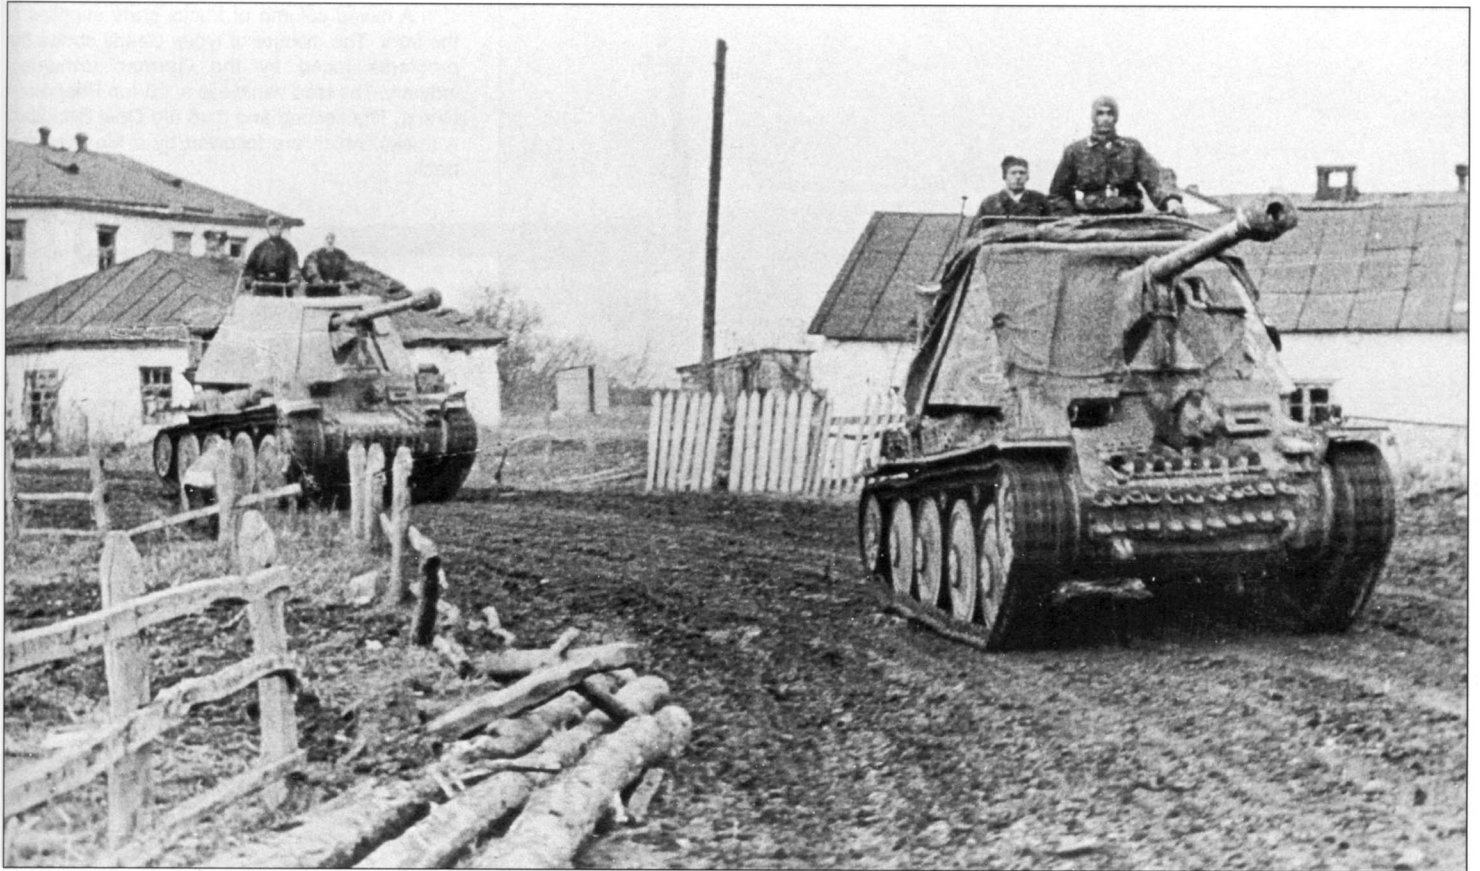
A pair of Marder III Ausf. H maneuvers through a village. Based on the hull of the Pz.Kpfw. 38(t), this tank hunter used the German 7.5cm Pak 40. The lead vehicle is thoroughly camouflaged, while the second is finished in plain dark yellow. Living and fighting in these tiny vehicles was not easy, and the crew had no protection from the weather. Posing a danger to all Soviet tanks, these tank hunters had to rely on their speed and agility when changing position.

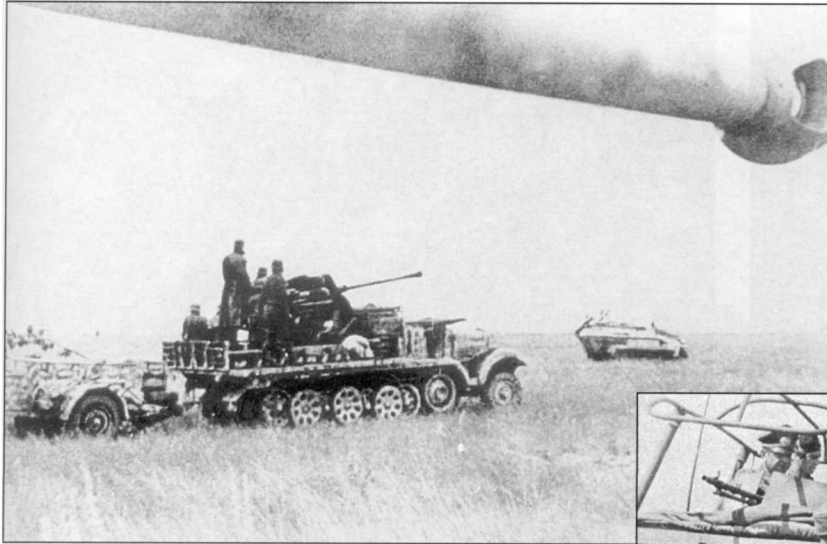
Supporting the advance of an APC section, a 3.7cm Flak 43 mounted on a 5-ton half-track waits for low-flying dive bombers. Combat tactics like this were hazardous for the half-track crews since they enjoyed no protection at all. Losses were very high in the *Sturmflak* units.

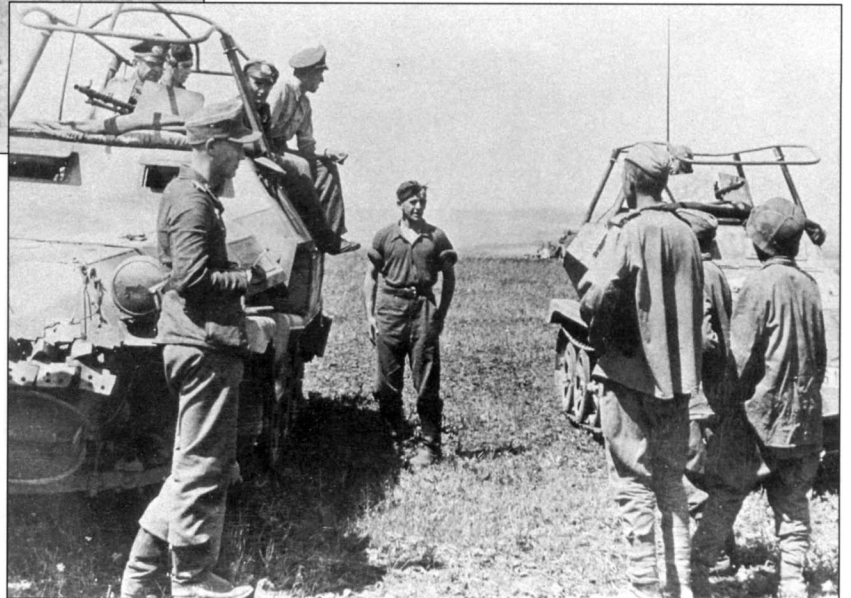
Officers of a *Panzergrenadier* unit interrogate Russian prisoners of war. The vehicle at left is a Sd.Kfz. 251/6 (Ausf. C), the one at right a Sd.Kfz. 250/3. Both vehicles were prime targets for enemy guns because they were easily recognizable from a distance as command vehicles due to their conspicuous frame antennas.

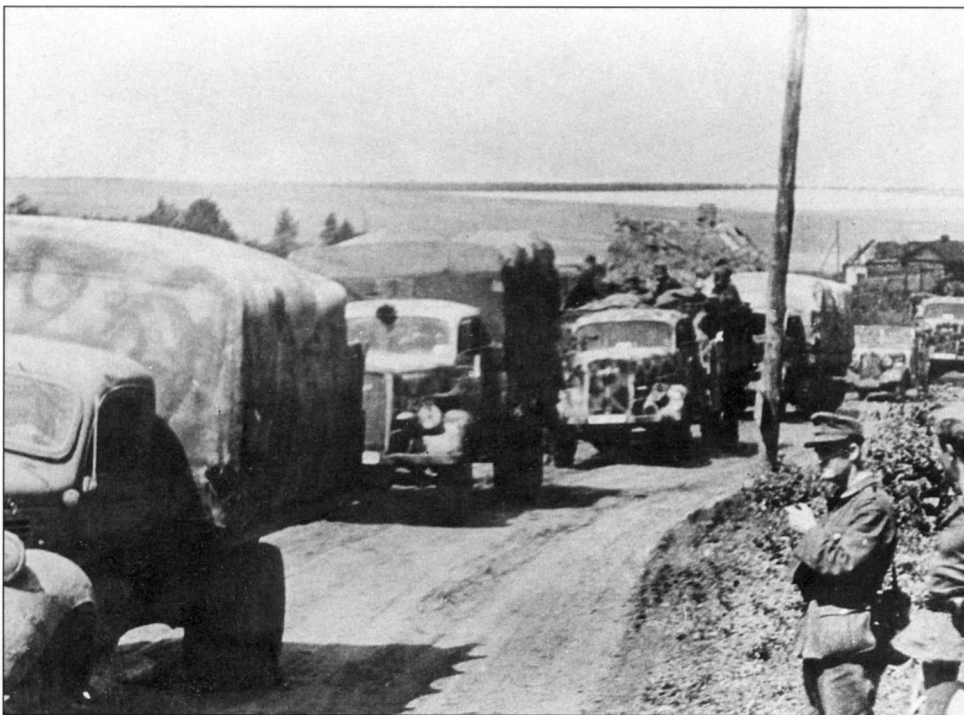
A mixed column of trucks carry supplies to the front. The mixture of types clearly shows the problems faced by the German armament industry. The lead vehicle is a 1.5-ton Phenomen Granit. The second and third are Opel Blitz 3000 A trucks, which are followed by a Maultier half-track.

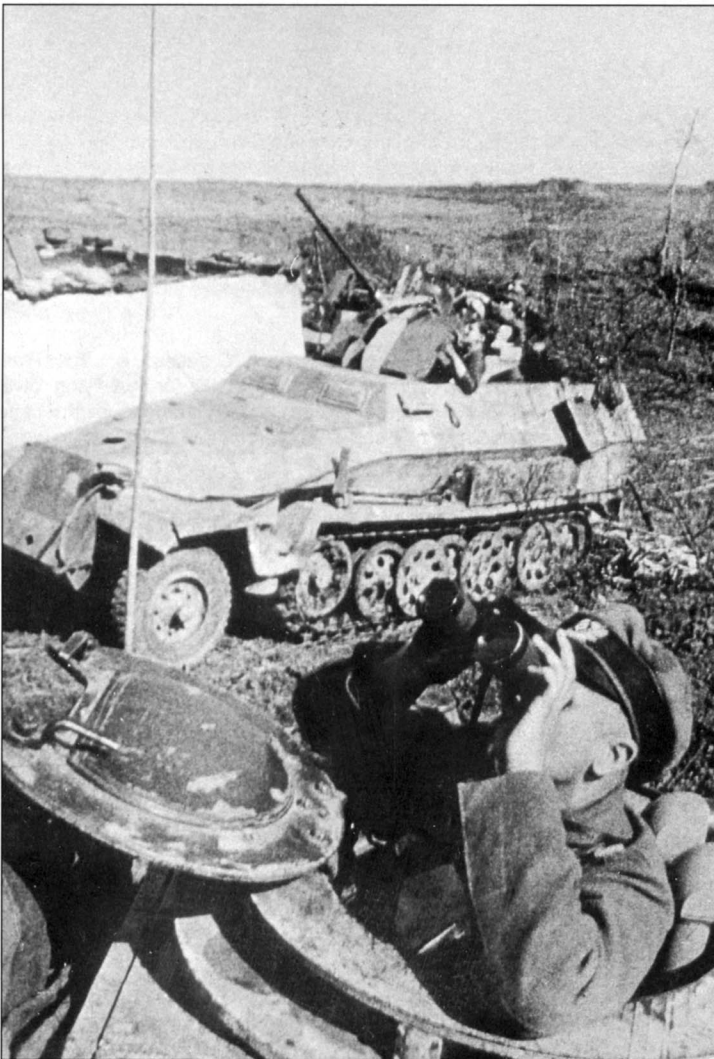
One of the more rare vehicles used by the *Wehrmacht* was the Sd.Kfz. 251/17. Designed as an armored anti-aircraft gun, this weapon mounted the 2cm Flak 38 in the cramped crew compartment of a medium APC. This vehicle did not prove to be practical, however. Side traverse was not sufficient, and limited elevation made engagement of ground targets impossible.

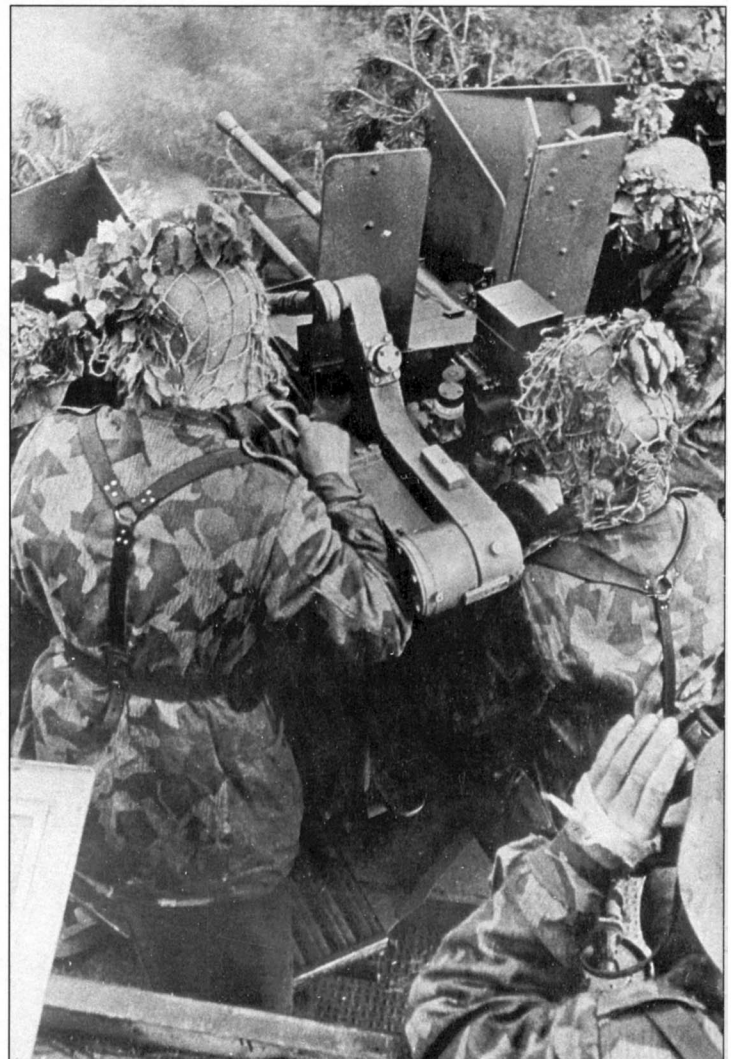
Engaging a ground target, this quadruple *Flakvierling* fires with all barrels. Offering a high rate of fire, these guns were very effective against soft targets. The loading of ammunition was complicated, however. Each gunner had to take care of two guns, changing the 20-round magazines every few minutes. This procedure was not easy as both gunners had to coordinate the exchange with the gunner.
