PANZERWAFFE AT WAR

(2) MOSCOW TO BERLIN

Robert Michulec & Thomas Anderson

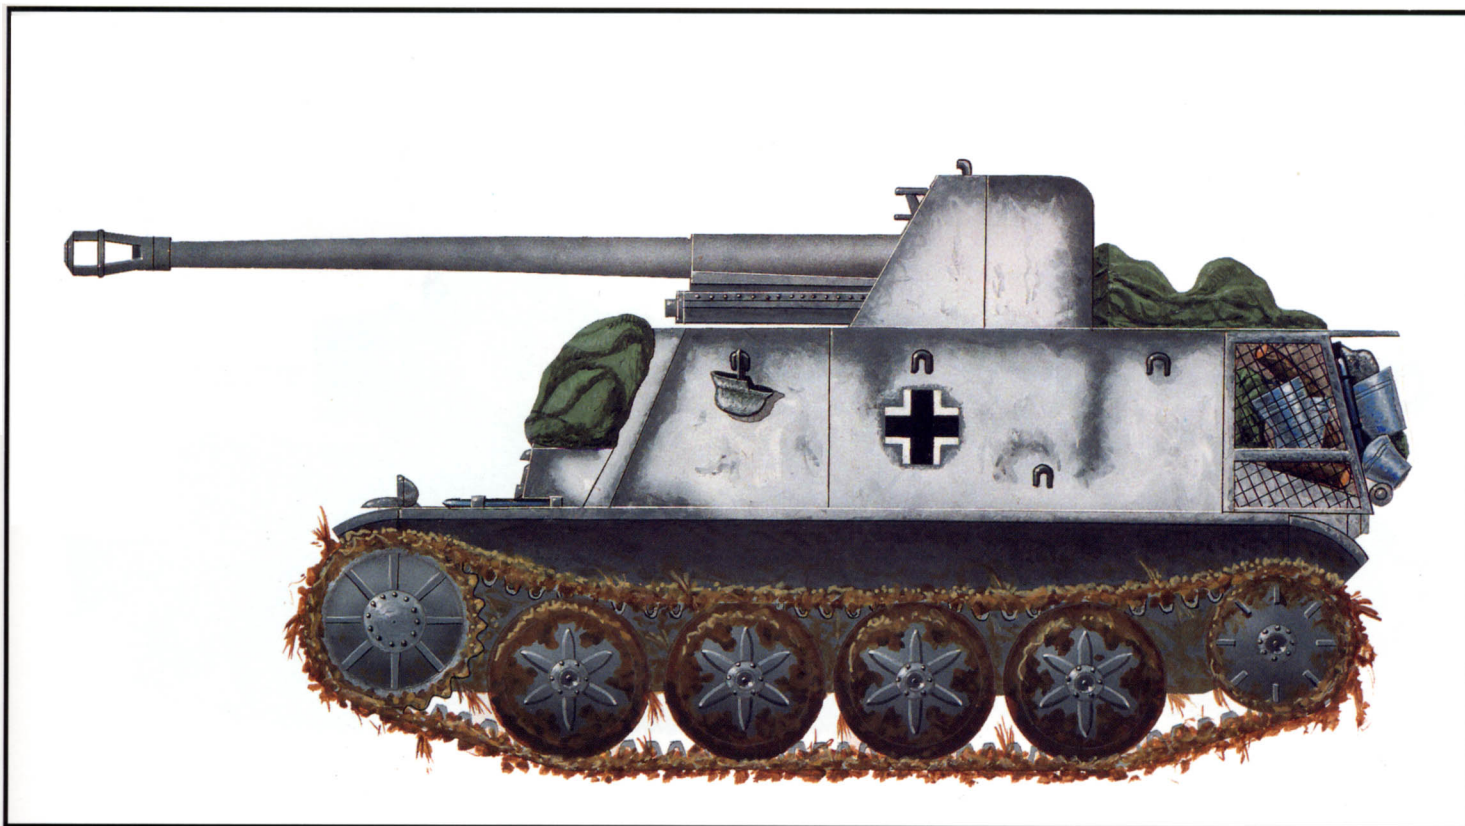
Marder II (7.62cm Pak 36(r) auf Pz.Kpfw. II Ausf. D/E), unidentified unit, Stalingrad, winter 1942/43

This tank hunter is camouflaged with a scruffy winter whitewash over a dark gray base color (RAL 7021). Unlike one year earlier, the units at this time were supplied with appropriate equipment and paint. The vehicle displays a prominent German cross, but no further markings. With the spring coming, the first rains slowly but surely washed off the paint. With the addition of mud, the vehicles blended well with the surroundings.

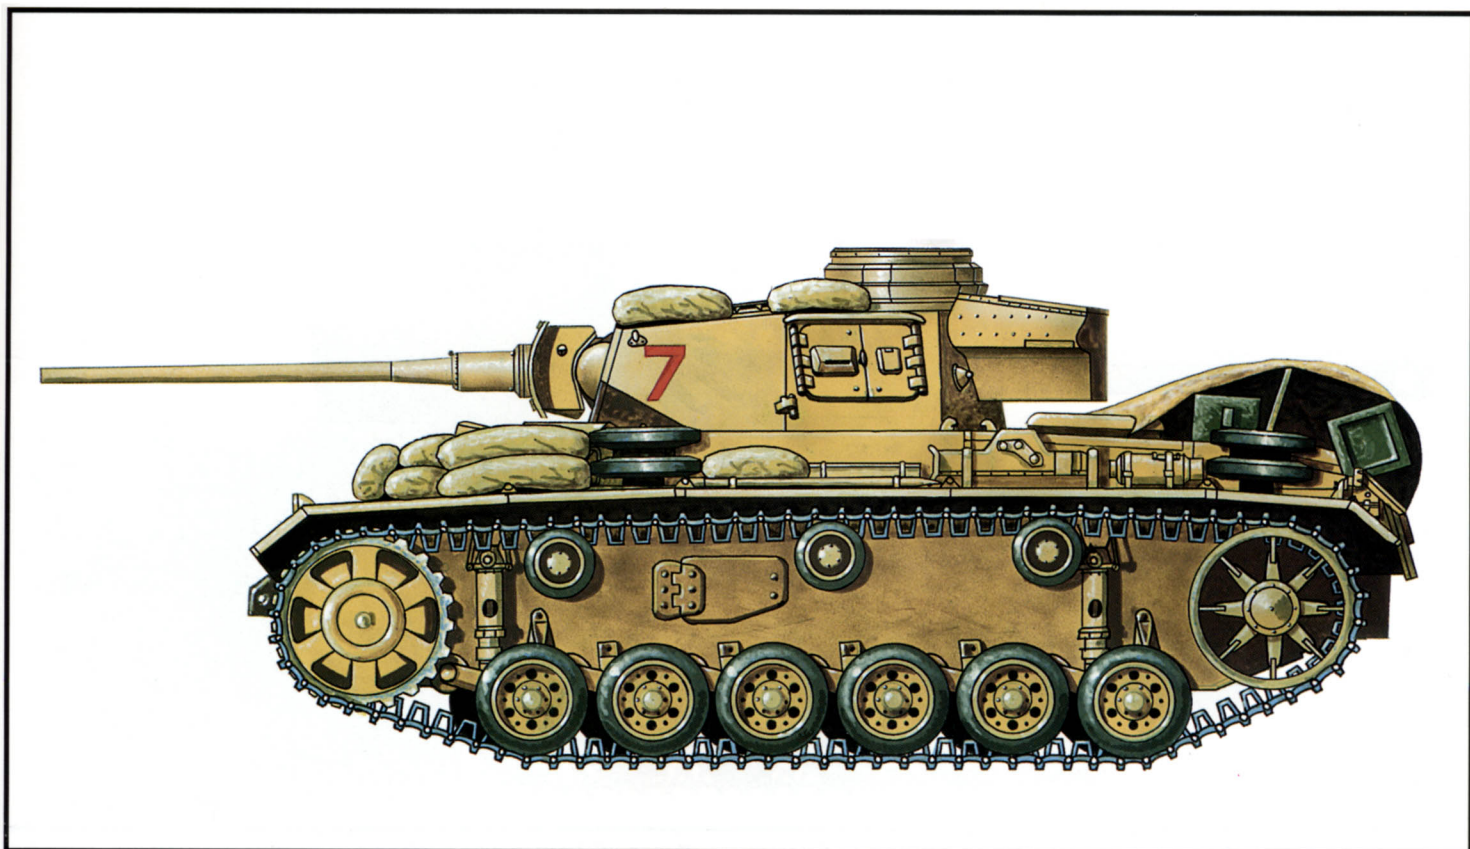
Pz.Kpfw. III Ausf. L, 10.Panzer-Division, Tunisia, late 1942

Toward the end of hostilities in North Africa, the Germans used different camouflage colors. This Pz.Kpfw. III Ausf. L is finished in RAL 8020 desert yellow. Some units used a second color, RAL 7027 light brown, for camouflage. The only visible marking consists of a red '7', which denotes the company. The ubiquitous dust of the region would have covered the entire vehicle under a heavy layer of natural camouflage.

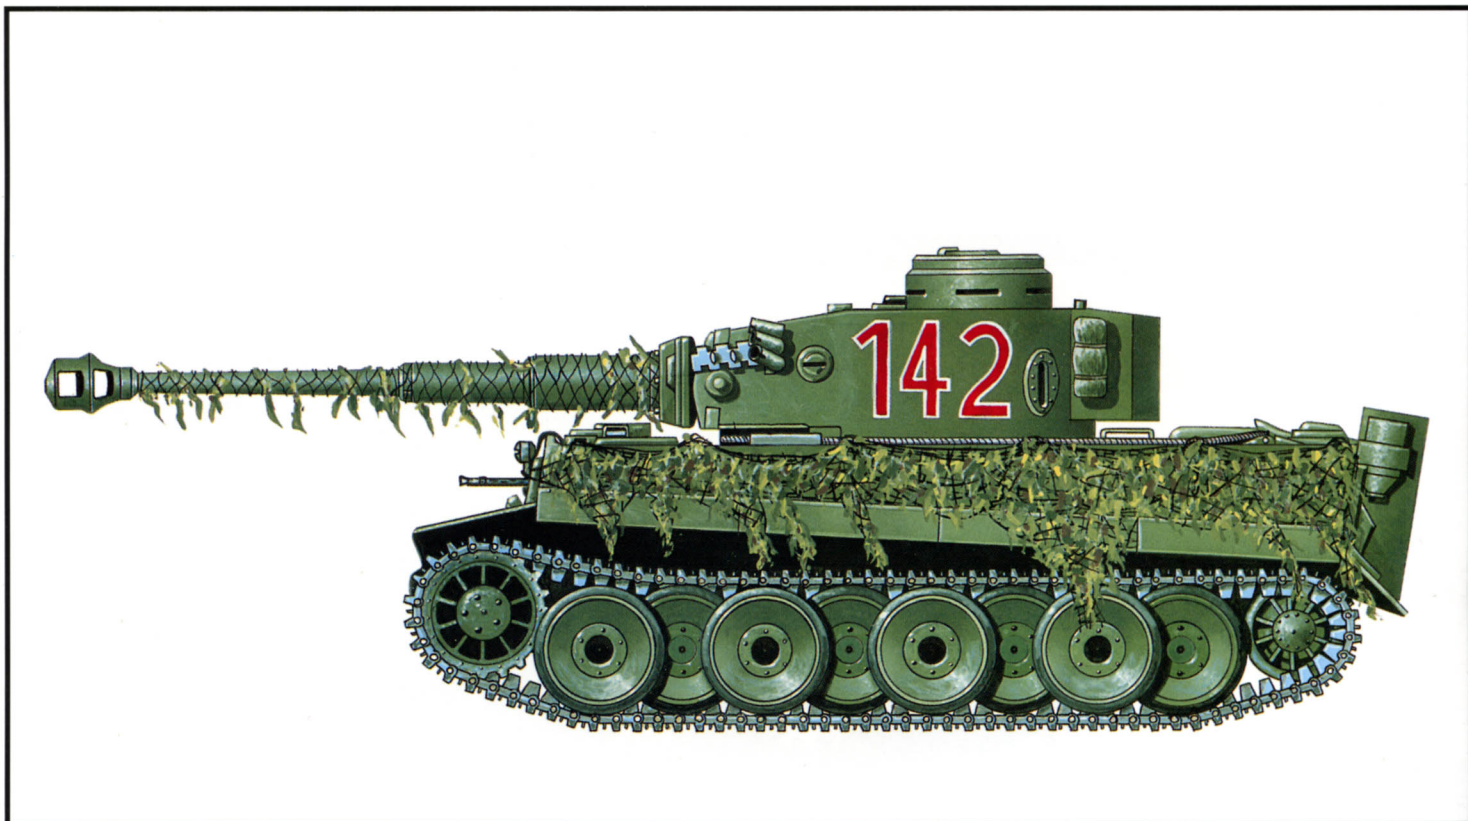
Pz.Kpfw. VI Ausf. E Tiger, s.Pz.Abt.501, Tunis, spring 1943

Some of the vehicles of s.Pz.Abt.501 were finished in an unofficial light olive green. This paint was probably chosen by the unit because the terrain of Tunisia consisted more of green shades. The tank carries prominent tactical numbers on its turret, which made direction for the Abteilung commander easy. A camouflage net was used to further conceal the vehicle.

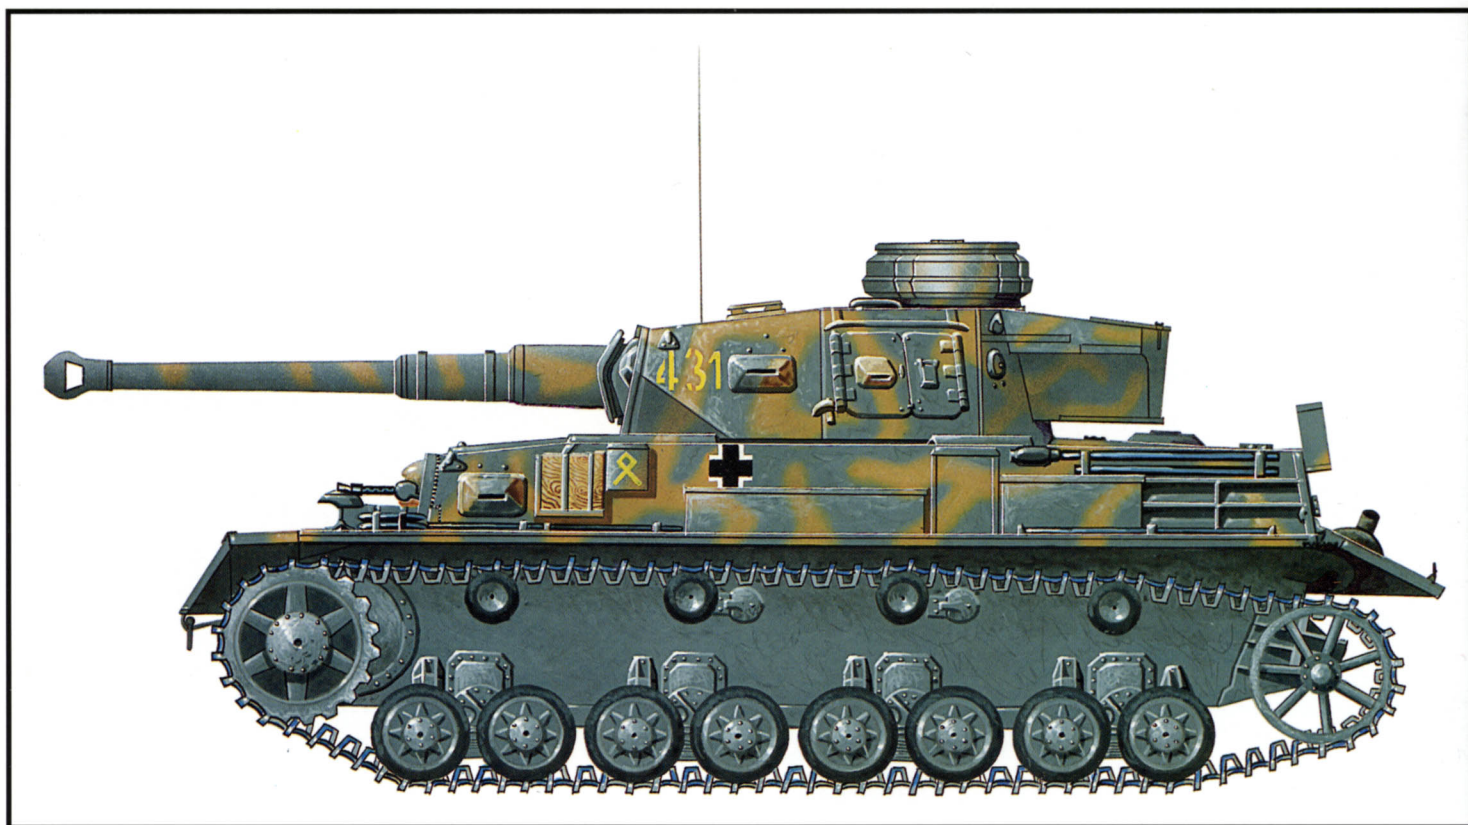
Pz.Kpfw. IV Ausf. F2, Pz.Rgt.36, 14.Panzer-Division, Russia, southern district, spring 1943

When new camouflage colors were introduced, the tank units would receive the paint to redo their vehicles. Although tanks were normally not overpainted near the front lines, some vehicles received irregular camouflage patterns applied with these paints. This Pz.Kpfw. IV is decorated with narrow lines of RAL 7028 dark yellow over a dark gray base color. The shape of the tank was effectively broken up by the paint scheme, and local mud or dust would further conceal the tank.

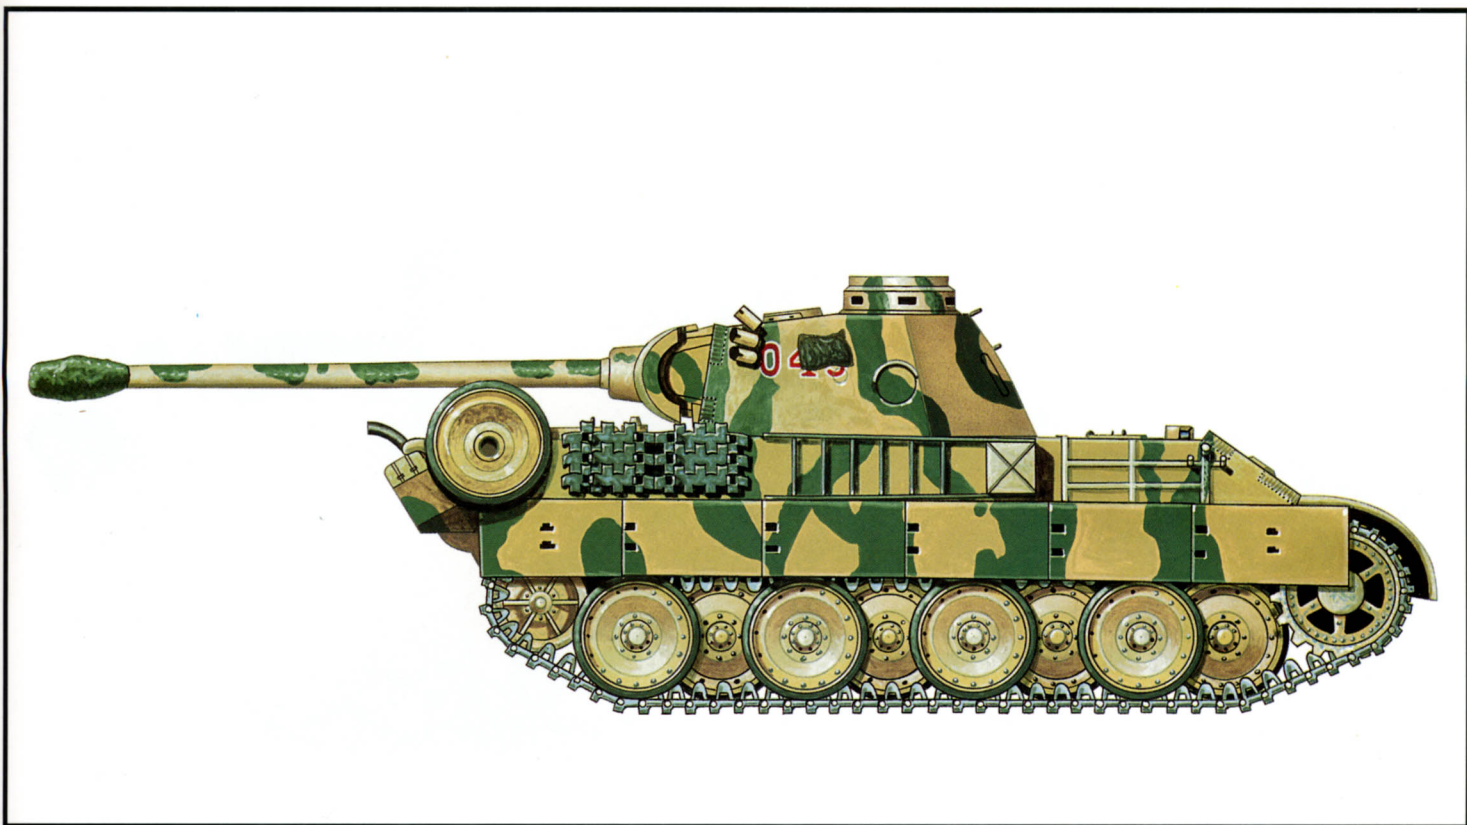
Pz.Kpfw. V Ausf. D, Pz.Abt.51, Kursk area, July 1943

All German tanks sent to the Eastern Front in the spring of 1943 were delivered in dark yellow (RAL 7028 or something similar). The units were provided with camouflage colors, and they then painted their tanks according to the surroundings. In this example, Pz.Abt.51 applied dark green stripes, which was the typical mid-1943 scheme. The turret number '045' denotes the tank as being a staff vehicle.

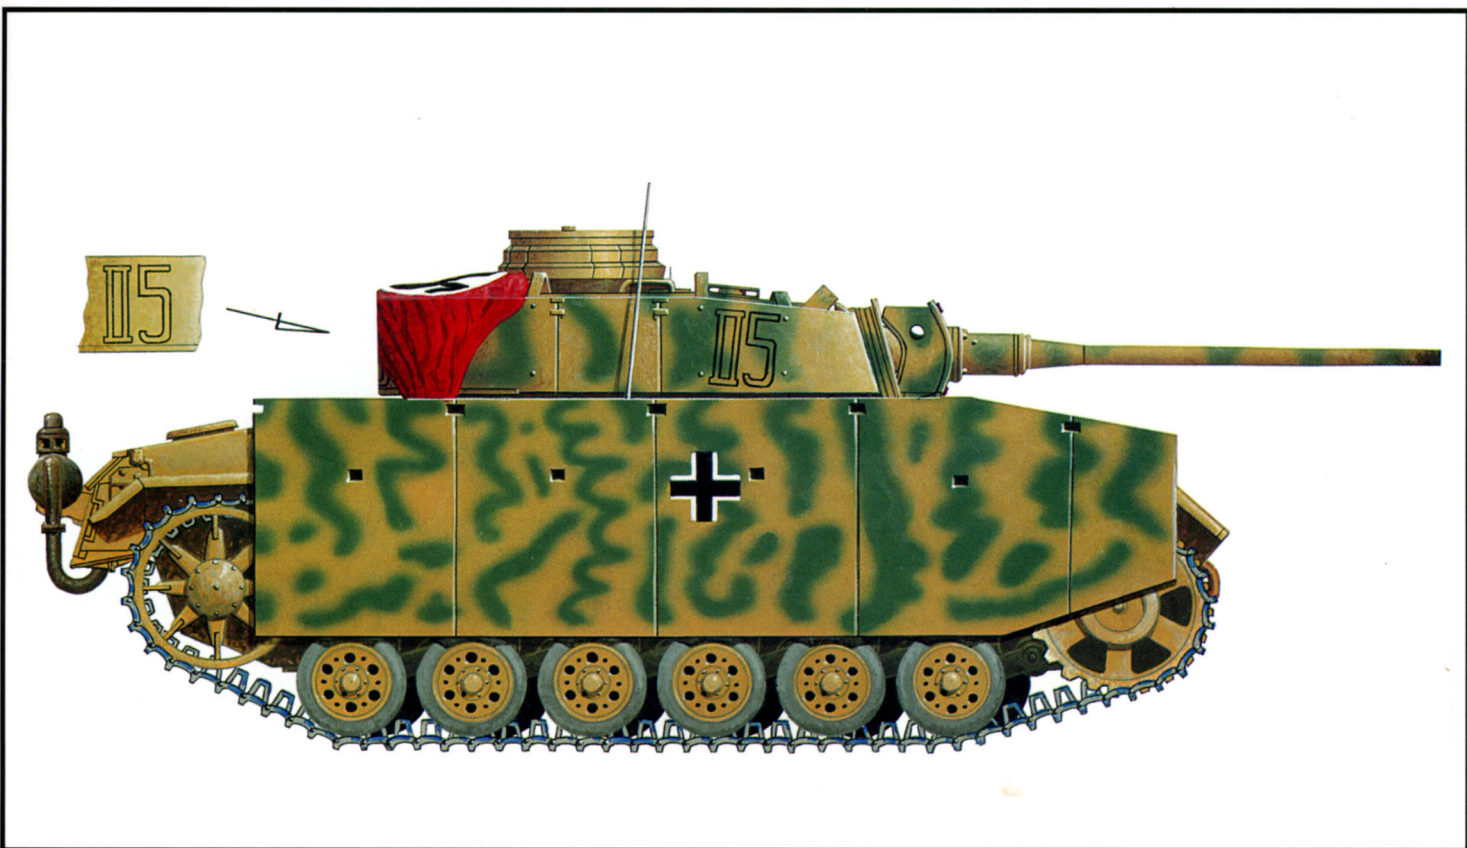
Pz.Kpfw. III Ausf. M, unidentified unit, Kursk area, summer 1943

Another fine example of a typical mid-1943 pattern, this Pz.Kpfw. III Ausf. M, which belongs to an unknown unit, is camouflaged with irregular narrow dark green stripes over a dark yellow base. Large German crosses have been painted on the hull side skirts. This tank was another staff vehicle of the II.Abteilung of the regiment. A Nazi flag is spread over the turret basket for air recognition.

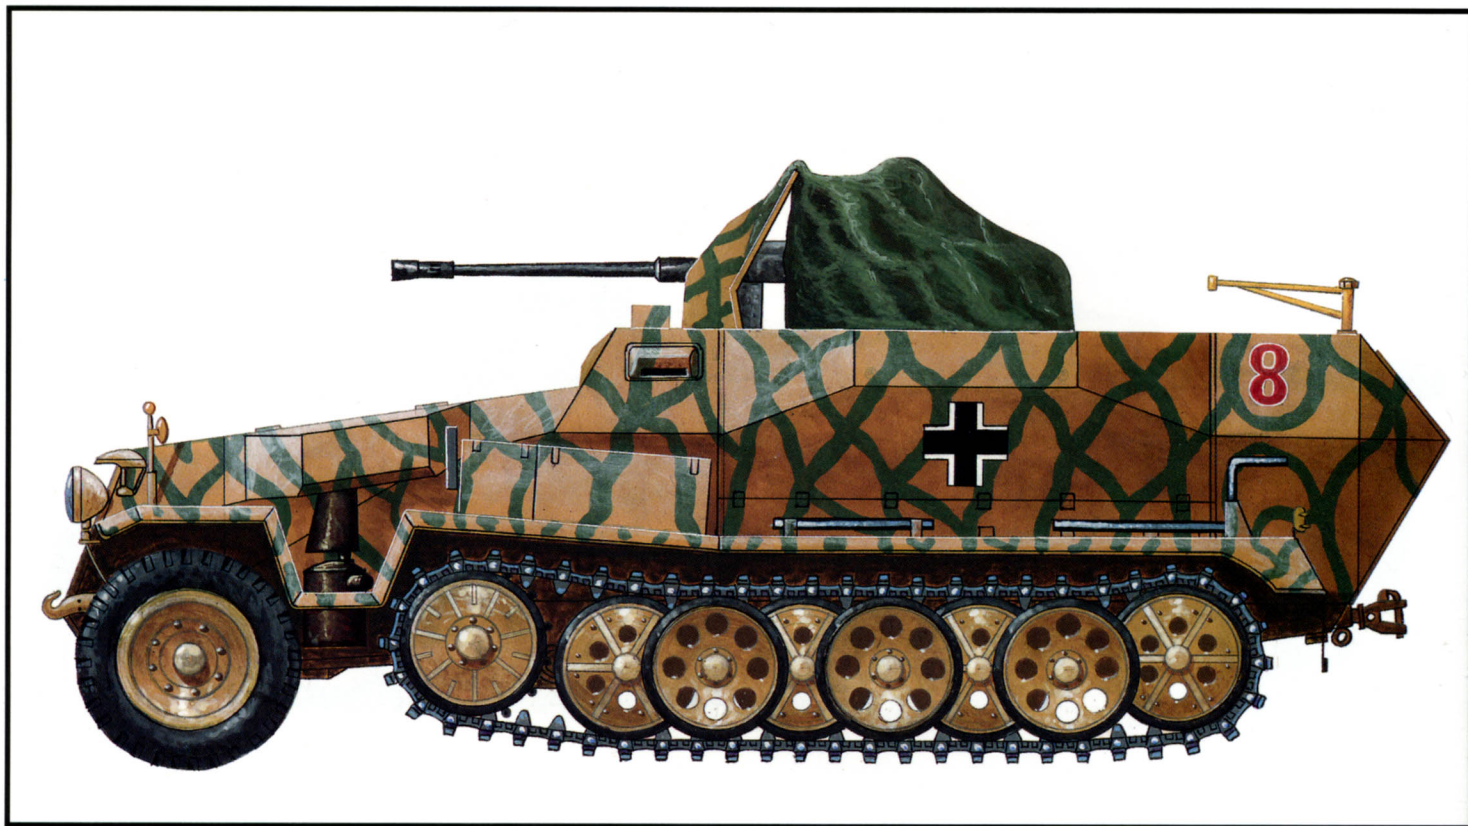
Sd.Kfz. 251/17, Panzer-Division 'Hermann Göring', Sicily, summer 1943

This armored half-track is one of the few produced with its superstructure widened to accommodate the 2cm Flak 38 gun. The vehicle wears the 1943-pattern camouflage. In this case, the dark green stripes were painted rather than sprayed over the dark yellow base. The red number identifies the Sd.Kfz 251 as the eighth vehicle of its company.

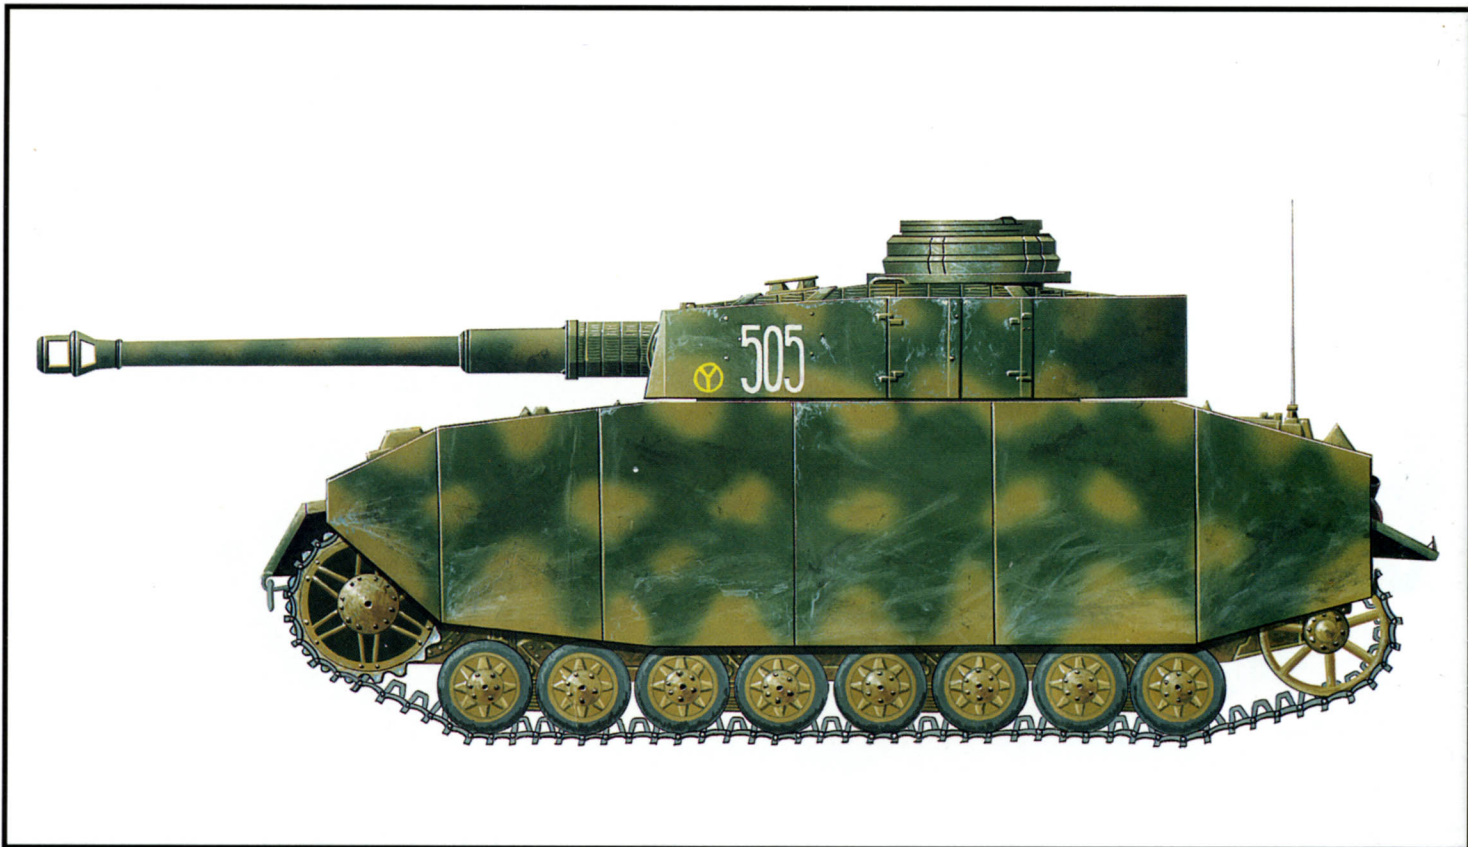
Pz.Kpfw. IV Ausf. H, Pz.Rgt.29, 12.Panzer-Division, central Russia, autumn 1943

This Pz.Kpfw. IV Ausf. H is a fine example of how the 1943-pattern camouflage could be adapted to local conditions. In an area of lush vegetation, Pz.Rgt.29 increased the proportion of dark green, creating a spider's web of green stripes over the vehicle's dark yellow base. The vehicle features both the tactical number and division insignia painted on the turret skirts.

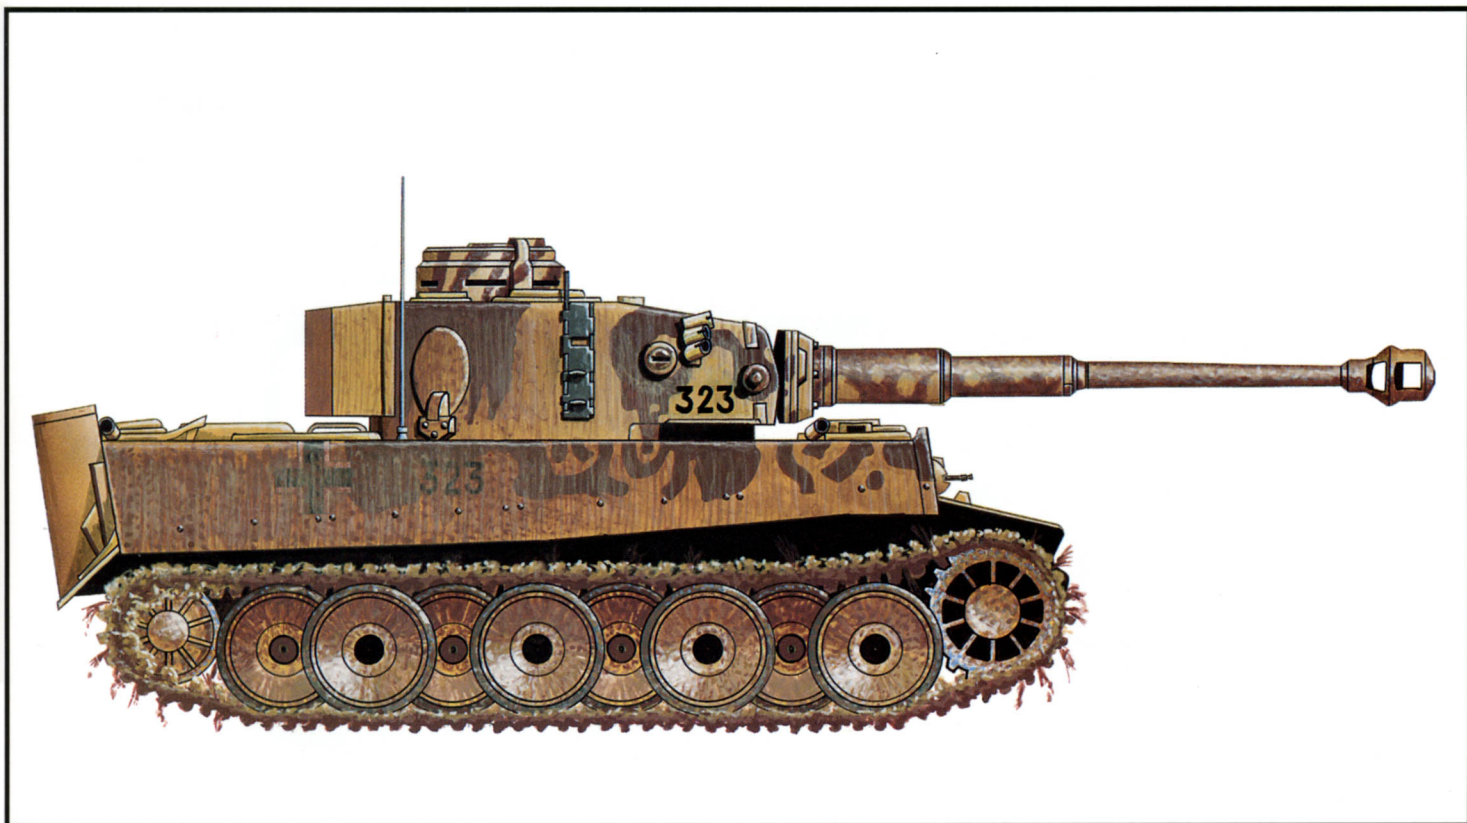
Pz.Kpfw. VI Ausf. E Tiger, s.Pz.Abt.502, Russia, late 1943

This Tiger of s.Pz.Abt.502 wears a camouflage scheme typical for the autumn, and for southern Russia's dry climate. Large brown blotches (RAL 8017) have been applied to the dark yellow base. Often enough, the vehicles were covered with mud to further help them blend in with the surroundings. Small turret numbers are visible painted in black. Note that the mudguards are missing.

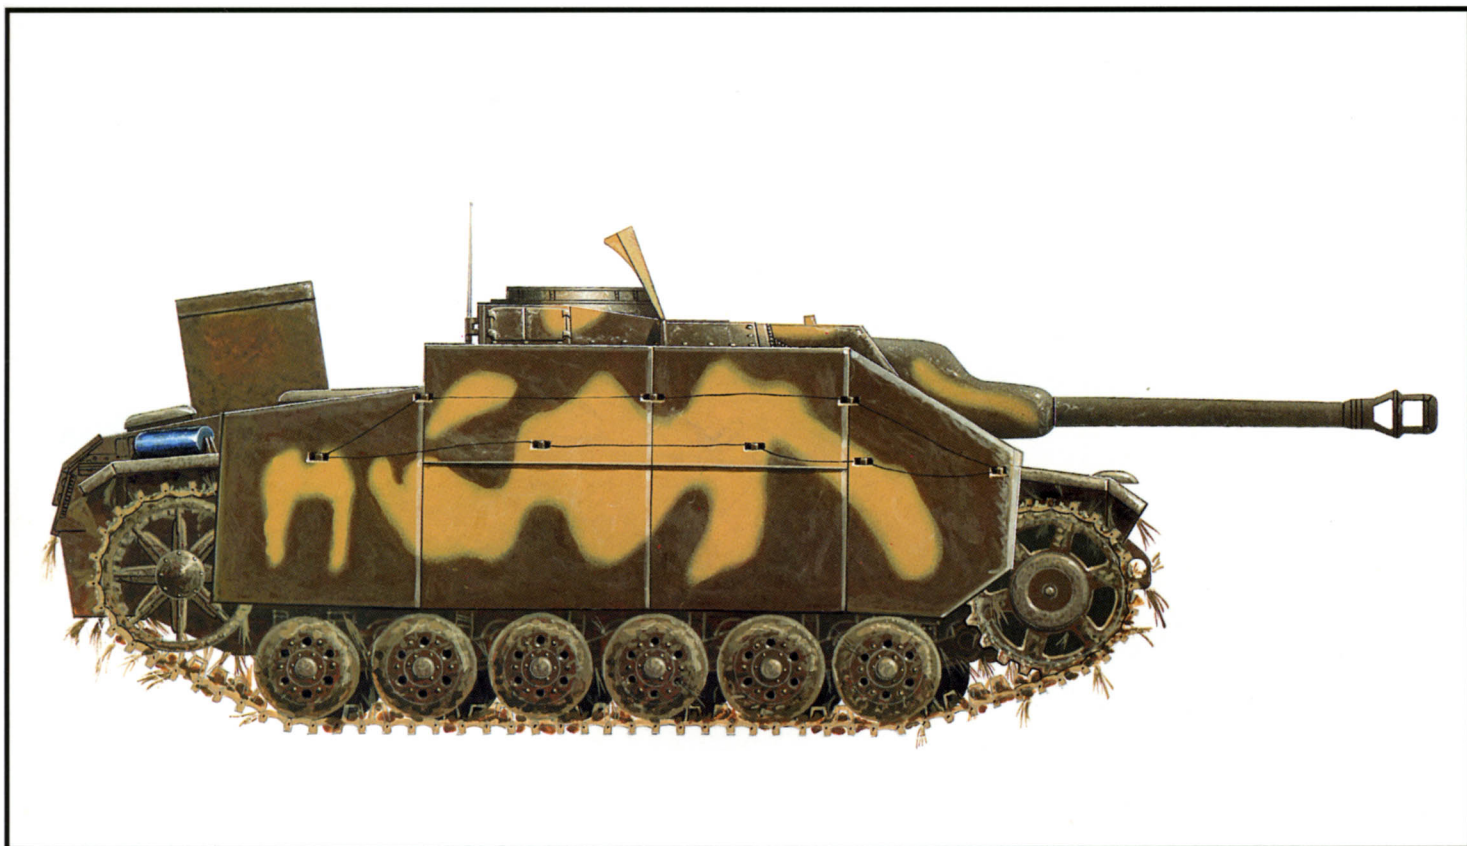
StuG III Ausf. G, unknown StuG.Brig., southern Russia, spring 1944

Very similar to the Tiger above, this StuG III Ausf. G shows a brown (RAL 8017) camouflage scheme applied in broad lines over the dark yellow base. Relatively little remains of the base color. This mid-production StuG is fitted with the late-style Saukopf mantlet, and a large crate is located on the engine deck, which was typical for StuG units.

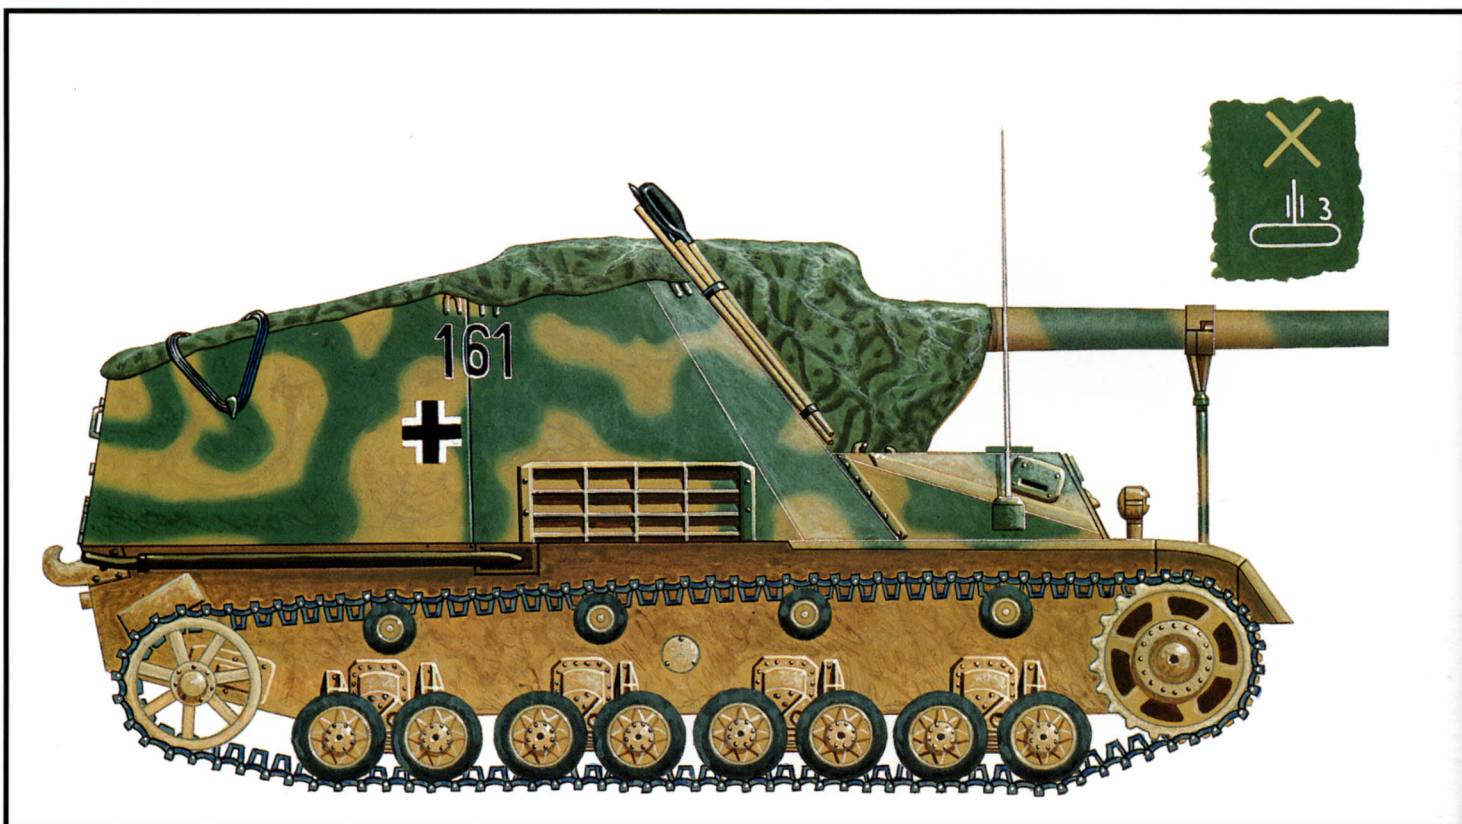
15cm s.FH 18 auf Gw III/IV Hummel, Pz.Art.Rgt.116, Russia, summer 1944

Painted in a standard summer camouflage scheme, this Hummel was finished with dark green stripes over dark yellow. The vehicle shows a full array of markings. The vehicle number and German cross were applied to the superstructure's sides. The tactical sign of the 3rd heavy battery, as well as the 5.Panzer-Division's symbol, were painted on the left front of the superstructure.

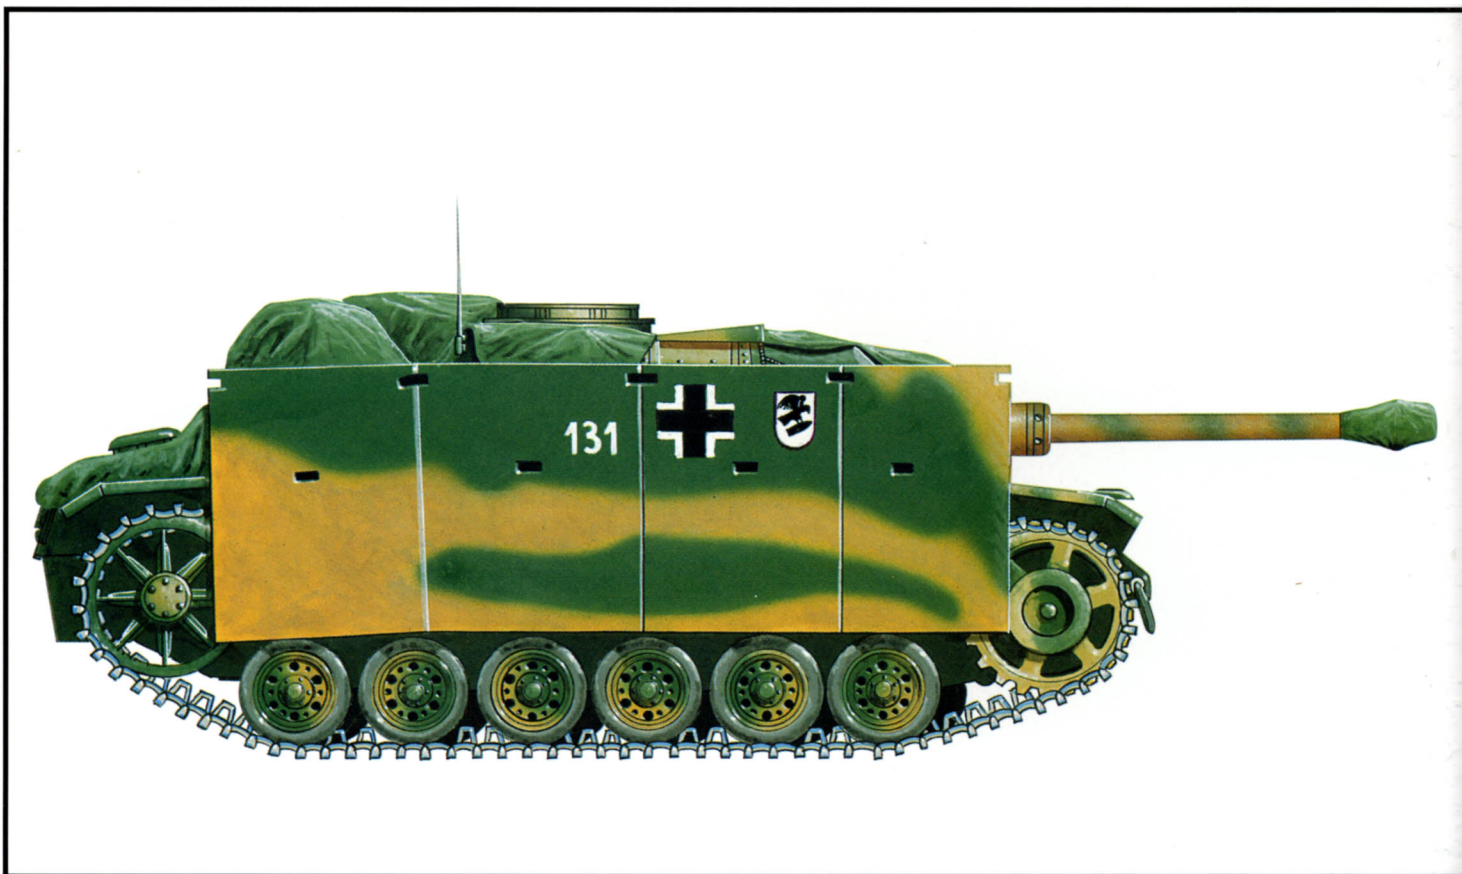
StuG III Ausf. G, StuG.Brig.245, France, summer 1944

This StuG of StuG.Brig.245 shows yet another two-tone camouflage scheme. The interesting pattern shows dark green (RAL 6003) applied in broad horizontal stripes. The brigade insignia, the German cross, and the vehicle number are all painted on the side skirts.

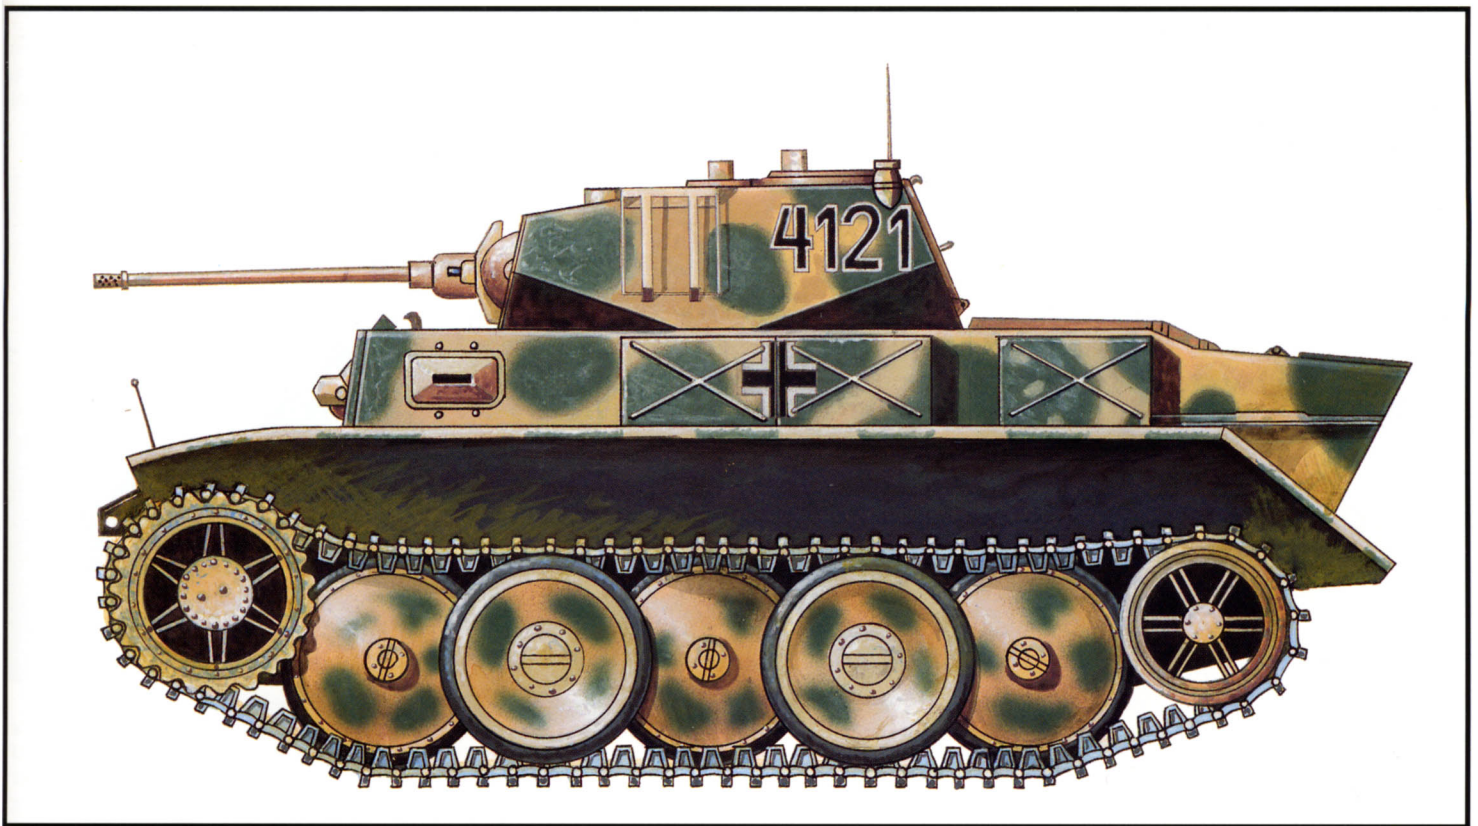
Pz.Kpfw. II Ausf. L Luchs, 116.Panzer-Division, France, summer 1944

This light reconnaissance vehicle is finished with small dark green blotches over a dark yellow base. The vehicle number '4121' was painted on the turret in black with white outline. These vehicles were very popular due to their high speed. They were occasionally called 'Mini-Panthers' by the US due to the similar running gear.

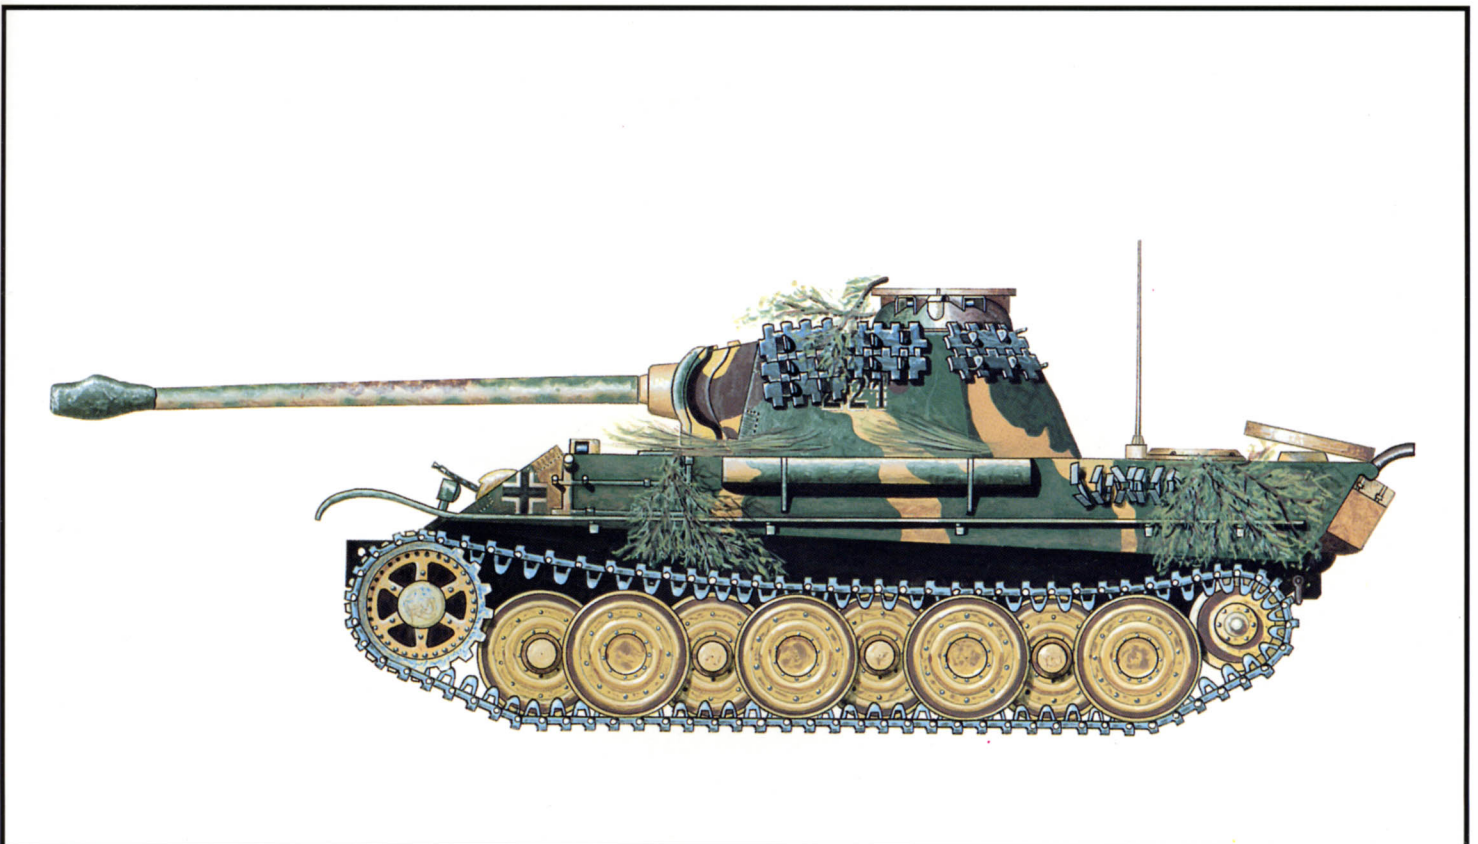
Pz.Kpfw. V Ausf. G Panther, unknown unit, Western Front, autumn 1944

This Panther shows the typical 1944 camouflage consisting of dark green and brown blotches over a dark yellow base. The proportion of the lighter dark yellow was decreased, making it more suitable for the temperate climate of middle Europe. German crosses and a low-visibility number were also applied. Typical for the Western Front, the vehicle is partially camouflaged with foliage.

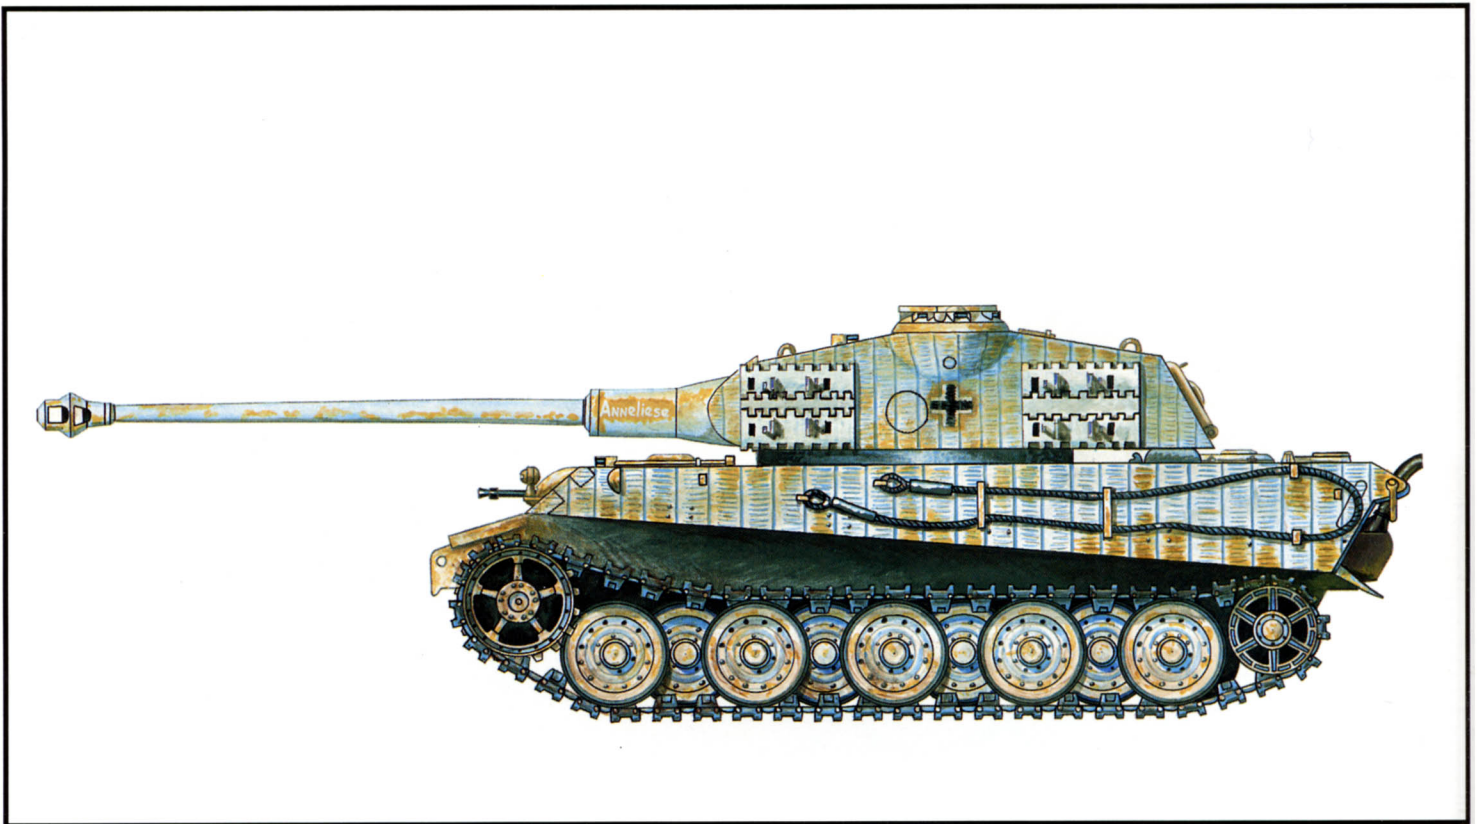
Pz.Kpfw. VI Ausf. B Tiger, s.Pz.Abt. 'Feldherrnhalle', Hungary, early winter 1945

This early-production Tiger Ausf. B was completely whitewashed to blend with the snow. The vehicle, which is equipped with the early Porsche-style turret, is completely covered with Zimmerit. Besides the German cross and the nickname 'Anneliese', no further markings are evident.

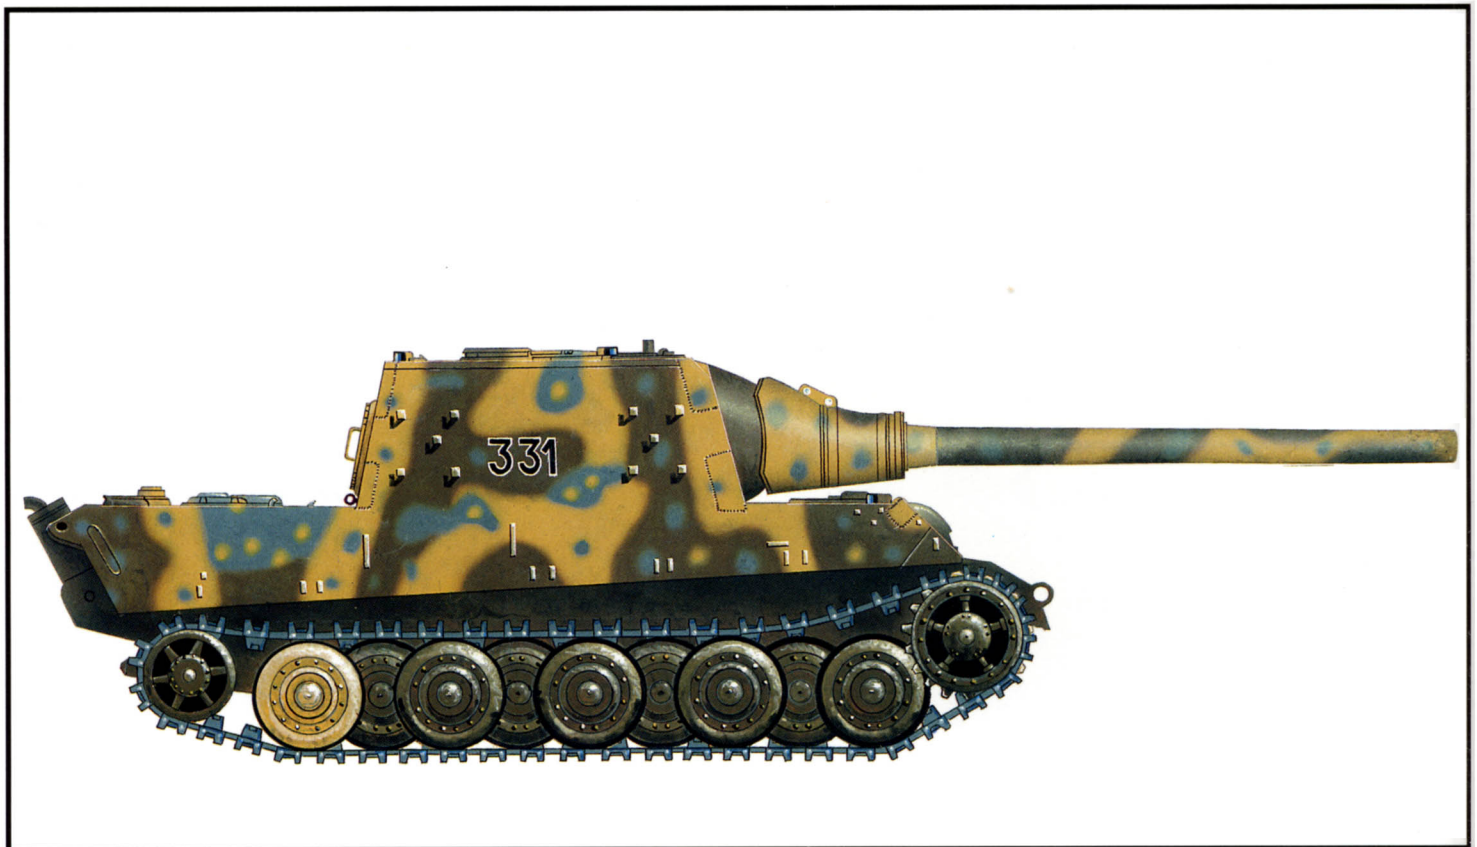
Jagdtiger, s.Pz.Jäg.Abt.512, Germany, spring 1945

This ultra-heavy tank hunter, the Jagdtiger, is decorated in a non-standard camouflage pattern. Towards the end of the war, supply problems forced the tank troops to use whatever was available to camouflage their vehicles. In this case, the Jagdtiger was delivered wearing only a coat of rust red primer. A camouflage pattern of dark yellow and dark gray (RAL 7021) was then sprayed over this base.

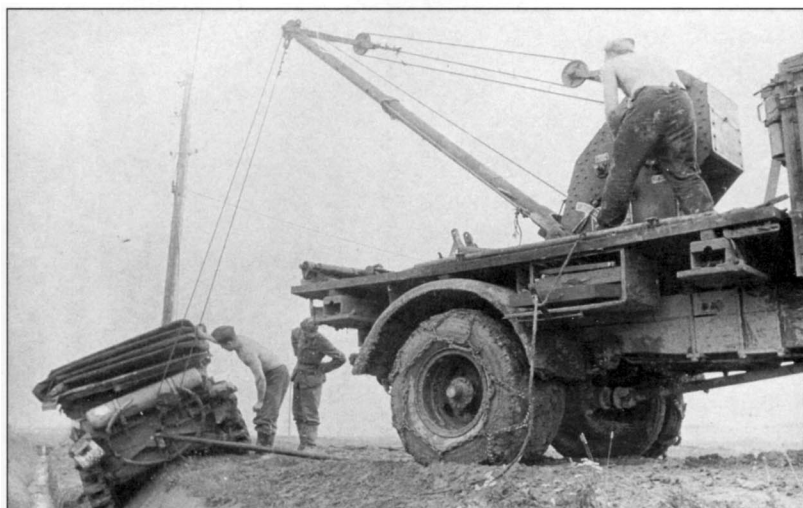
A 4.5-ton lorry (possibly a Büssing) recovers a Demag 1-ton half-track that has slipped off the road. The truck carries a Bilstein crane, which was standard equipment for workshop units. Note that winter-weather chains have been applied to the rear tires. An earlier recovery attempt using a towing bar failed, so the crane was put into action.
