PANZERWAFFE AT WAR

(2) MOSCOW TO BERLIN

Robert Michulec & Thomas Anderson

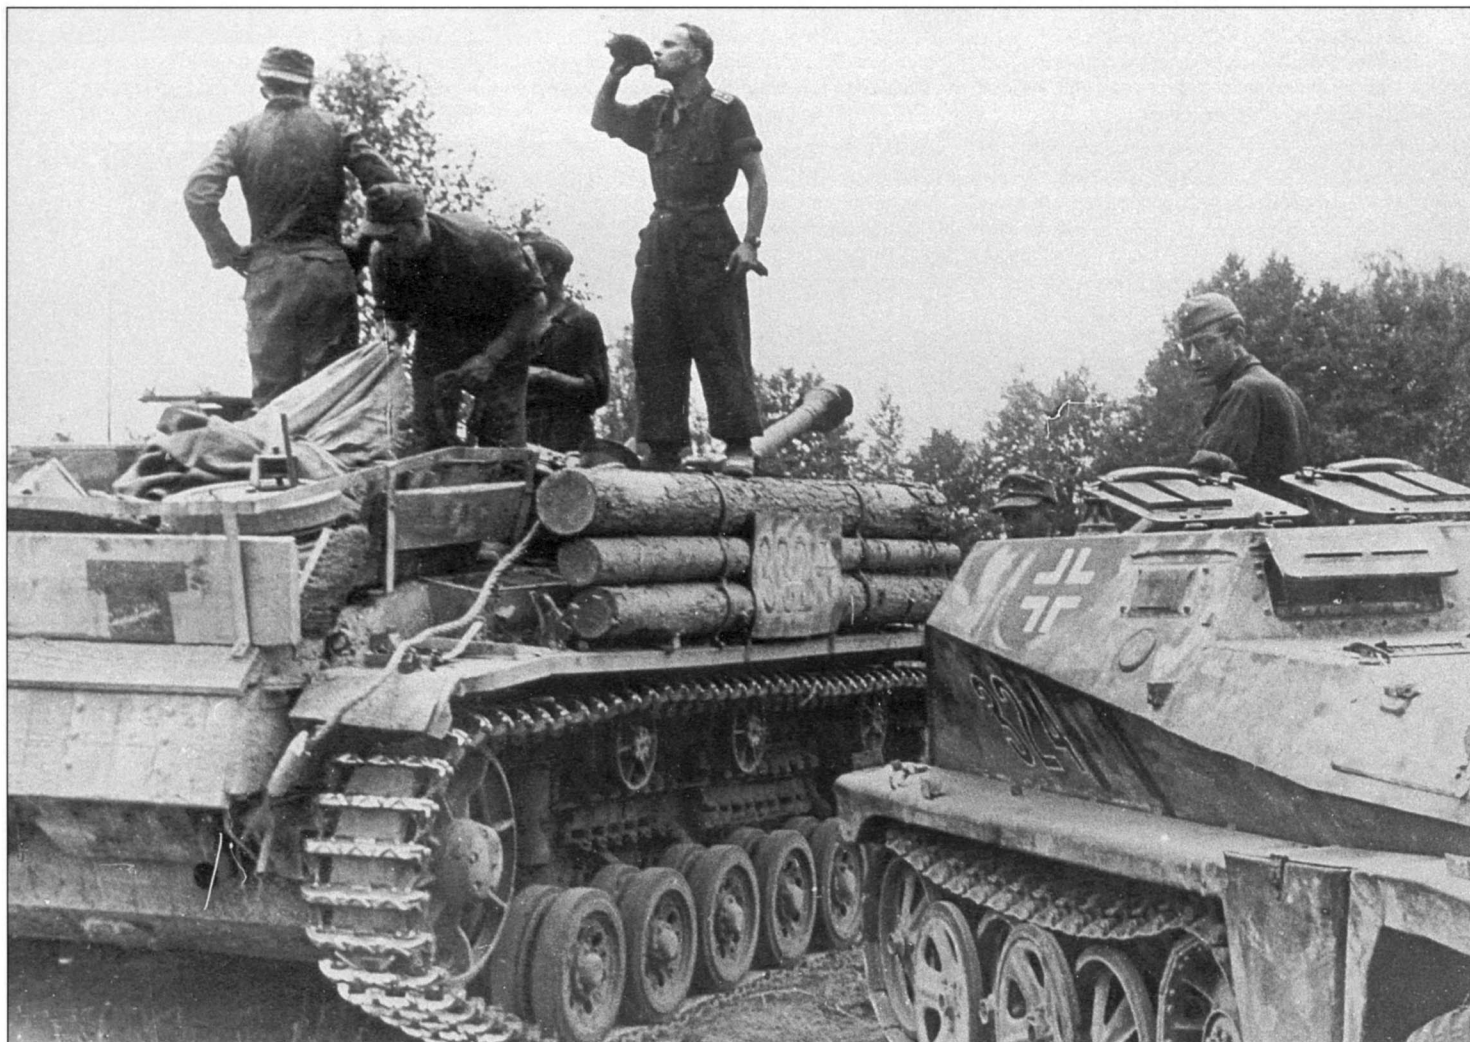
A surviving Sd.Kfz. 252 supplies a StuG III Ausf. G in mid-1943. The low silhouette of the half-track allowed it to be concealed easily during combat. The assault gun carries three long wooden beams on each side for additional 'armor' protection. The national marking and vehicle number are painted on a thin piece of sheet metal attached to the beams. The hull sides have been reinforced by sections of spare tracks.

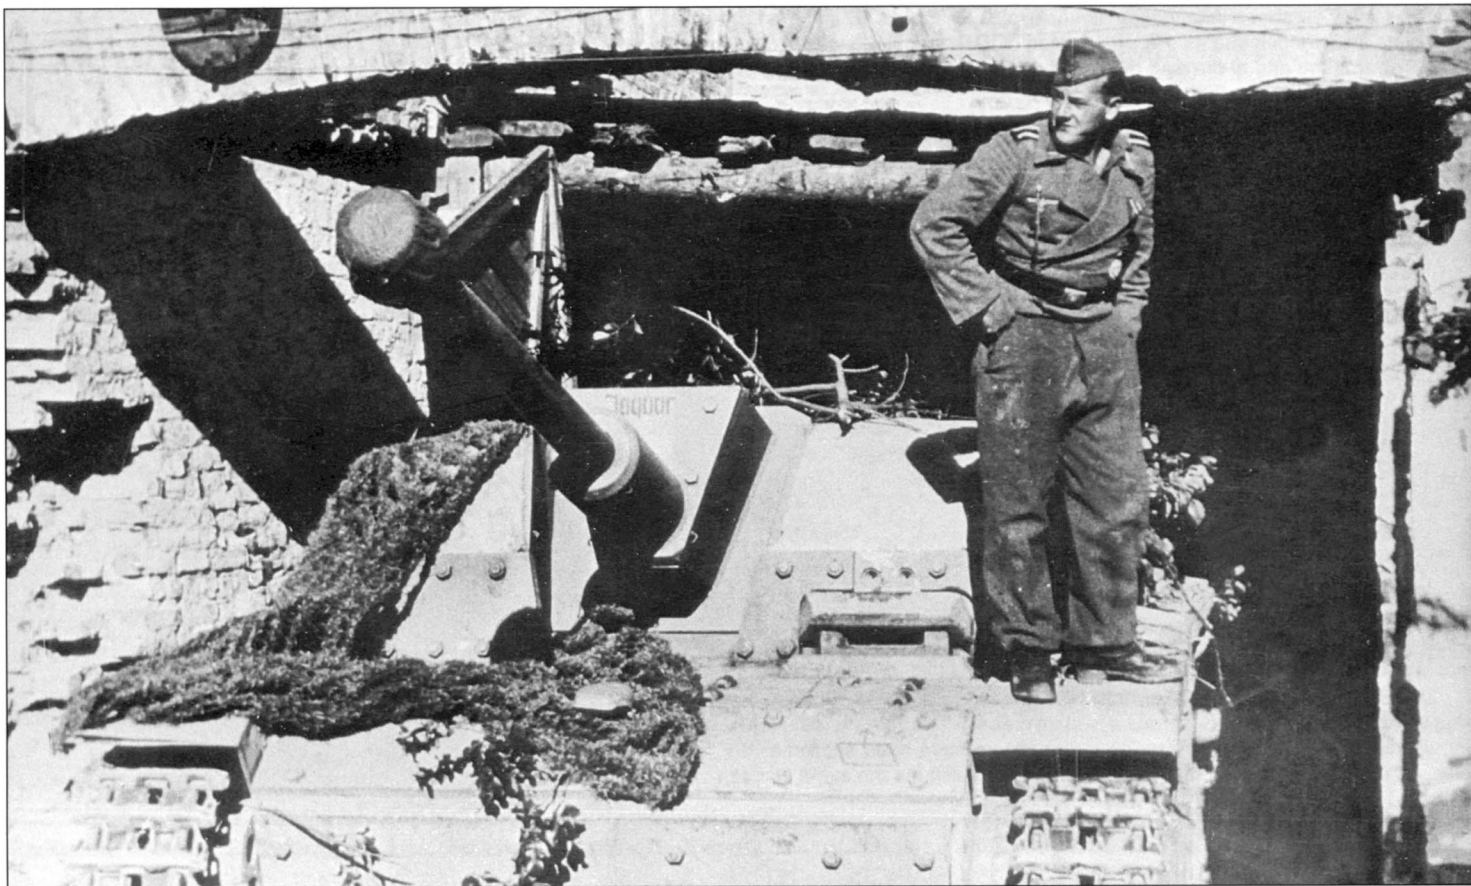
'Jaguar', a StuG III Ausf. G with extra bolted-on armor, has been moved into a garage. The assault gun is finished in plain dark yellow and displays its tactical sign on the left side of the nose plate. Assault gun units often gave names to vehicles, a practice that probably stemmed from the old German artillery tradition of denoting guns by letters.

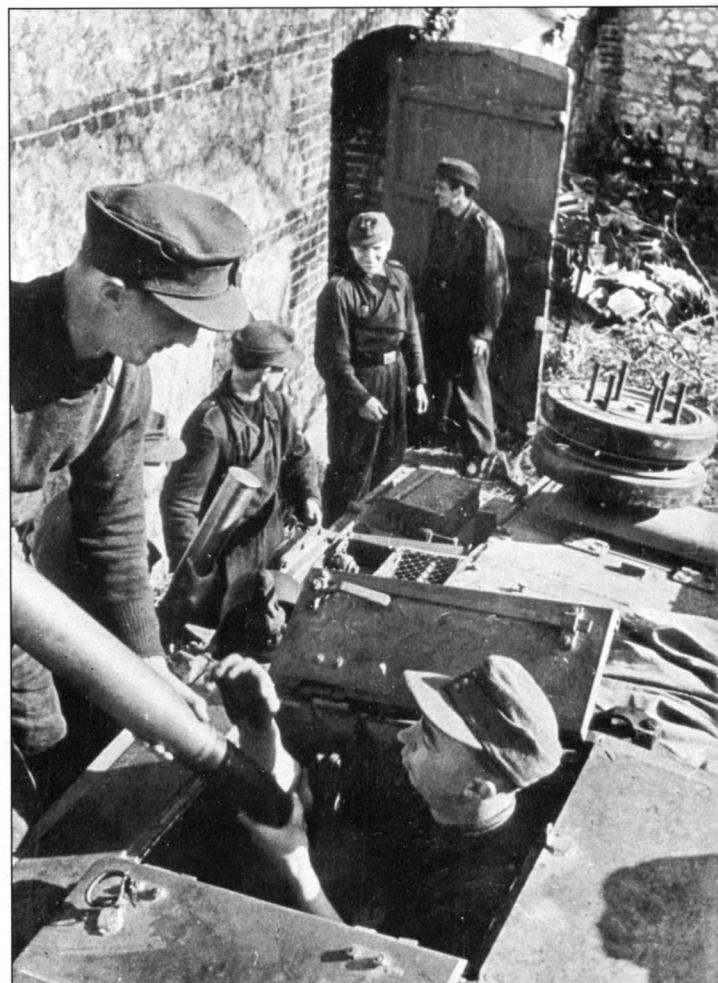
The crew of this StuG III replenish ammunition under cover of a farmhouse. The Ausf. G normally carried 54 rounds, but experienced crews removed the storage racks, thus doubling the capacity. Assault gun crew members were considered the elite of the artillery branch, and they were even issued special uniforms.

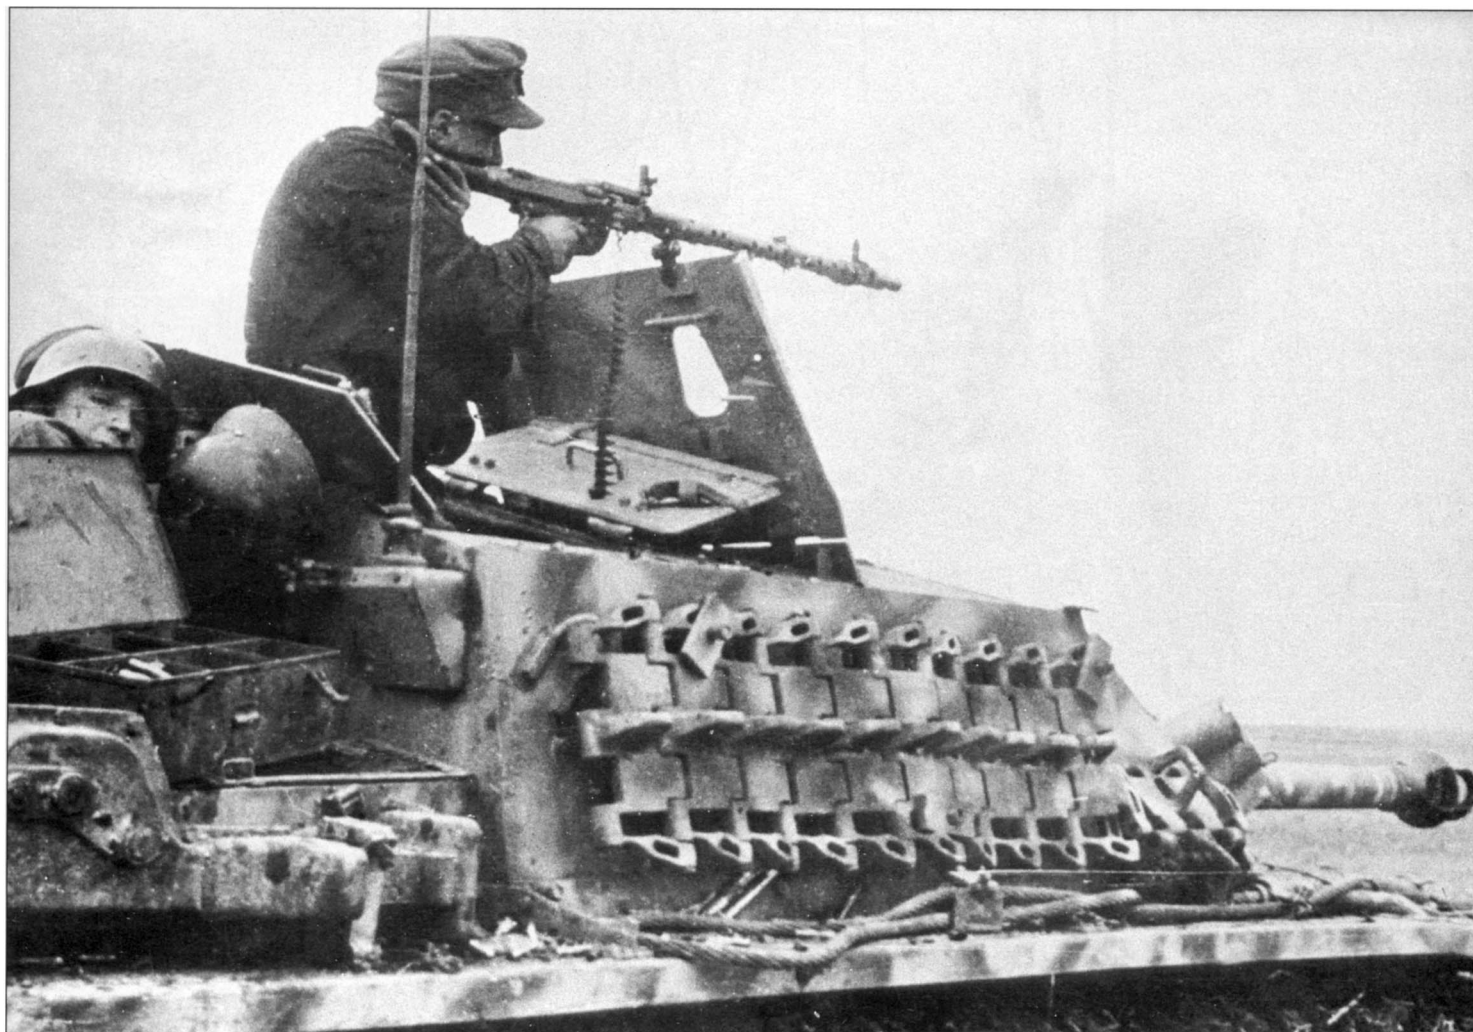
The loader of a StuG III opens fire at Soviet infantry. To get a clear shot, he has affixed his MG34 to the holder originally intended for AA defence. Crouching behind a hatch, an infantryman seeks cover. This Ausf. G is from the one production lot fitted with smoke candles. Its camouflage consists of dark green stripes over a dark yellow base.

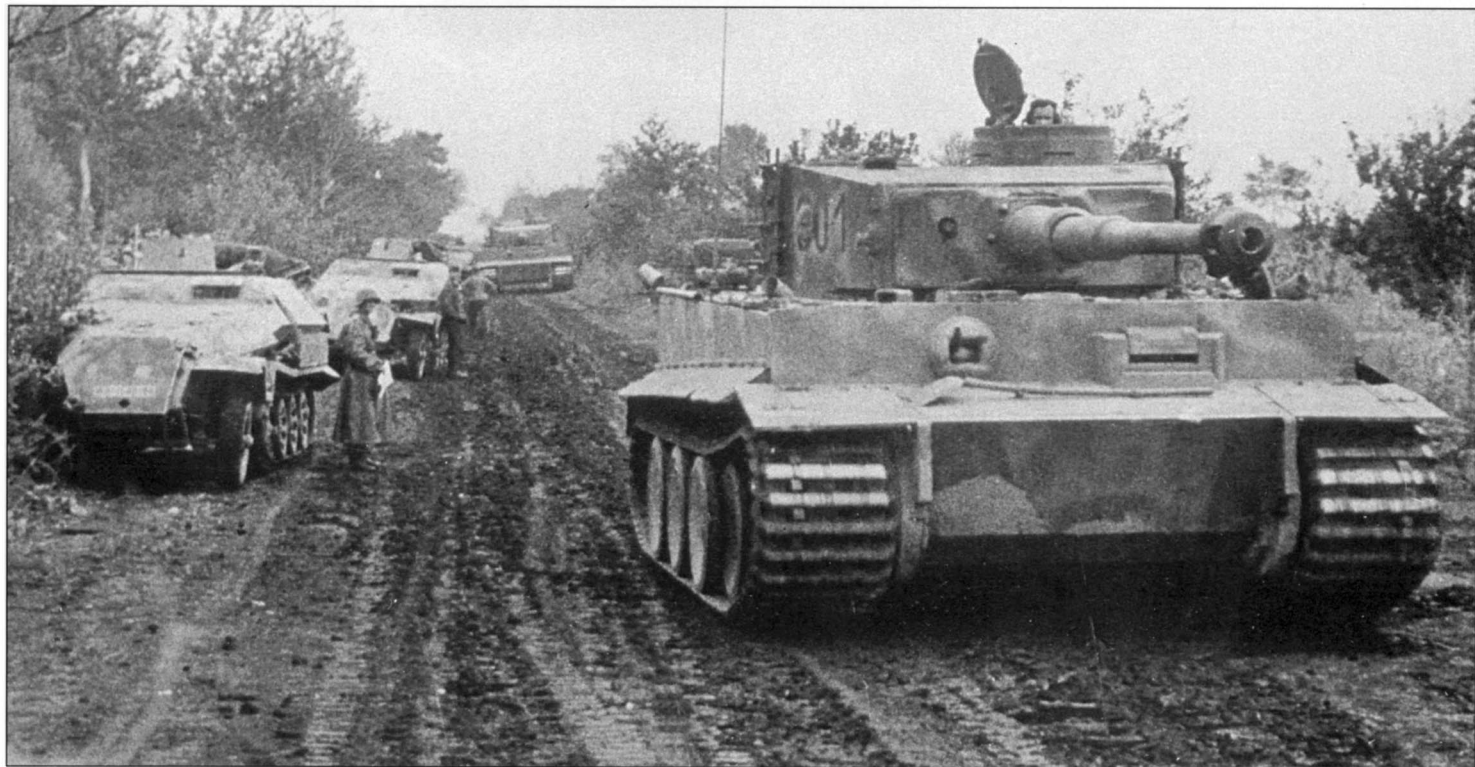
1943 was the year of the Tiger tank. Due to its heavy armor and deadly 8.8cm gun, it could easily destroy any enemy tank. The tank seen here, an early version, is painted in a three-tone camouflage pattern. Portions of the anti-magnetic *Zimmerit* are missing on the bow plate. Otherwise, the vehicle seems to be brand-new. The APCs in the background belong to Pz.Gren.Div. 'Großdeutschland'.

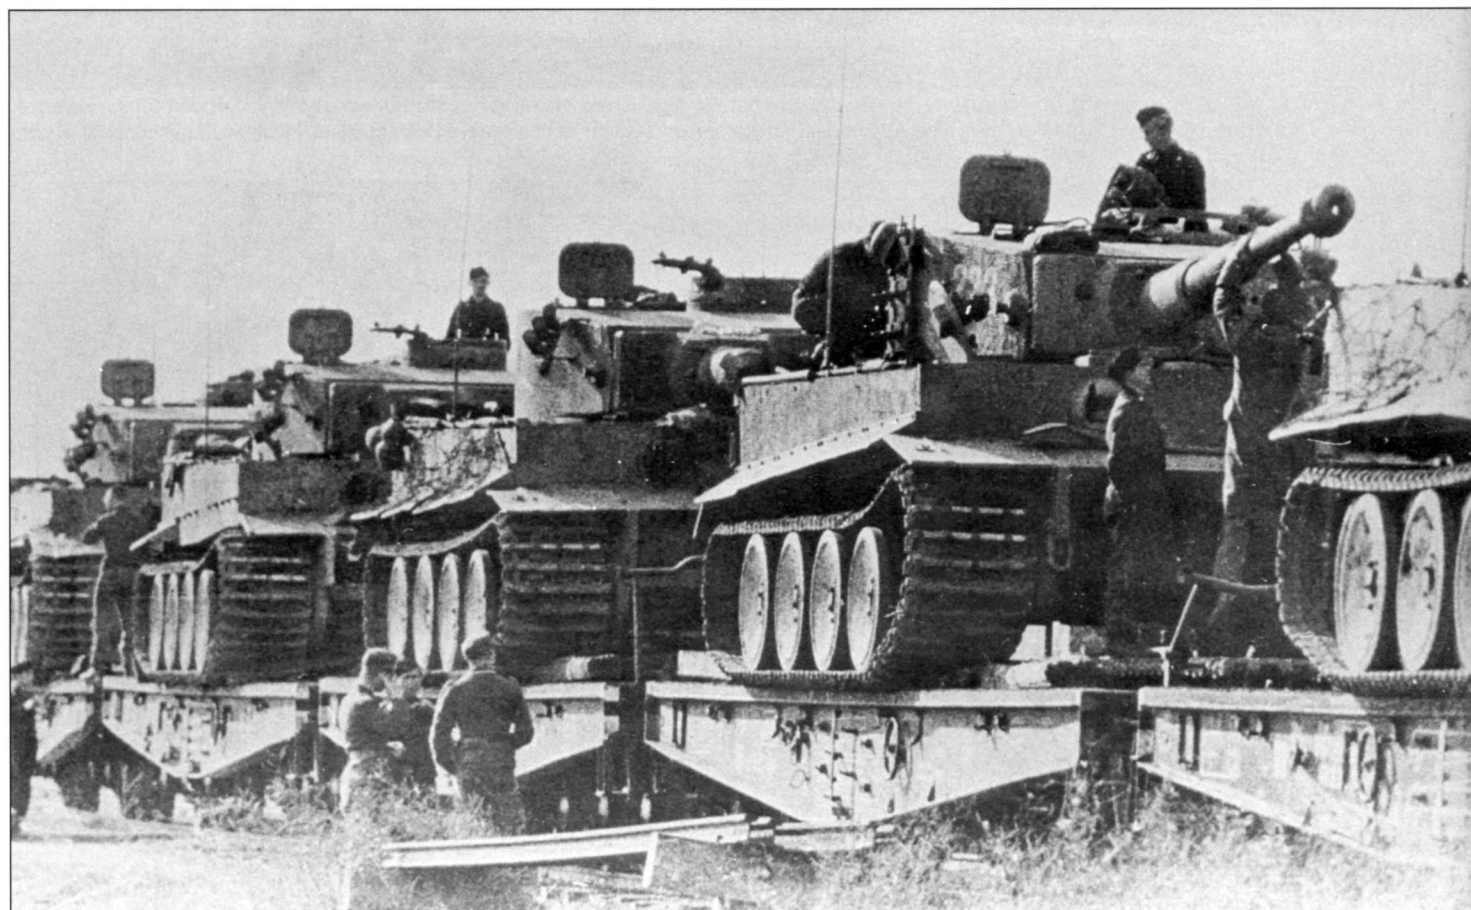
Railway transport was a common means of covering long distances during the war. Here a company of Tiger Ausf. E tanks is seen loaded for transport. Being too wide, the Tigers normally were fitted with a narrow transport track, but that was not done in this case, possibly due to time restraints. The vehicles are of different production lots, as is evident by the different commander's cupolas. Being produced after August 1943, only the second tank is covered with Zimmerit paste.

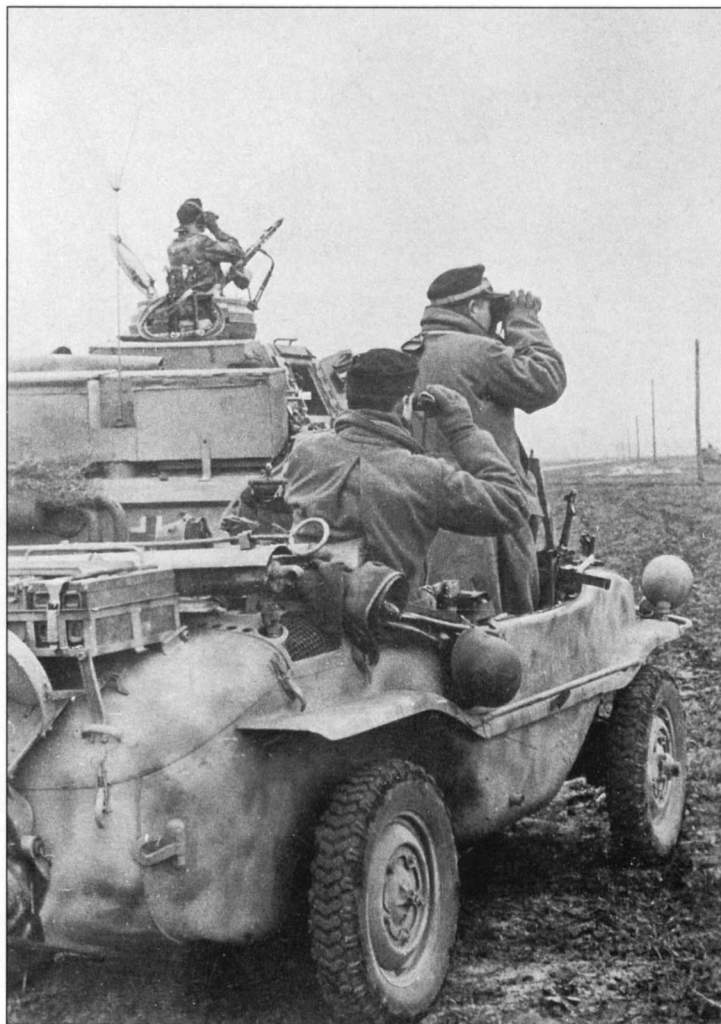
This interesting photo shows a Panzerbefehlswagen III Ausf. K command tank. The star antenna is visible on the rear of the engine deck. The commander and the two other officers standing in the VW Schwimmwagen use binoculars to watch the battle from a distance.

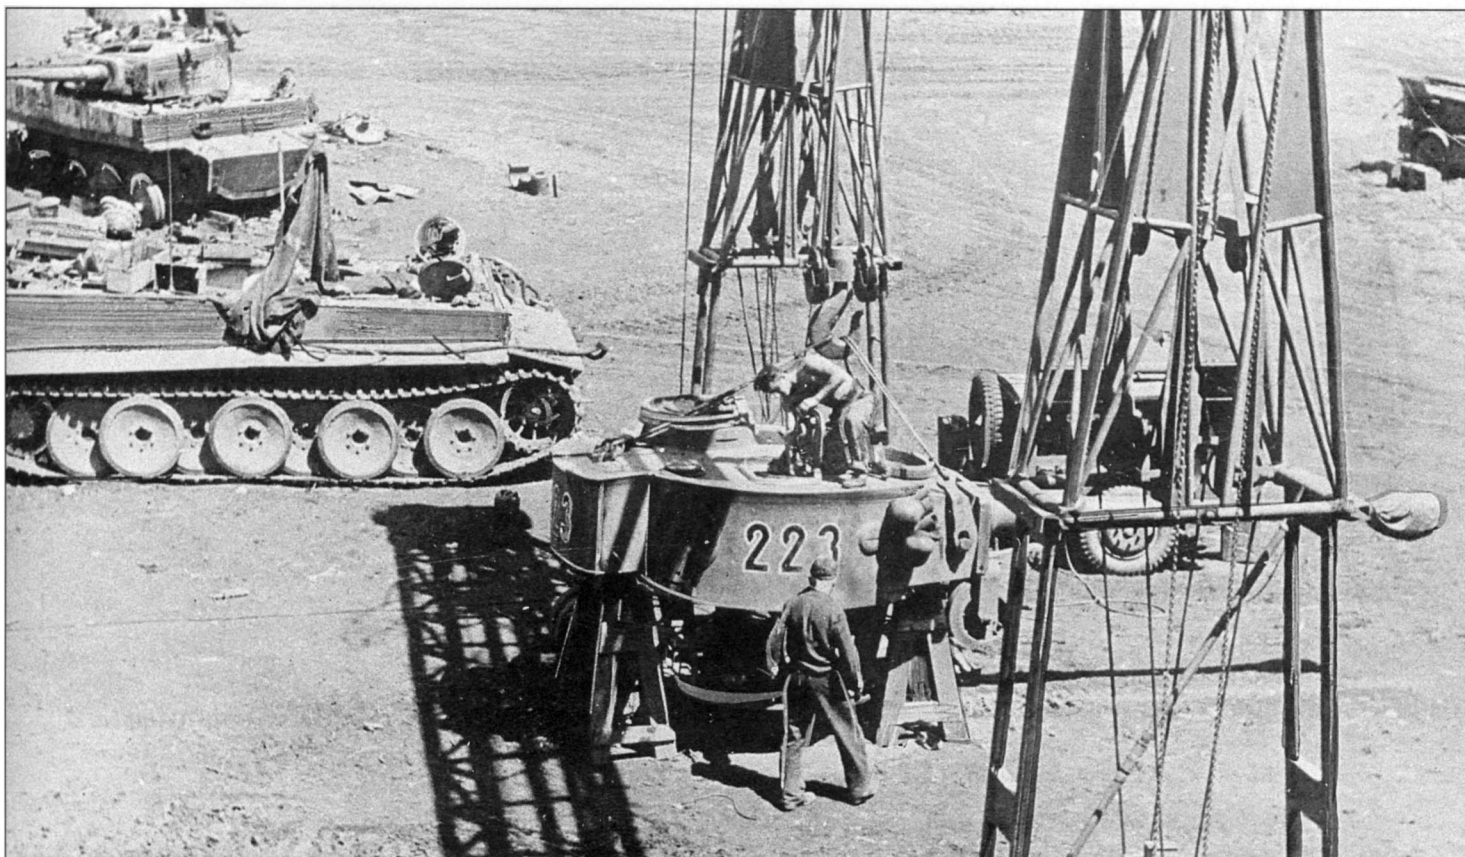
This heavily retouched photo shows a well-equipped workshop behind the lines. The heavy Tiger tanks required specially designed equipment. To remove the turret, portal cranes were used. Note how the control cable is attached to the lugs on the side of the turret.

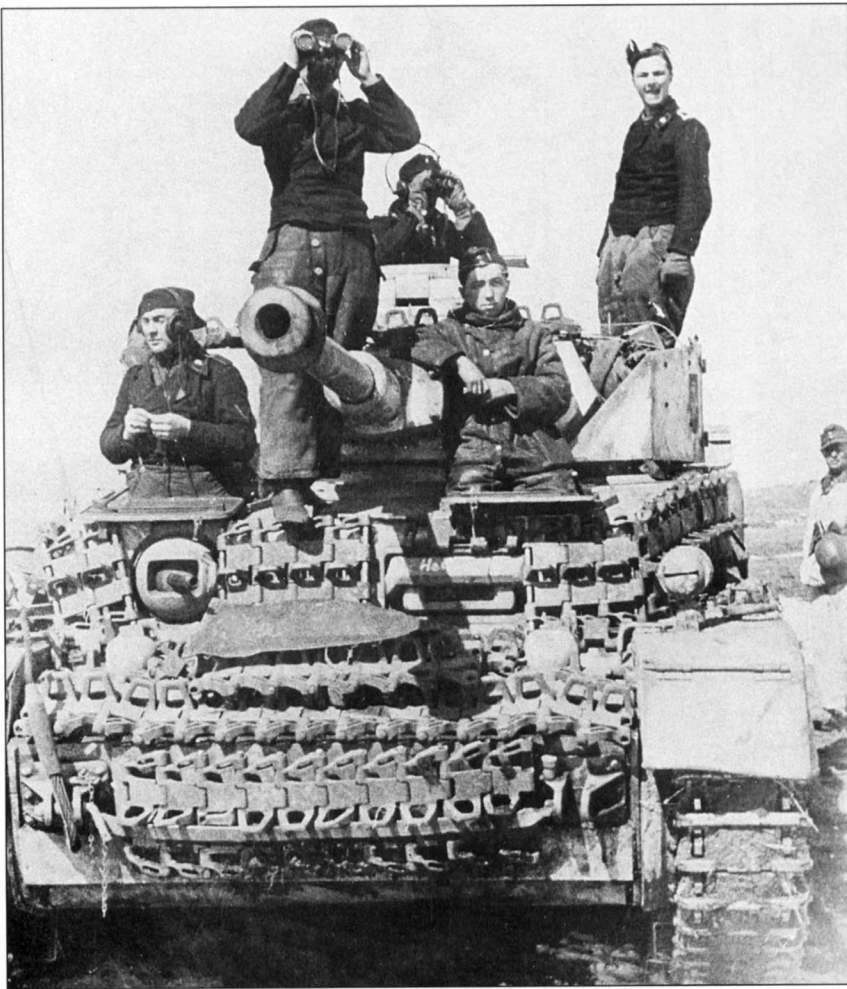
The crew of this reworked Pz.Kpfw. IV Ausf. G appears happy while posing for the camera. Perhaps this photo was taken after heavy fighting. The tank is packed tight with extra track links for maximum armor protection. The name 'Heidi' is just visible on the driver's visor.

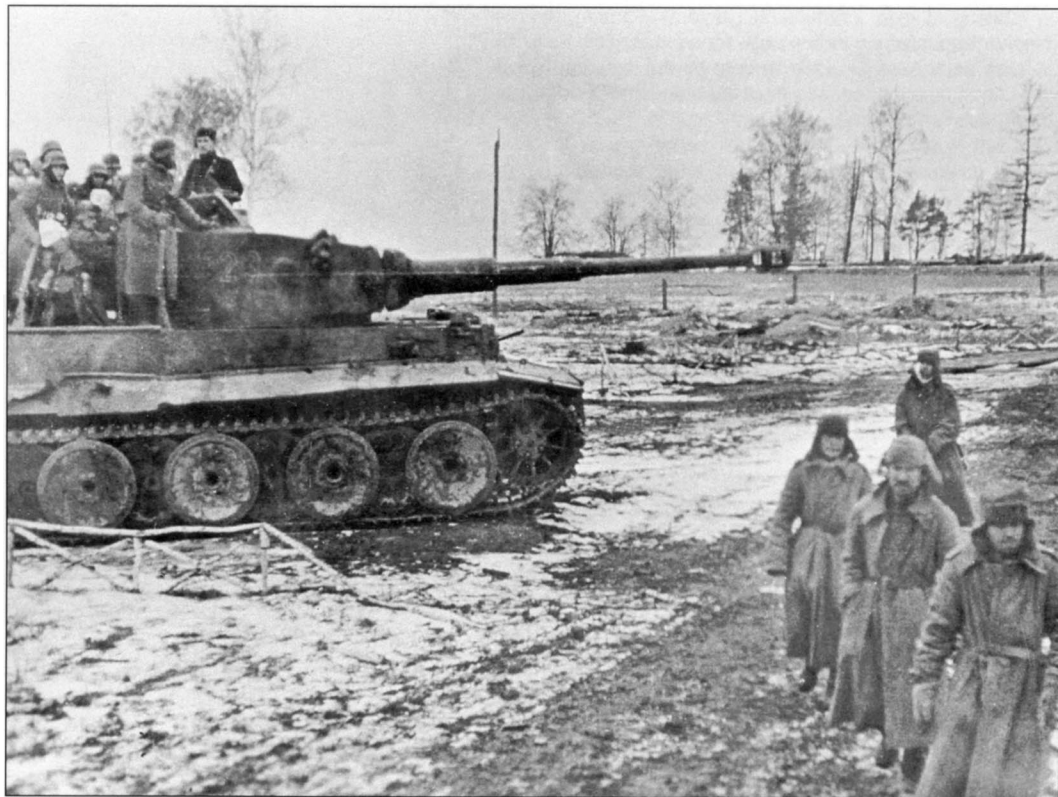
This photo quite dramatically illustrates the superiority of the Tiger tank. Though a number of hits are evident, not one has penetrated the heavy armor. The damaged roadwheel appears to be somewhat perforated by artillery splinters, however. The crew of this early Tiger is reloading ammunition. Note that the empty cartridges from the previous battle have been thrown to the ground.

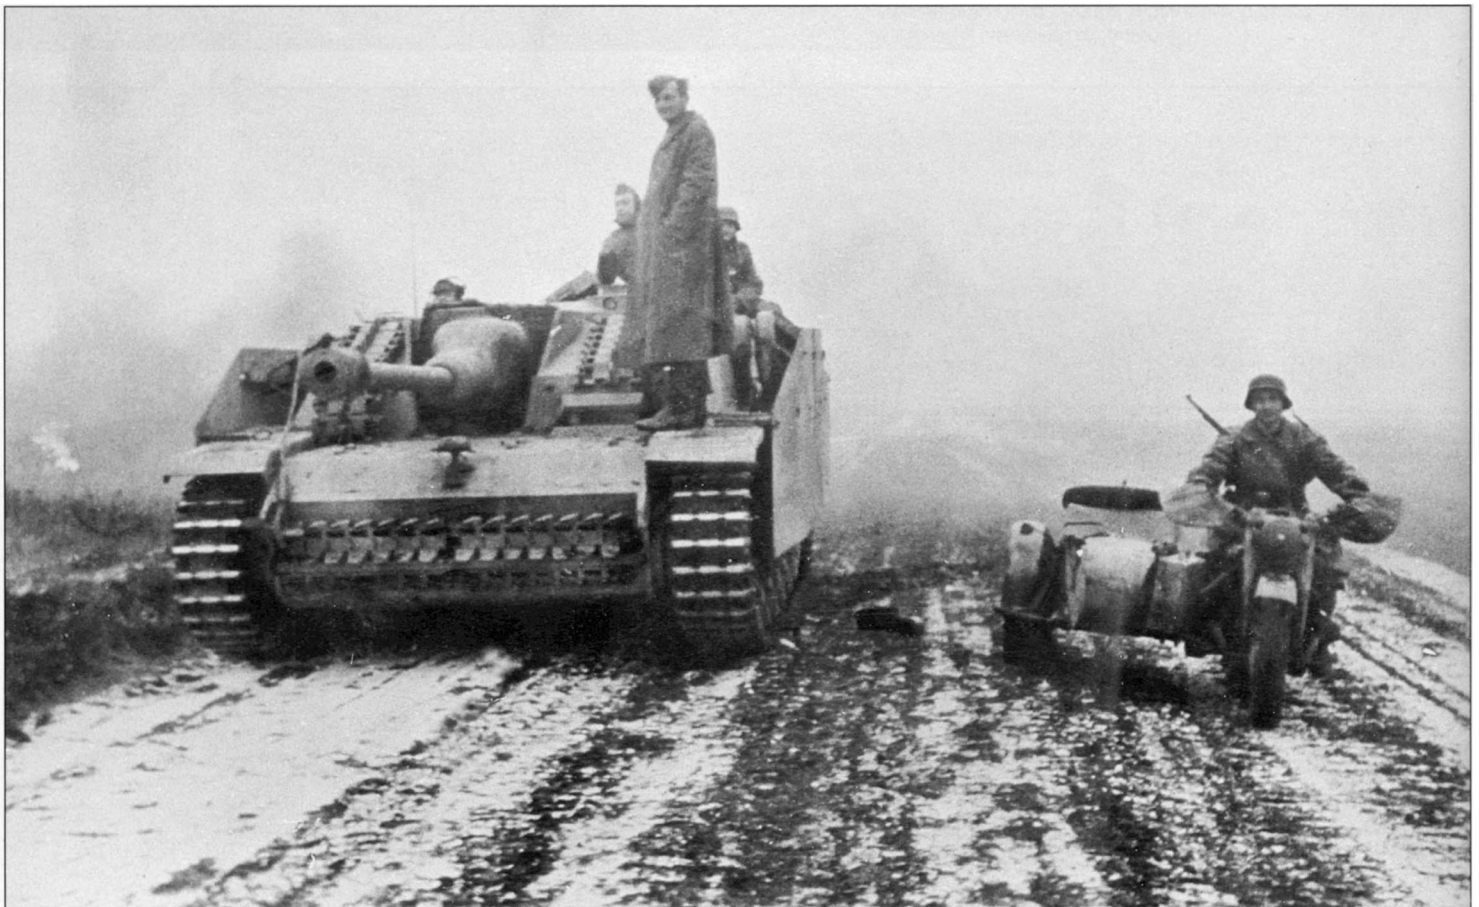
Standing still in its tracks, this StuG III waits for further orders. This late Ausf. G, which is in mint condition, is possibly a new vehicle. Of note are the large sections of spare tracks that have been applied to the casemate's frontal slopes.

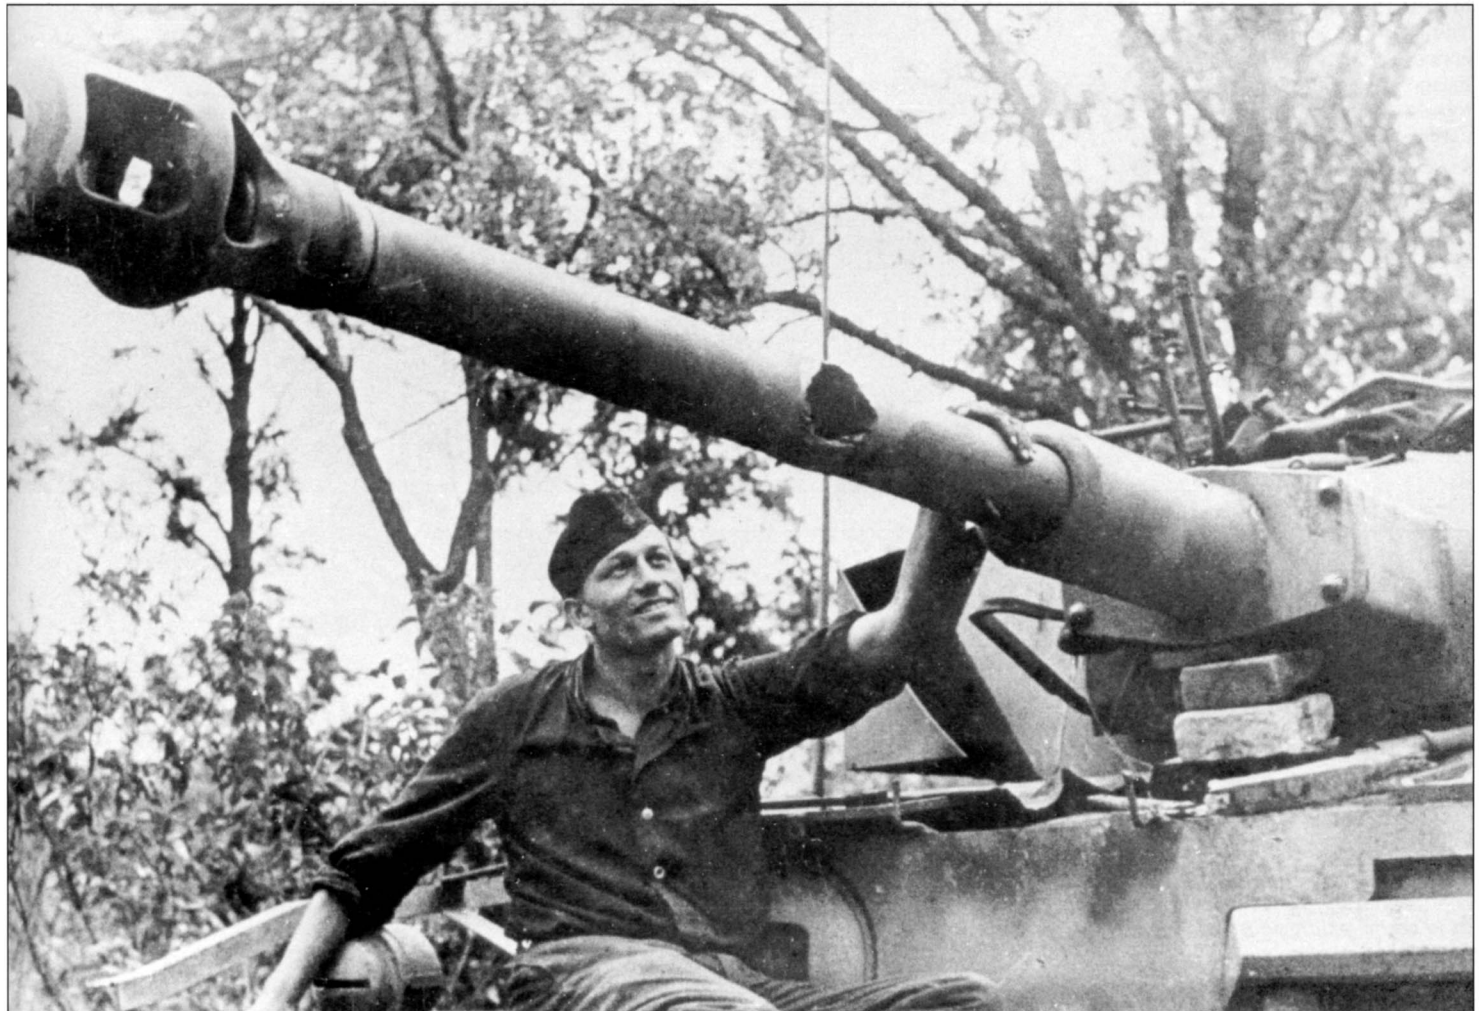
This Pz.Kpfw. IV Ausf. G (reworked) suffered a remarkable fate: the barrel of its 7.5cm L/43 gun was penetrated by a well-placed shot. Having immediately withdrawn itself from combat, the vehicle was saved and repaired. The Pz.Kpfw. IV shows retrofitted additional armor welded to the front and side skirts. The antenna, however, is still mounted on the right side of the hull.

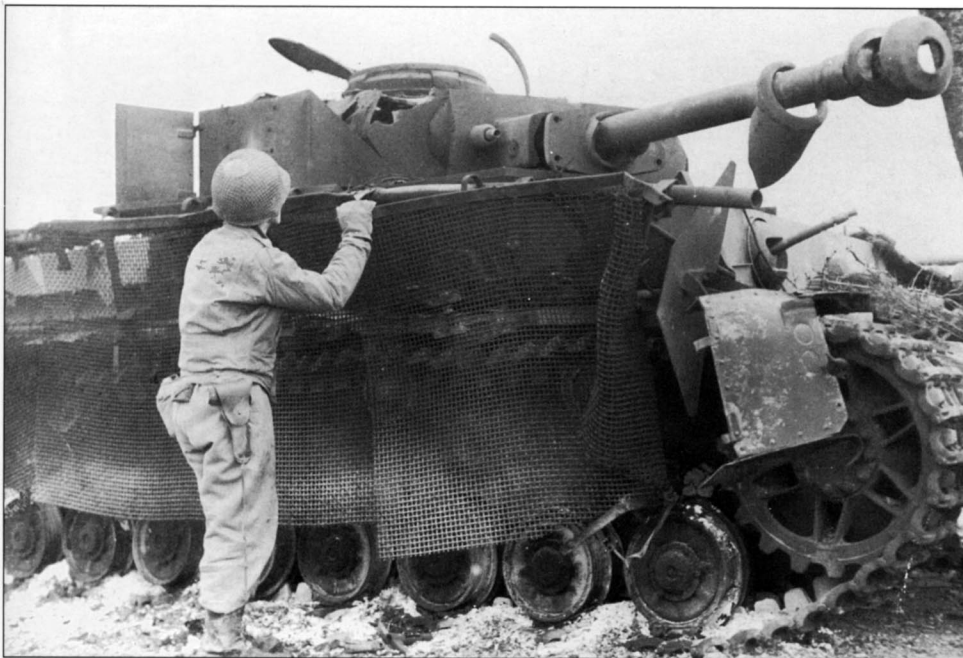
A fine view of a late-production Pz.Kpfw. Ausf. J. The tank was hit at the turret edge, but probably some other rounds penetrated its armor and caused a fire. All rubber coatings have burned down to ash. The G.I. is holding on to a wire mesh screen known as a *Thoma Schild* (Thoma shield), which was an antibazooka shield.

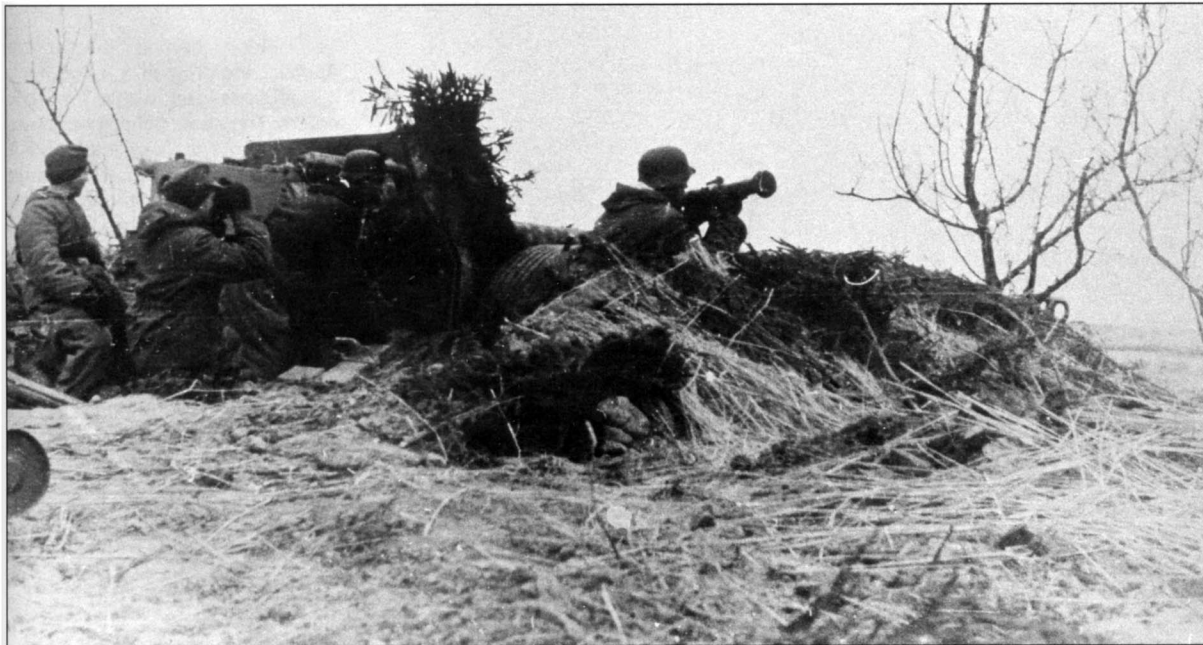
This 8.8cm Pak 43 has been effectively dug-in in expectation of a tank attack. The soldier to the right employs a range finder to make long range shots more accurate. There are cases known where such AT guns destroyed enemy tanks at distances well beyond 3,000m (3028 yards).

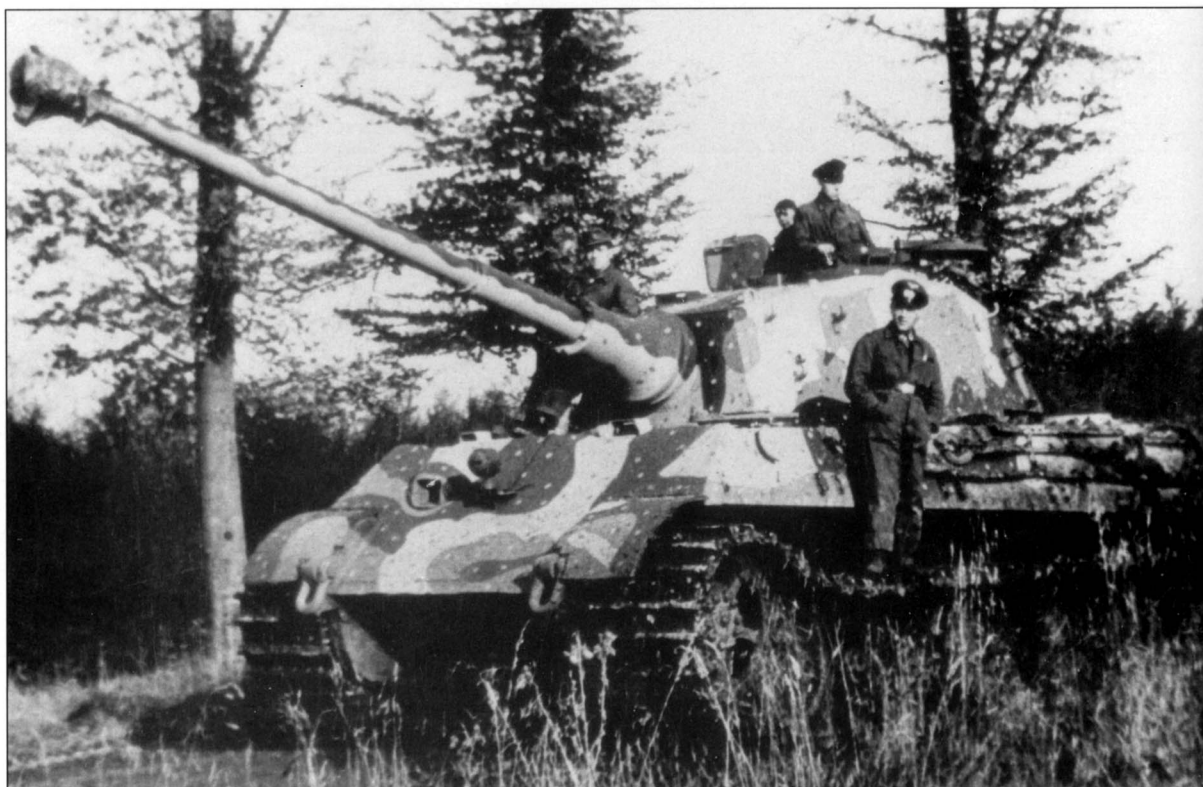
The heaviest German tank in action was the Tiger Ausf. B. Weighing 70 tons, it combined heavy armor with the famous 8.8cm gun. Here crew members pose in front of a late production vehicle. It shows no *Zimmerit* coating and is finished in the 'ambush' scheme. (Photo: Gruber).

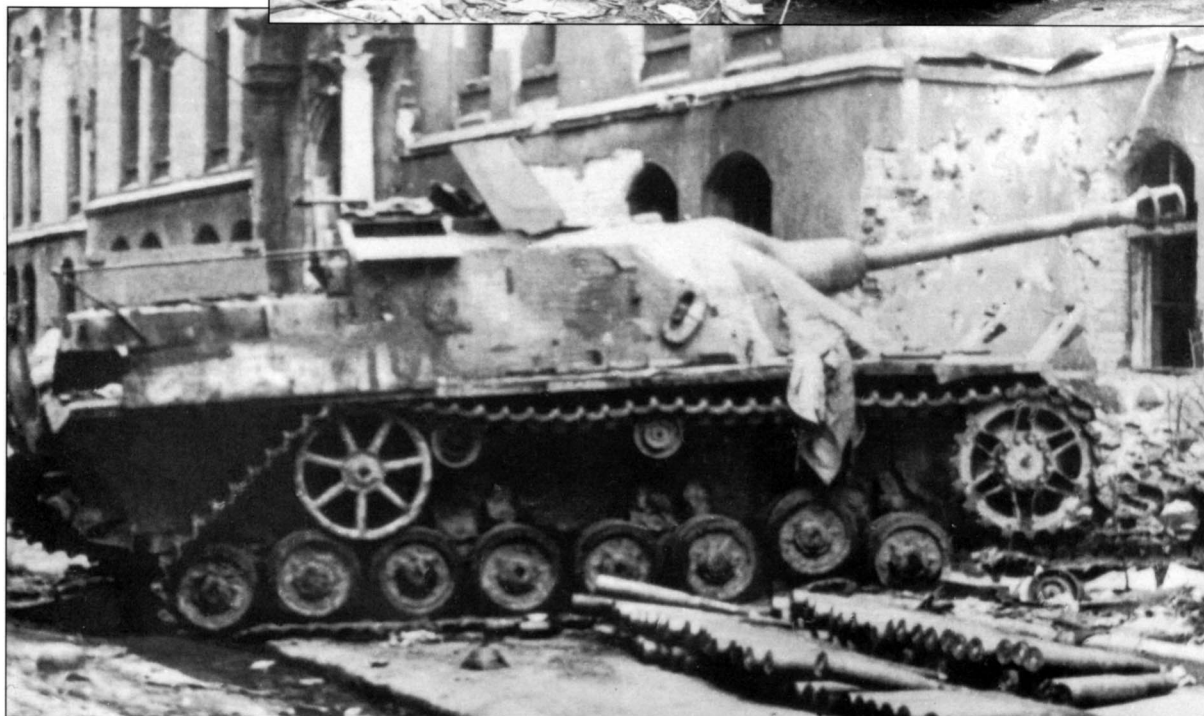
Littering the same road, this StuG IV apparently lost its idler wheel. The damaged running gear stopped the vehicle, which had to be abandoned. Note that the MG shield of a Sd.Kfz. 251 was used to improve protection of the loader. Remnants of a three-tone camouflage are evident. The ammunition, more than 50 rounds, has already been recovered from the vehicle.

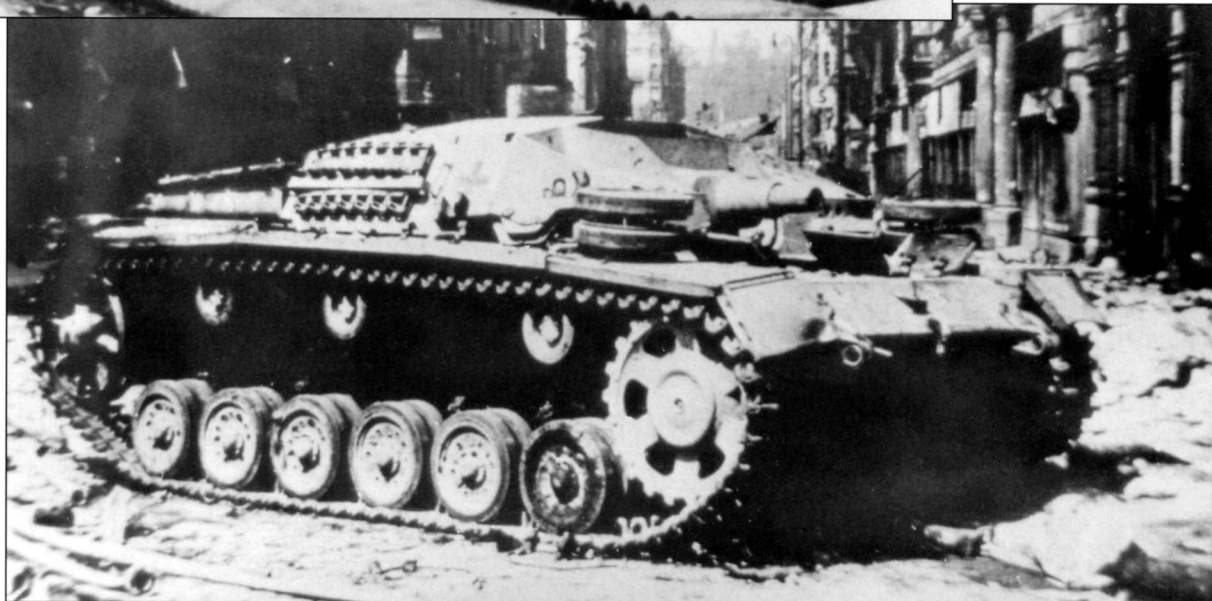
A lot of short-barrelled assault guns were still in service in 1945. This early-production StuG III Ausf. D was abandoned in Prague in May of 1945. After introduction of better ammunition for these guns in 1943, the combat value was increased again. However, combat against heavy tanks like the JS was senseless.

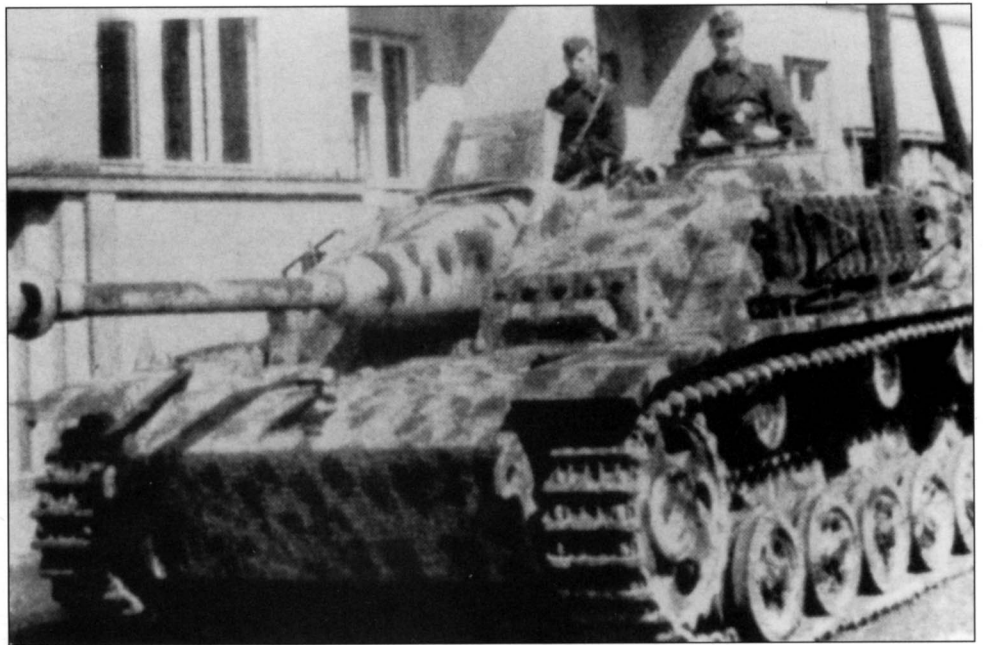
Sporting a very interesting camouflage of dark green or brown mottling over dark yellow, this late StuG III Ausf. G is seen in an eastern German town. Due to battle damage, the side skirts are missing and the rails were removed. Spare tracks were added to the superstructure's side as extra armor.

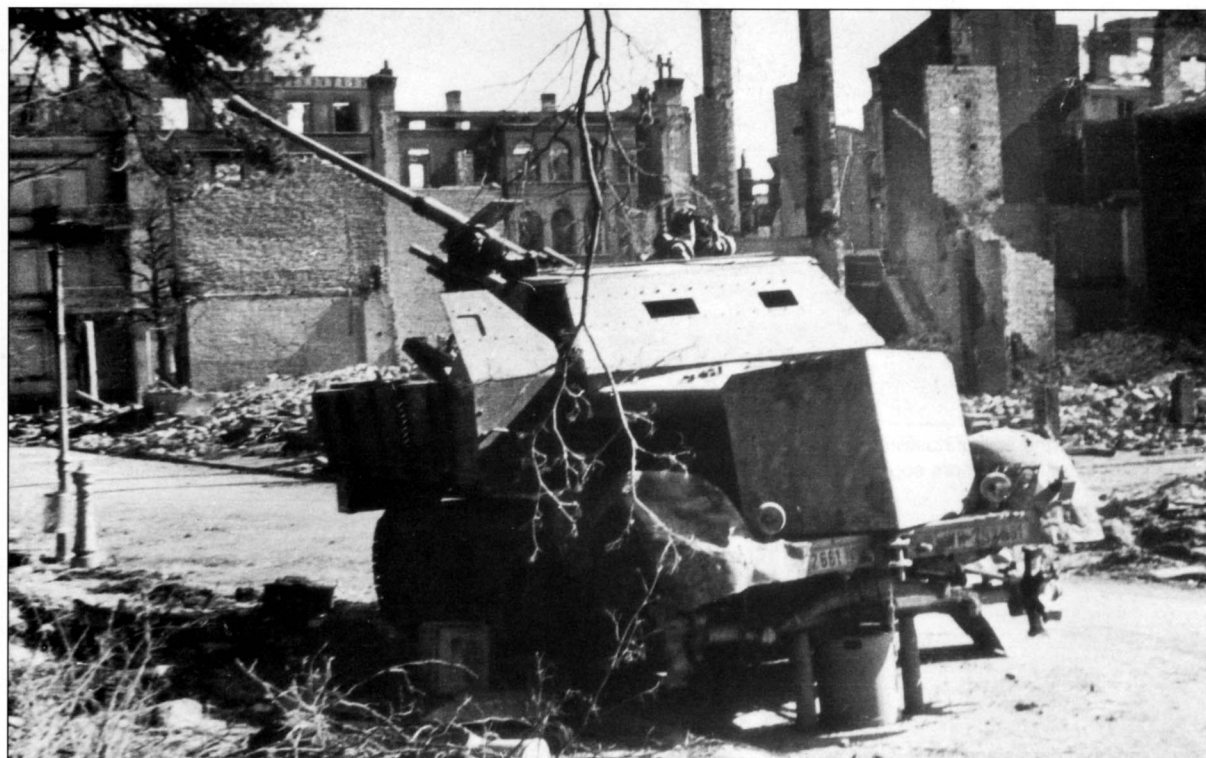
This Sd.Kfz. 7/2, which is fitted with an armored cabin, was abandoned after an unsuccessful attempt to repair the front axle. In the background, the ruins of a German city testify that the end of the war is fast approaching.
