# PANZERS IN THE EAST

(2) Decline and Defeat 1943-1945

Robert Michulec

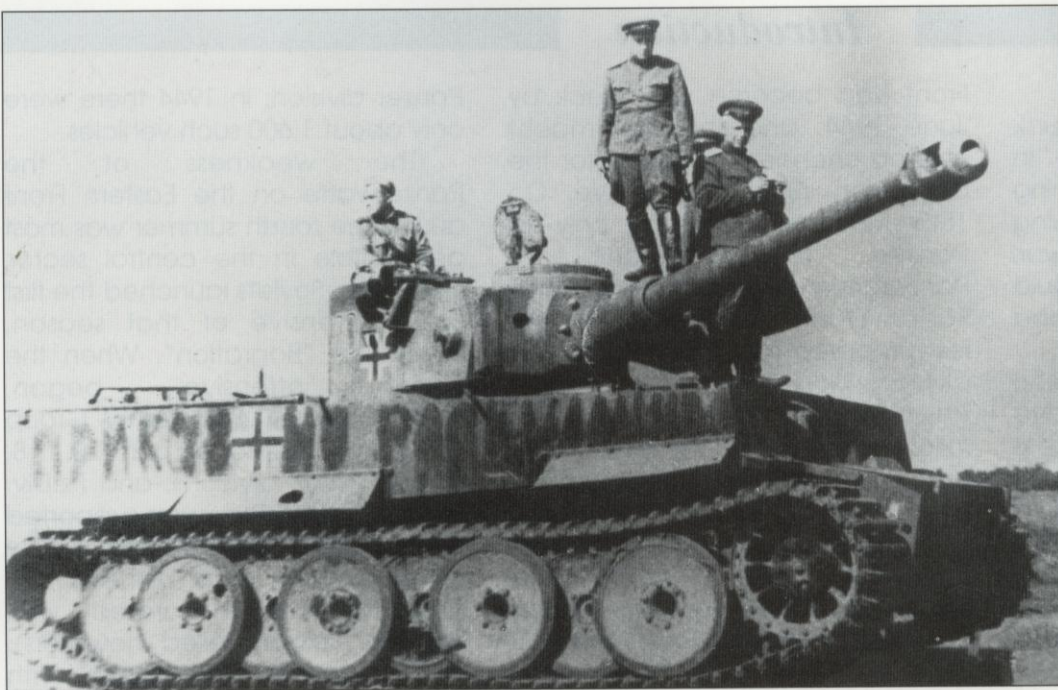
The aftermath of the Battle of Kursk, where heavy losses were inflicted on both the German and Soviet armies. This Pz.Kpfw. VI Tiger I, which was a unit commander's vehicle, was damaged by the Soviets and abandoned by its crew. Note the Cyrillic inscription on the side of the superstructure and the penetration holes. The tank was captured by the Soviets on 10th August 1943 near Grajvoron.

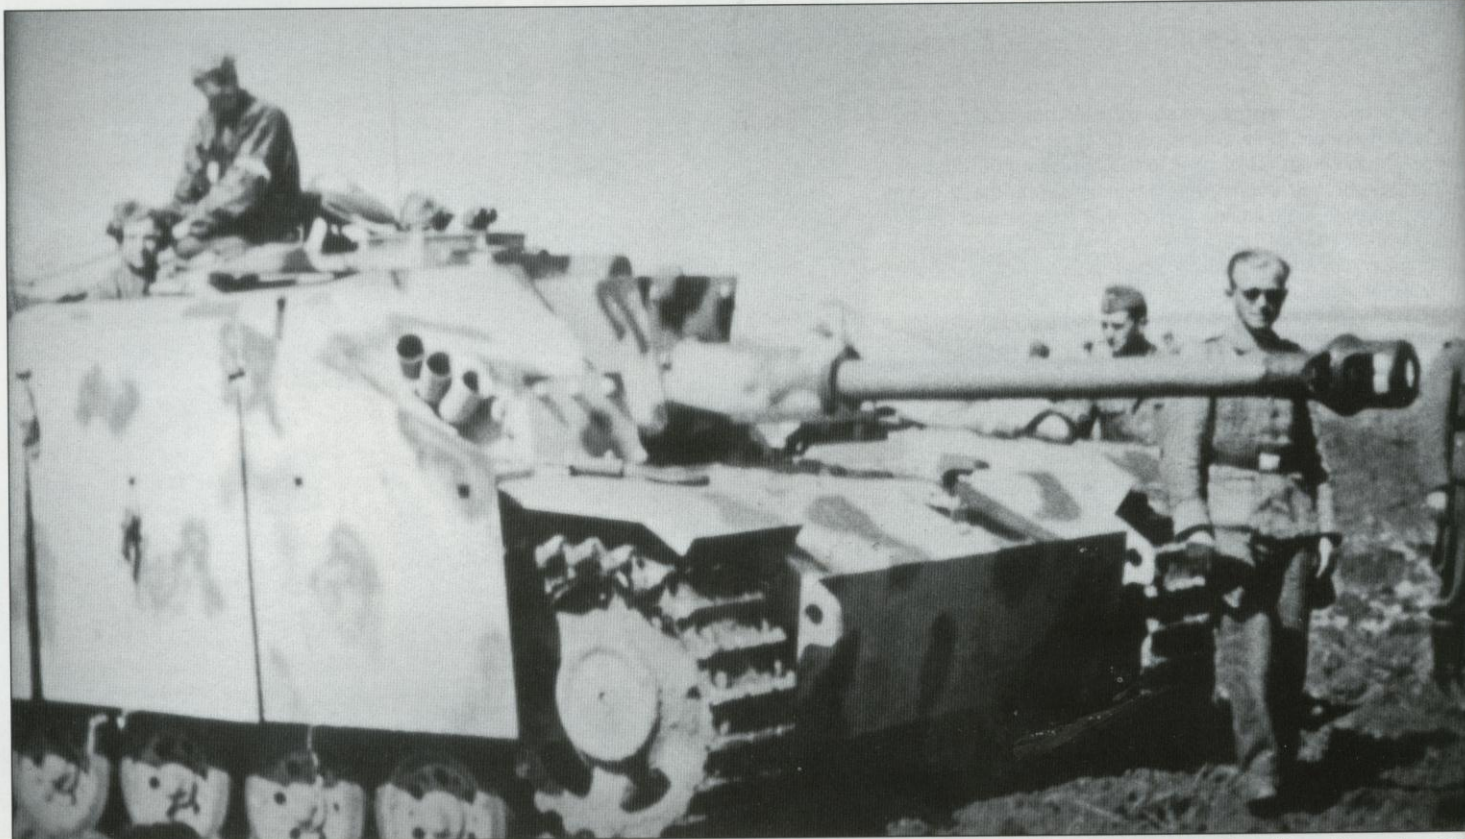
Another Ausf. G with its crew taking a breather. The vehicle is in very good condition. A total of 7,720 Ausf. Gs were produced from December 1943 onward, with an additional 173 converted from Pz.Kpfw. III in 1944.

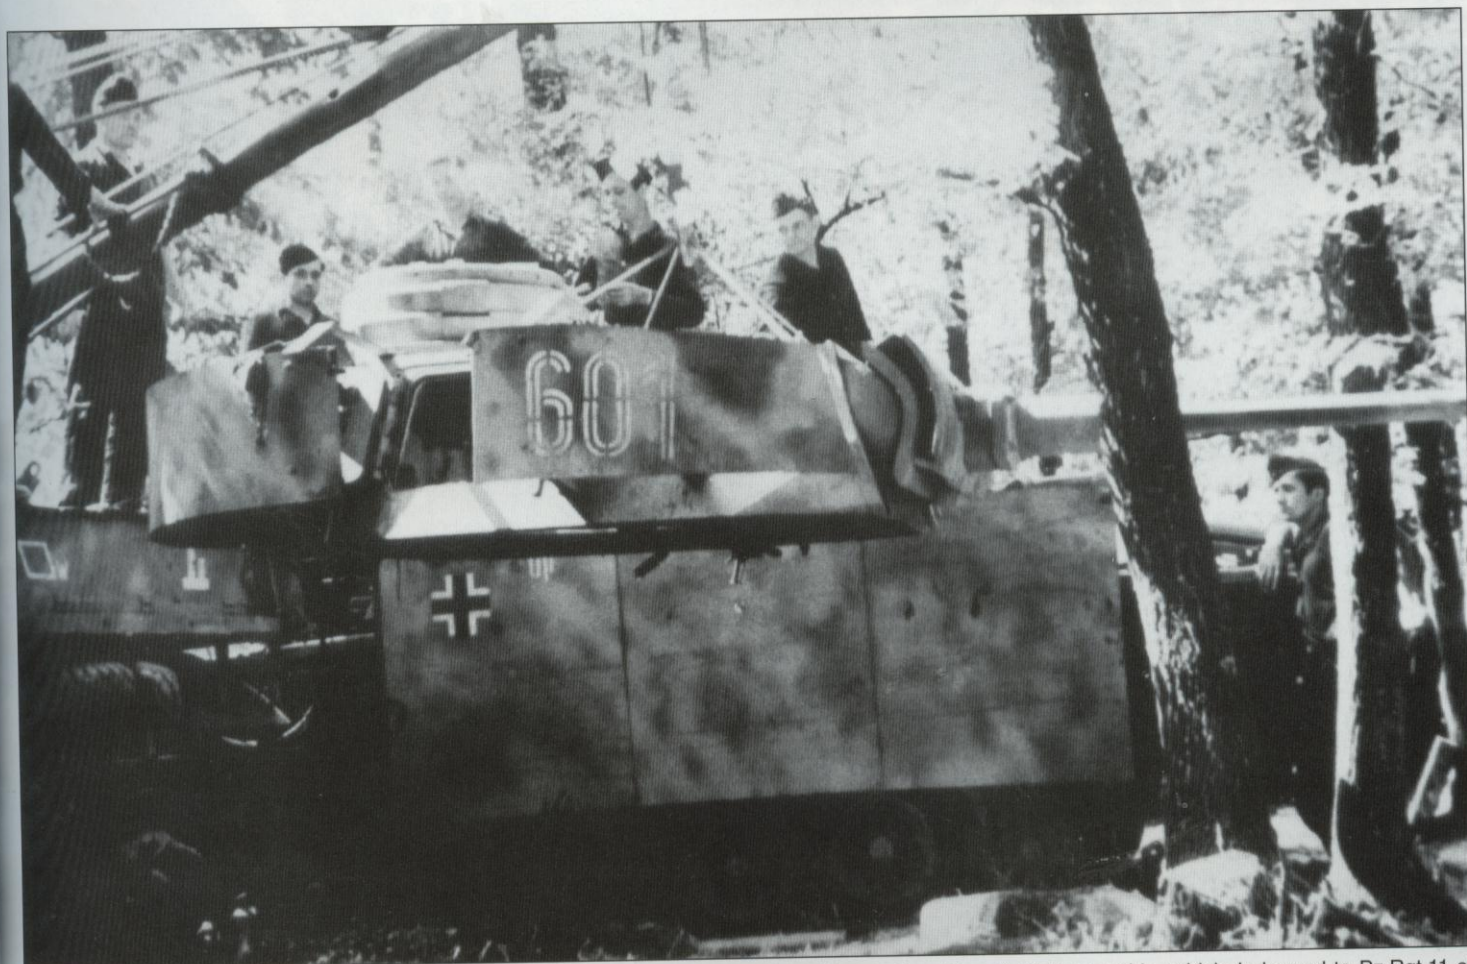
This Pz.Kpfw. III Ausf. M is having its turret lifted for repair works. The "Op" marking on the side skirt indicates this vehicle belonged to Pz.Rgt.11 of 6.Panzerdivision. The regiment fought near Belgorod during "Zitadelle" as part of III.Panzerkorps. The camouflage consists of olive green and red brown patterns sprayed over the dark yellow base.

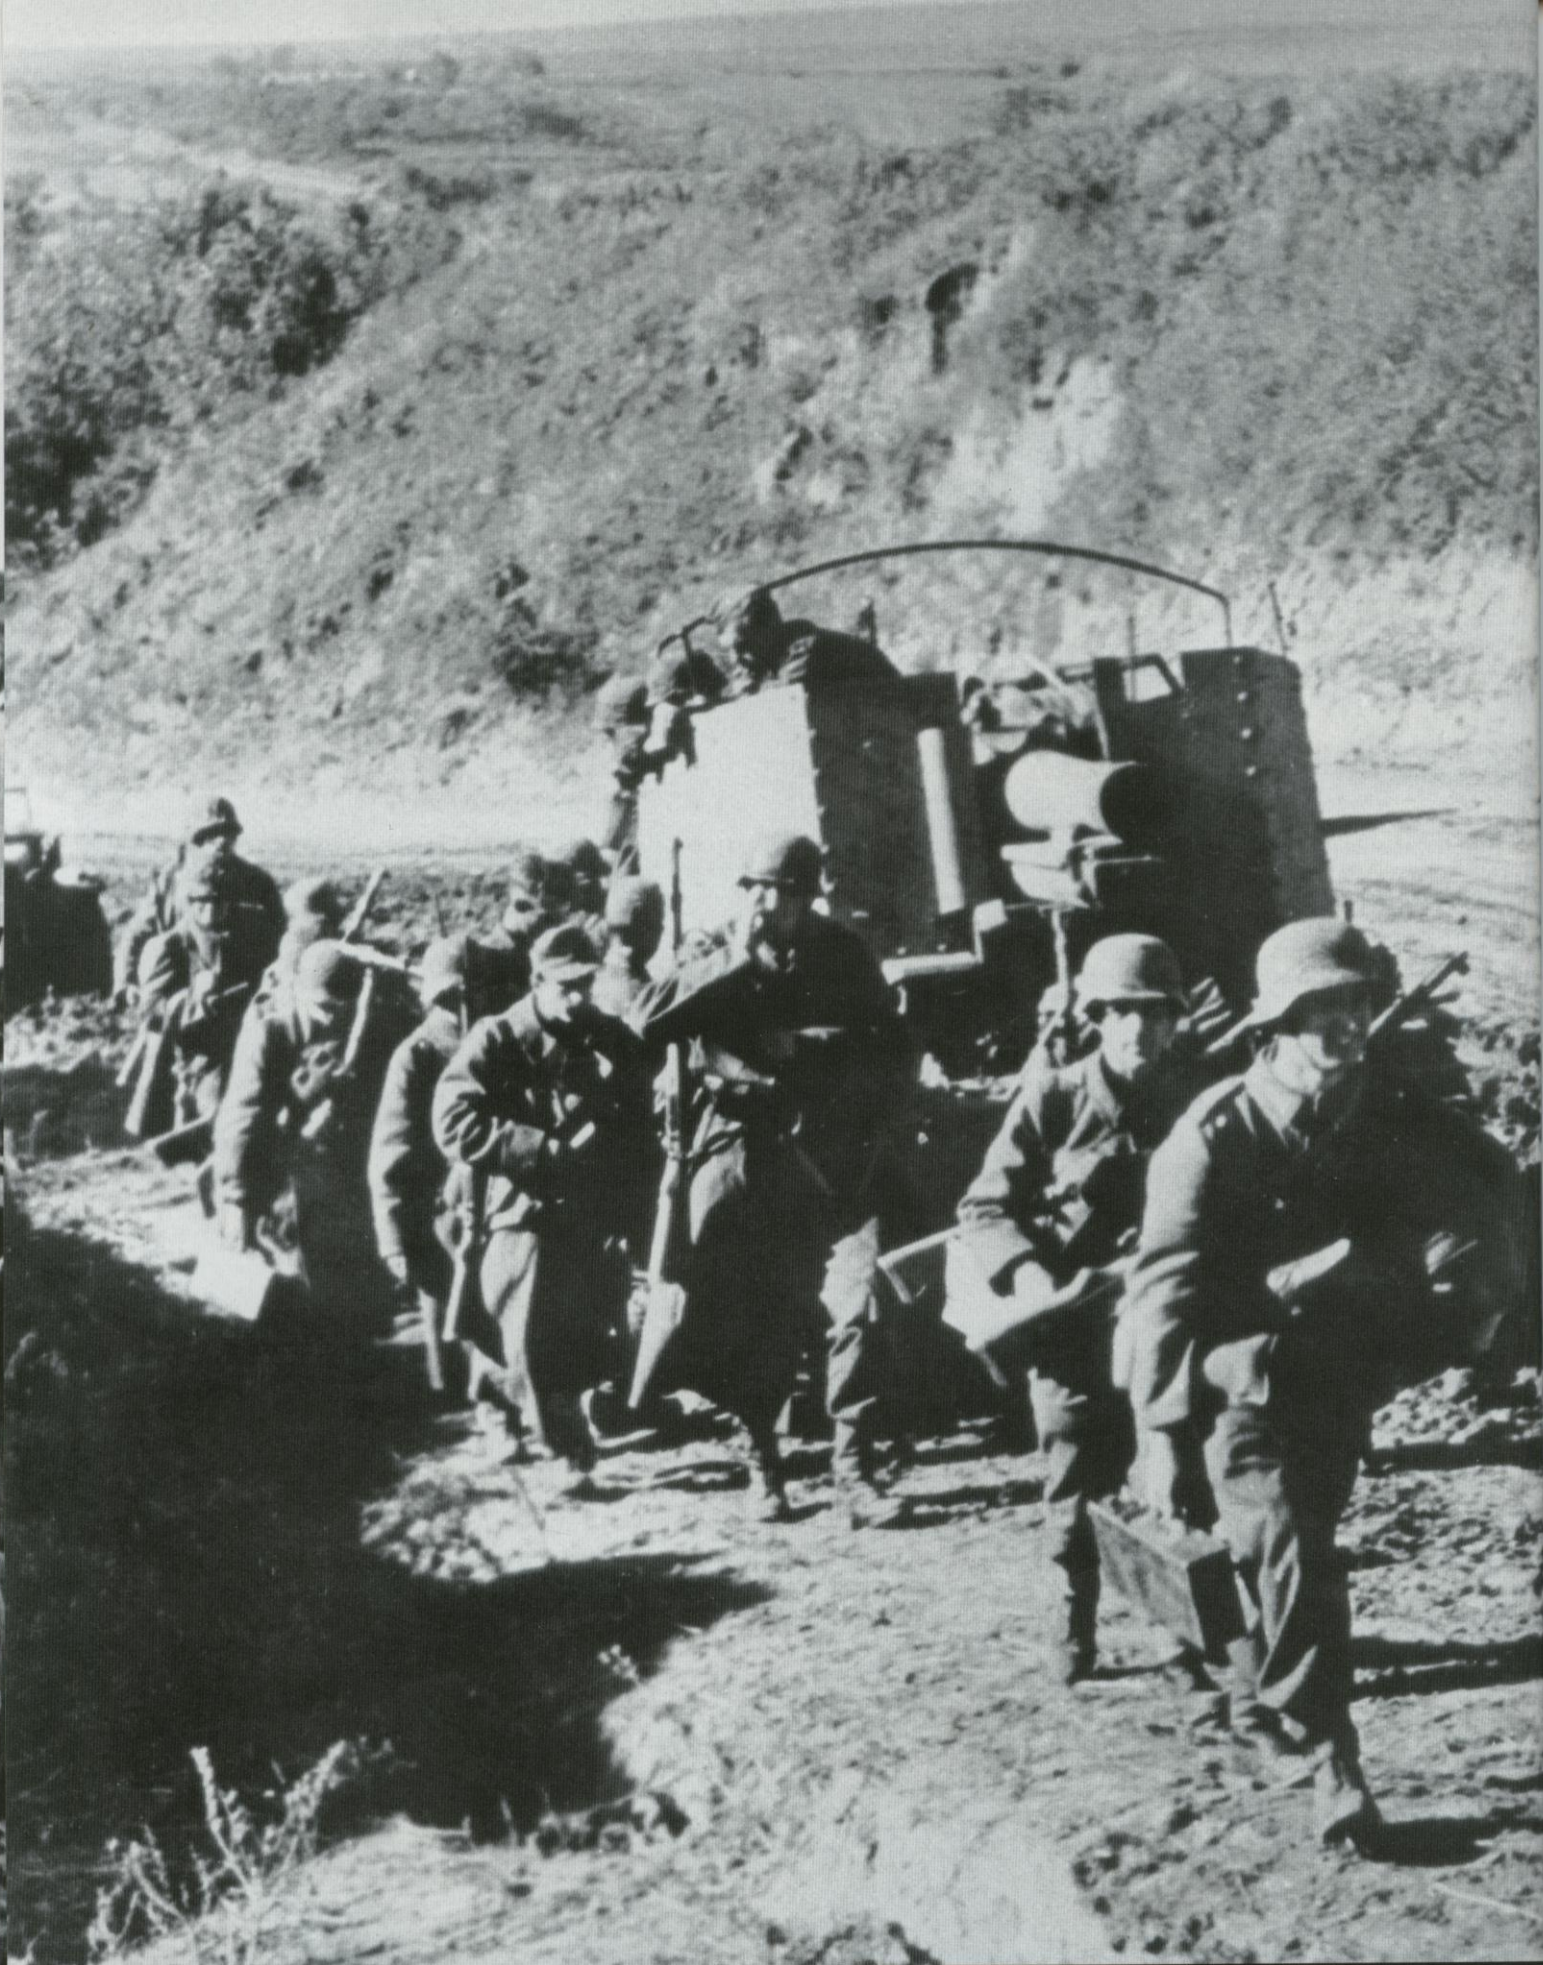
The vehicle shown here, the Sd.Kfz. 138/1 Grille (cricket) heavy self-propelled gun (SPG), was rarely seen on the Eastern Front. It was built on the Pz.Kpfw. 38(t) chassis and was armed with a 15cm sIG 33 gun. About 100 of these vehicles were produced between the beginning and autumn of 1943. They were used in the artillery units of infantry regiments in Panzer divisions.

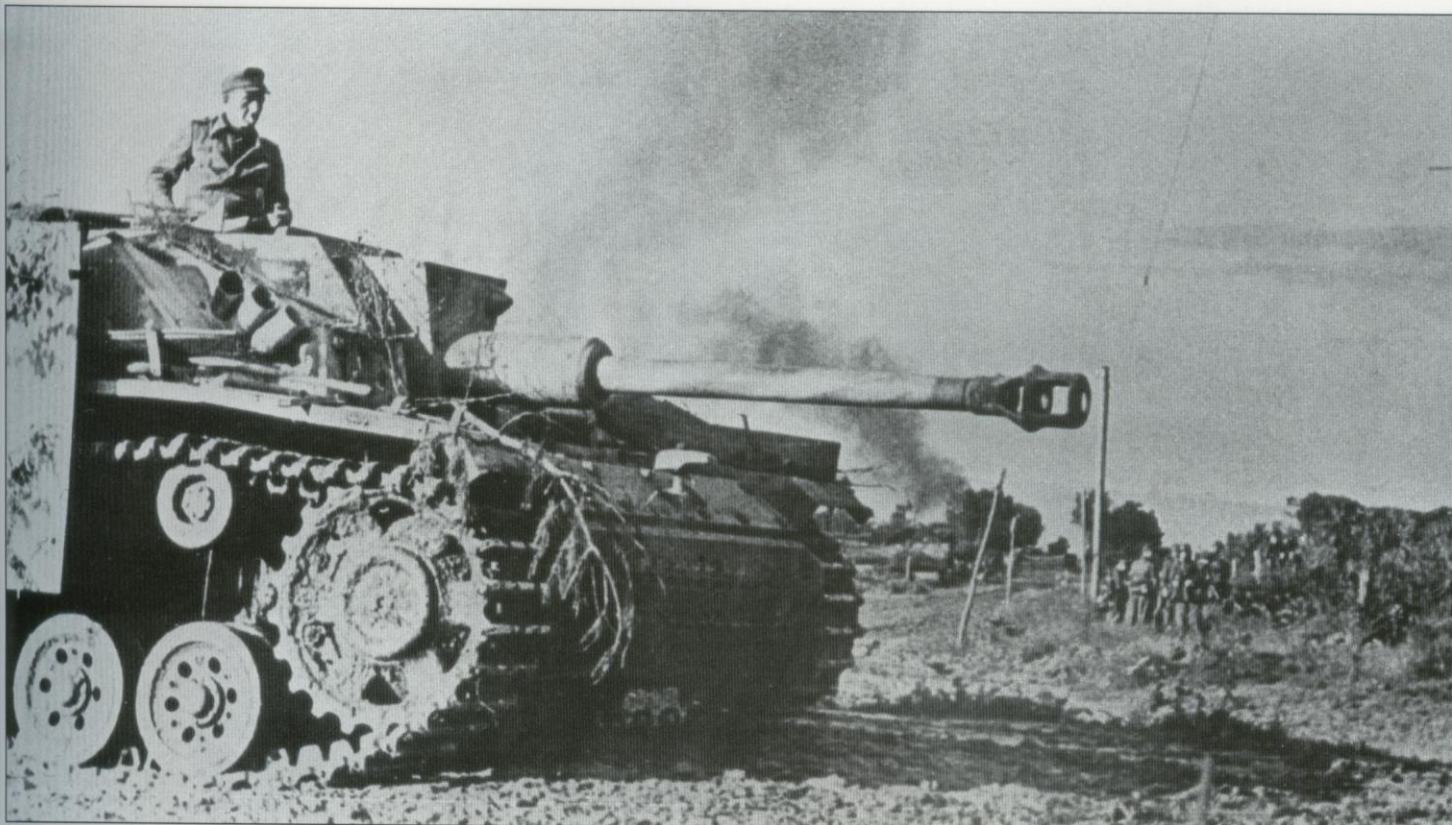
This photo shows a StuG III Ausf. G in action. The front part of the right set of skirts is missing, so the smoke grenade launchers are clearly visible. The muzzle brake illustrates the typical German practice of painting the muzzle brake of tanks and self-propelled guns a very dark color — usually dark gray. During combat in the autumn of 1943, the Panzerwaffe lost the largest number of StuGs since the beginning of war against the Soviets — about 200 vehicles per month. Most of them were lost on the Eastern Front, of course.

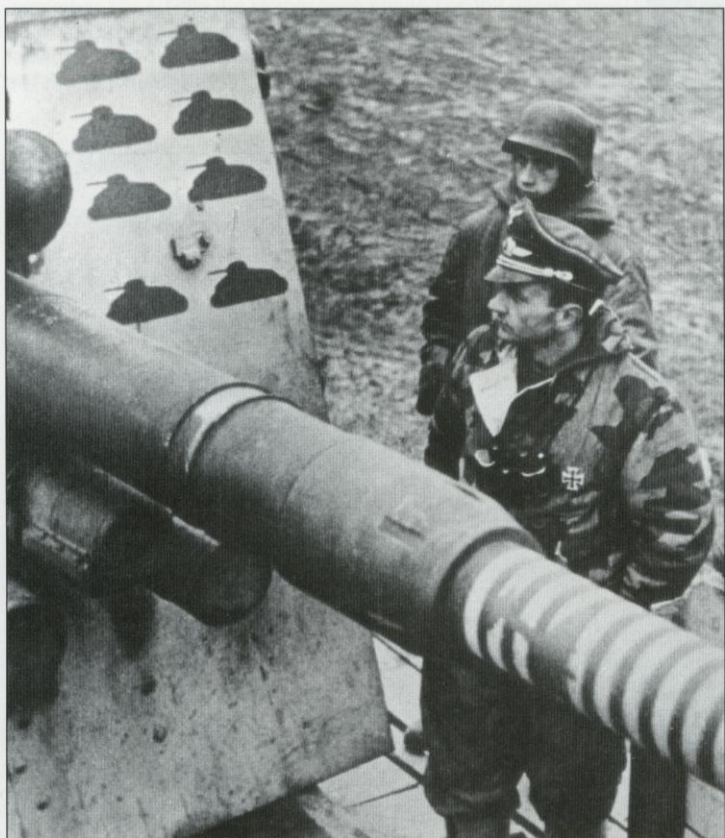
The commander of an *Eisenbahnpanzerzüge* with 8.8cm Flak gun studies the kill marks painted on the armored shield of one of his guns. The eight markings indicate victories over enemy tanks. The ten kill rings with the silhouette of an aircraft seen on the barrel of the gun represent the number of aircraft downed by the gun. This gun belonged to the "armored railway trains" that had achieved success as an anti-tank, anti-aircraft and artillery support weapon since 1942.

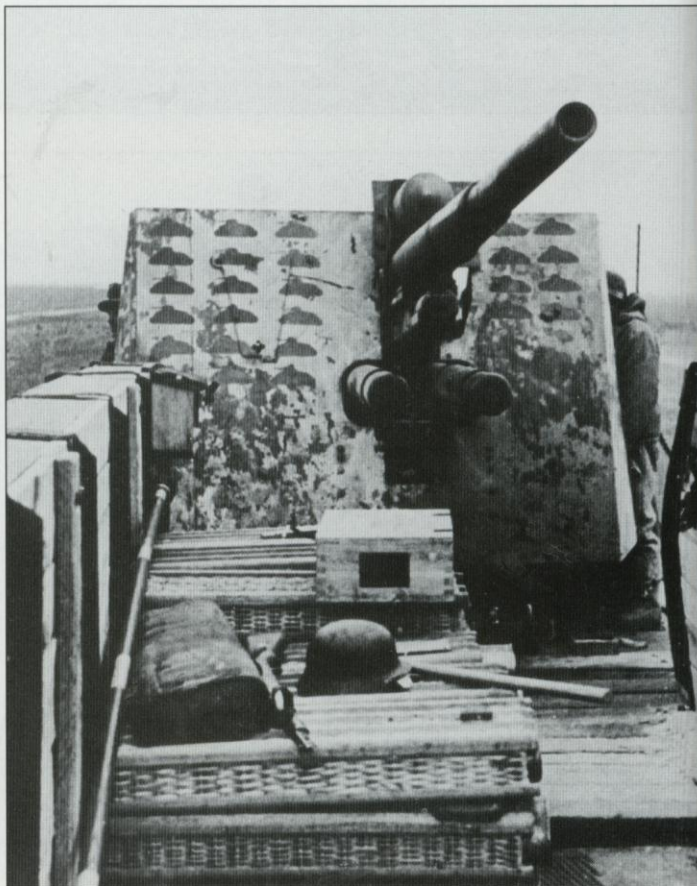
Another "88" gun from the same *Eisenbahnpanzerzüge* displays its successes: 26 tank "kills" on the gun shield and seven or eight air victories on the barrel. Note the damage to the right "armor plate" (composed of sand in a wooden framework), and that the gun has a dark gray barrel and a sand-colored shield.

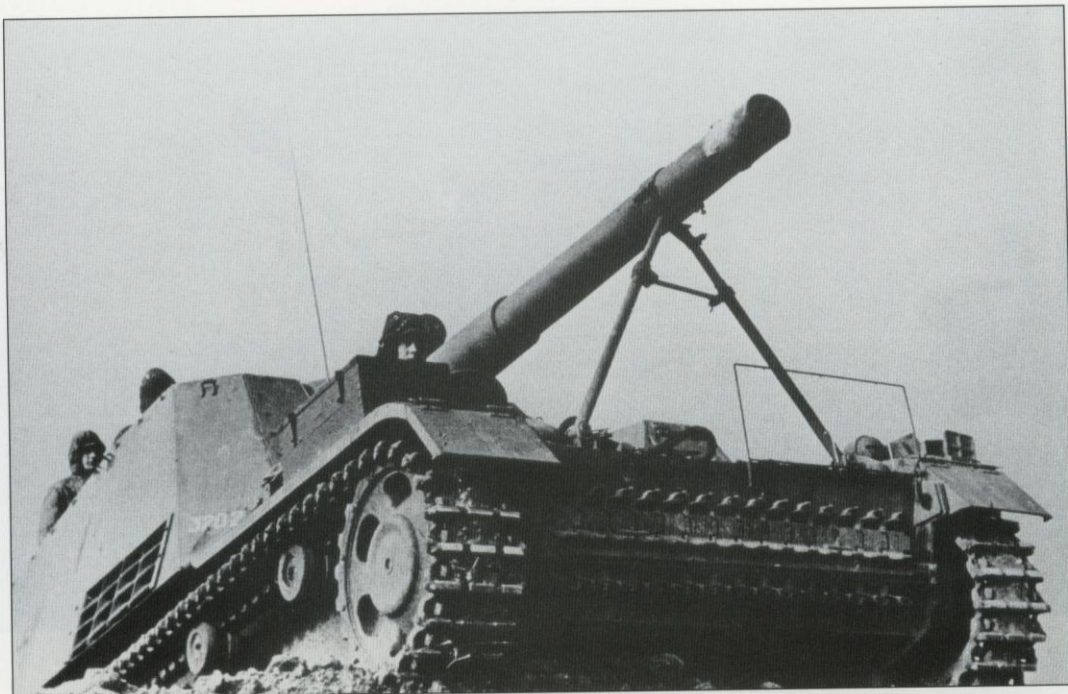
This Hummel self-propelled howitzer was captured on film as it drove negotiating a slope. This is a very rare Eastern vehicle, which is indicated by the lack of horizontal camouflage and the serial number painted in white on the dark yellow colored superstructure. The Hummel features a 15cm sFH 18/1 mounted on a Pz.Kpfw. III/IV chassis.
